**AIRCRAFT ACCIDENT
INVESTIGATION REPORT**

**PRIVATELY OWNED
JA 3825**

CESSNA 172N RAM, JA3825

MINAMIFURANO-CHO, SORACHI-GUN, HOKKAIDO

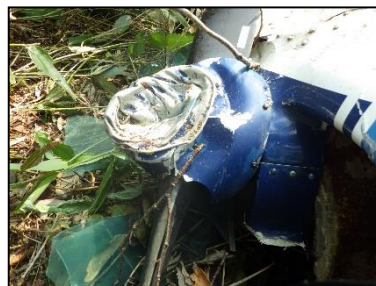
Figure 3: Spinner

- (1) Extent of damage of the Aircraft: Destroyed
- (2) Damage to parts of the Aircraft
 - a. Fuselage
 - The spinner was crushed and deformed from the front.
 - The skin between the engine mounting area and cabin had been torn off.
 - The strut supporting the left main wing was fractured at its attaching point to the fuselage and tree chips were attached.
 - The cargo compartment of the aft fuselage had buckled.

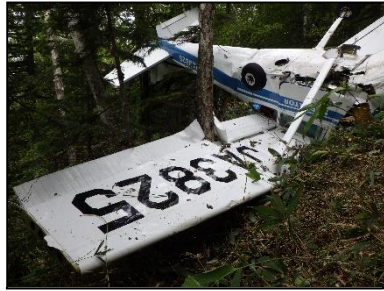
Figure 5: Left main wing

- b. Main wings
 - The flap positions were at the Full Up for the right main wing and slightly Down for the left main wing.
 - The left main wing was damaged between flap and aileron because its trailing edge had hit trees.

- The left main wing tip was ripped off.

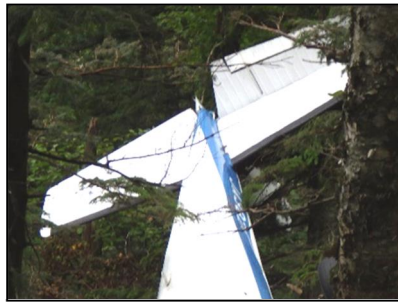
Figure 7: Bottom of the empennage

- The horizontal stabilizer had hit trees and the elevator was in an asymmetrical position.
- Slight damage was confirmed on the skin of the rudder.

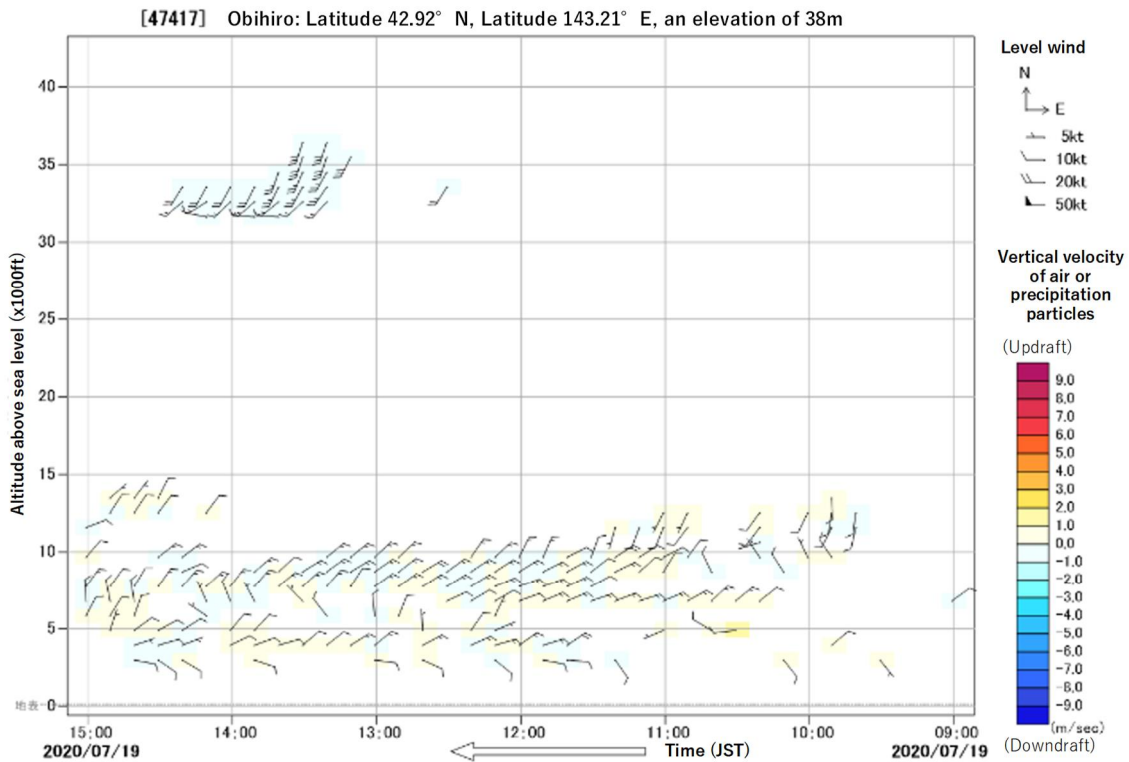
Figure 10: Wind Profiler (Obihiro)

The values observed by a wind profiler at Obihiro during the time period relevant to the accident are shown in Figure 10, with a wind of 10 kt from east to southeast at an altitude of 3,000 ft between 13:00 and 14:00, and there was no major fluctuation. (See Figure 10)

The JTSB concludes that during the time period relevant to the accident (13:00 to 14:00), a wind profiler at Obihiro had observed a wind of 10 kt (about 5.1 m/s) from east to southeast, and no major fluctuation in wind direction and velocity was observed, in addition, a wind of 10 kt or more was not observed at Ikutora, Shintoku and Shimukappu, which are located around the accident site.

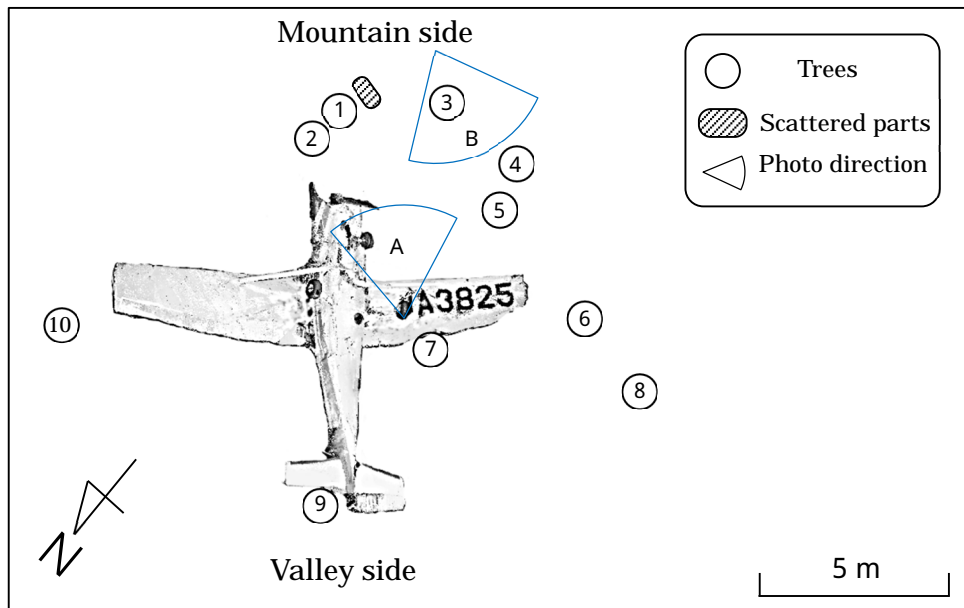
Figure 11: The accident site (Image view from above)

The accident site was located on the slope with about 30-degree inclination in the woods at an elevation of about 780 m on the west side of Mt. Karikachi. In the accident site, the Aircraft lay upside down with its nose facing the mountain side and its tail being supported by trees (see Figure 11).

The barks of the two trees (Figure 11 and) on the side of the Aircraft's nose (mountain side) were heavily peeled off. Out of the two trees, near the one (Figure 11) located on the mountain side, scattered around were fragments of the Aircraft. The trees (Figure 11) southwest of these trees were broken off at approximately 1.5 m from the ground. On the trees (Figure 11 and) east-northeast of the broken trees, newly formed scars were confirmed. In addition, the branches about 3 m high of the trees behind it (Figure 11 and) were sharply broken off.

No damage was observed to trees adjacent to the trees (Figure 11 and) whose branches were sharply broken off.

The JTSB concludes that from the extent of the damage to the trees around the accident site and to the Aircraft, the Aircraft most likely crashed into the slope from west-southwest. In addition, it is highly probable that the spinner hit the trees (Figure 11 and) whose barks were

heavily peeled off. The broken trees (Figure 11) were most likely damaged because the strut supporting the left main wing contacted with them. Based on these, immediately before the crash into the slope, the attitude of the Aircraft was most likely tilted to the left with the nose down and the undersurface of fuselage facing toward the mountain slope. It is highly probable that the speed at that time was significantly low.

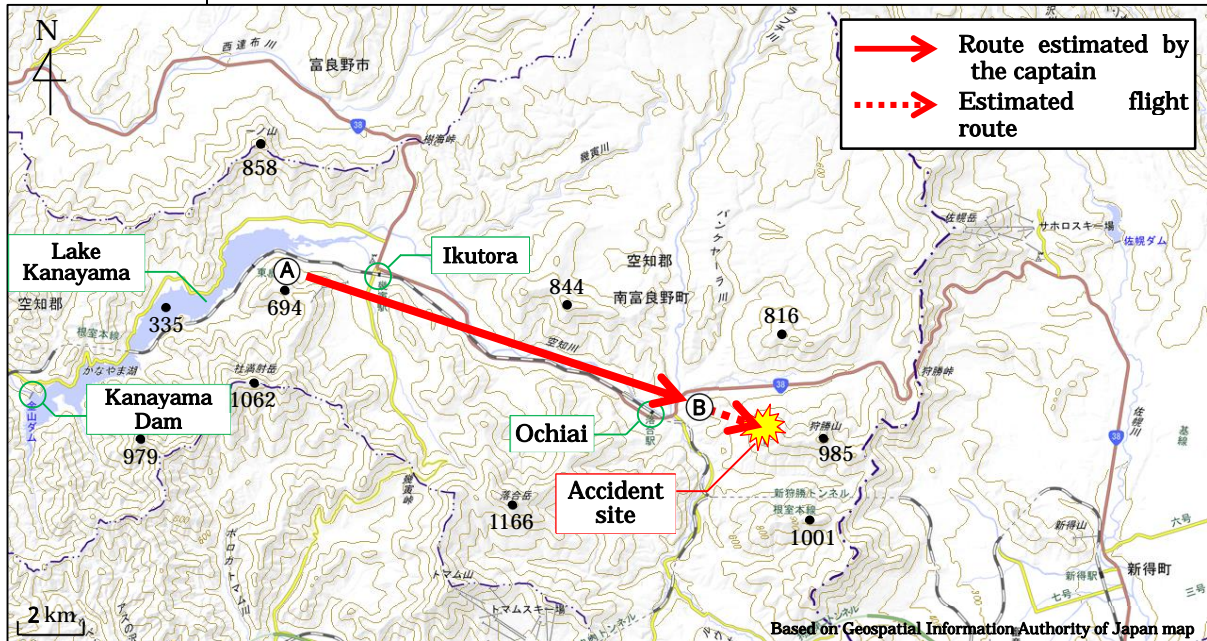
Figure 13: Estimated flight route immediately before the accident and its surrounding terrain

According to the captain, the estimated flight route immediately before the crash was the one from the Point A to the Point B of Figure 13. The topographic cross section profile for this route is shown in Figure 14. In addition, around this route, there were mountains over 1,000 m (about 3,280 ft) on the south and east, and there were mountains over 800 m (about 2,600 ft) on the north, thus, it was surrounded by mountains in all three directions.

The airspace where the flight training was conducted at the time of the accident had the mountains over 1,000 m (about 3,280 ft) on the south and east and those over 800 m (about 2,600 ft) on the north, and was surrounded by mountains in all three directions. Thus, making a round-trip flight in the airspace likely results in approaching those mountains when turning or unintentionally, it is necessary to ensure sufficient safe altitude when conducting flight training in such an airspace accordingly.

In order to prevent a recurrence of similar accidents to this one, as described in "3. ANALYSIS", it is probable necessary to conduct flight training while selecting safer training area depending on the training contents and ensuring sufficient AGL.

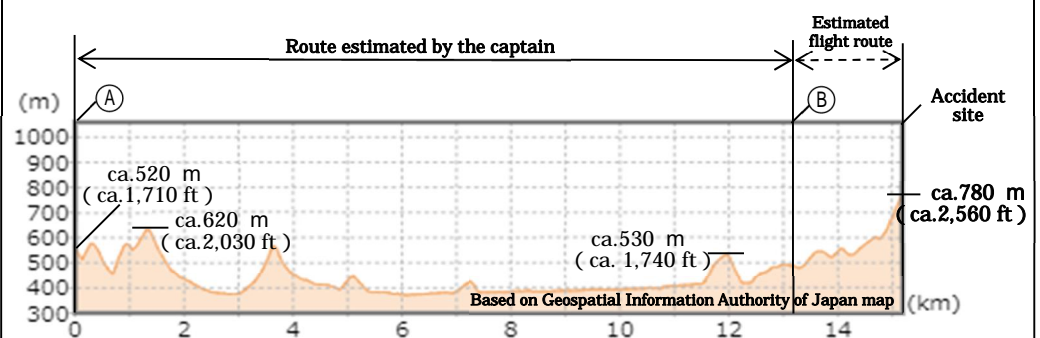
Figure 14: Topographic cross section profile for the estimated flight route

Besides, there were some areas where elevation exceeds 500 m (about 1,640 ft) immediately below the estimated flight route, and it is probable that even with a flight altitude of 3,000 ft, it had been less than 1,500 ft AGL that is the safe altitude for the slow flight training.

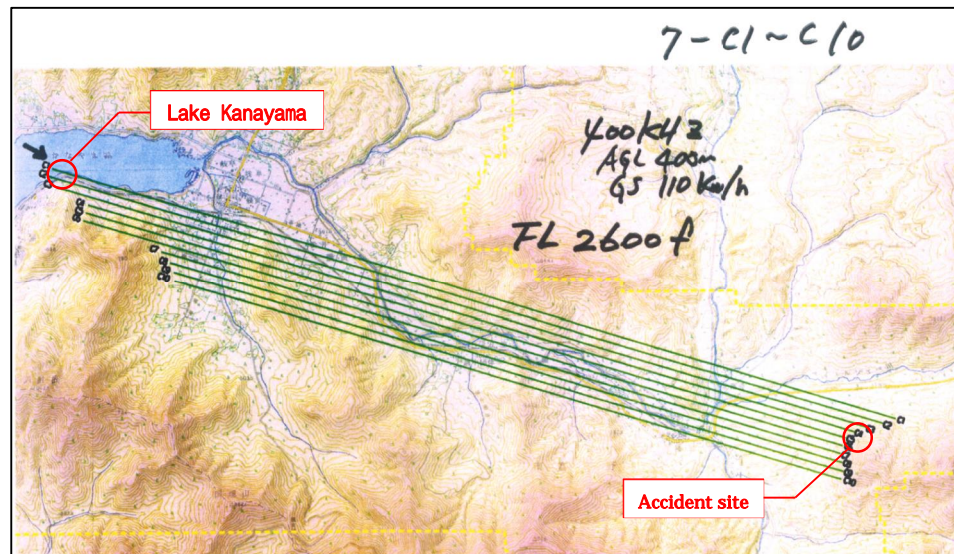
Figure 15: Map used as a reference (Red letters: additional notes)

On the survey map used by the captain and the trainee, it was written that the altitude above ground level (AGL) was 400 m, the ground speed was 110 km/h, and the flight altitude was 2,600 ft.

The JTSB concludes that the captain and the trainee stated that the flight altitude before the crash was approximately 3,000 ft, however, on the other hand, on the map used in their flight, it was written that the flight altitude was 2,600 ft, and the flight altitude could not be identified because the Aircraft was not equipped with any flight data recorders, which also were not brought in onboard.
