AA2016-2

**AIRCRAFT ACCIDENT
INVESTIGATION REPORT**

PRIVATELY OWNED CESSNA 172RG, JA3857 BELLY-LANDING AT KAGOSHIMA AIRPORT AT ABOUT 17:24 APRIL 26, 2015

February 26, 2016

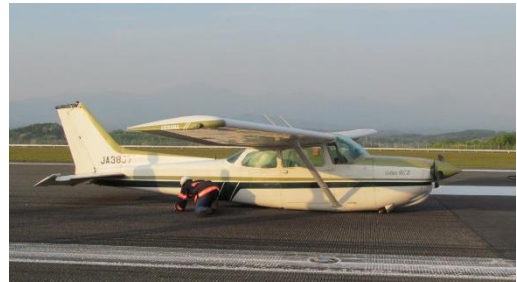
Aircraft involved in the accident

2.2 Injuries to persons	None
2.3 Damage to Aircraft	<p>(1) Extent of Damage: Substantially damaged</p> <p>(2) Damage to parts of the Aircraft</p> <ul style="list-style-type: none"> • Scratch marks on the lower part of the fuselage • Deformation and damage of propeller

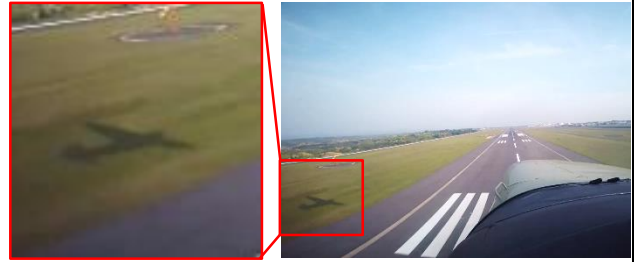
Picture of the Aircraft landing on the Airport was recorded by the video camera carried on the Aircraft.

The shadow of the Aircraft immediately before landing was recorded on the picture. The shadow shows that the landing gear was not extended.
