**AIRCRAFT ACCIDENT  
INVESTIGATION REPORT**

**NAKANIHON AIR SERVICE CO., LTD.**

**J A 3 9 0 2**

NAKANIHON AIR SERVICE CO., LTD.  
CESSNA TU206G, JA3902  
IN THE MOUNTAINS EAST OF MT. IWABE-DAKE,  
FUKUSHIMA-TOWN, MATSUMAE-GUN,  
HOKKAIDO PREFECTURE  
AROUND 10:40 JST, JULY 28, 2010

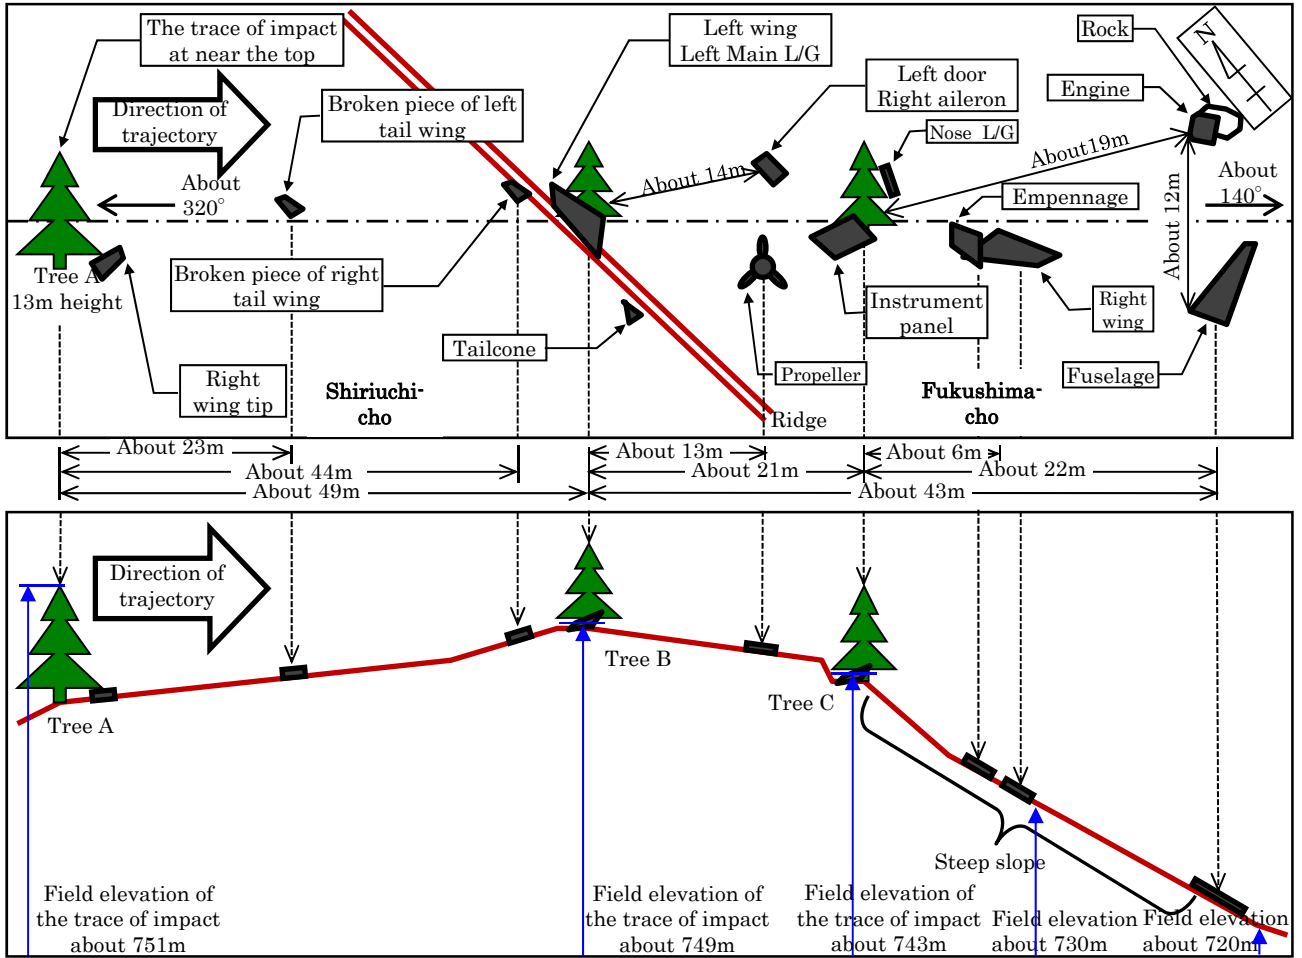
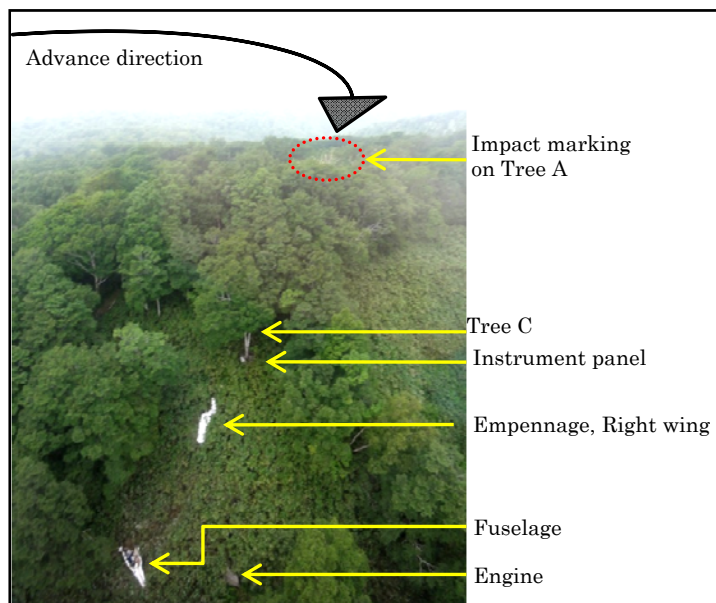
Figure 2 Accident Site Layout

Of the damaged trees at the accident side, the tree at the farthest place to the northwest (hereinafter referred to as "the Tree A") had branches near its top broken. Broken pieces of the right wing tip were found on the ground near its root. The elevation of the broken branches of the Tree A

was about 751 m (this includes about 12 m for the height of the damaged branch from the ground).

Broken pieces of the left horizontal tail wing were found at a place about 23 m southeast from the Tree A, while broken pieces of the right horizontal tail wing were found at a place about 44 m from there.

At the root of a tree near the ridge about 49 m southeast of the Tree A (hereinafter referred to as “the Tree B”) was the left main wing being detached from the fuselage and turned over. The trunk of the Tree B was found to have been bit with an area of the wing base connected to the fuselage. The left main landing gear was near the Tree B. There was an impact scar on the tree trunk of the Tree B about 4 m from the ground. The impact scar’s elevation was about 749 m.

The propeller was found at the place about 13 m southeast from the Tree B.

A tree about 21 m southeast of the Tree B (hereinafter referred to as “the Tree C”) had an impact scar about 3 m from the ground. The impact scar was at an elevation of about 743 m. The engine compartment fire wall, the instrument panel and the nose landing gear were found on the ground near the root of the Tree C.

The empennage and the right main wing were found at a place with an elevation of 730 m about 6 m southeast of the Tree C.

- (1) Of the damaged trees at the accident site, branches near the top of the Tree A which stands farthest to the northwest was broken. Meanwhile, broken pieces of the right wing tip were found on the ground near the tree. This fact indicates that the Aircraft had its right wing tip hit the Tree A during the maneuver.

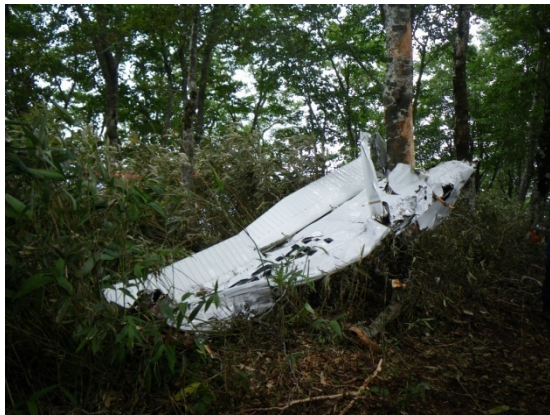
Photo 2 Left Main Wing

- (3) The engine was torn off from the fuselage and from the damaged engine cowling. Its whole exterior was damaged.
- (4) Both main wings were each found detached from the fuselage. The whole parts of the wings had cracks and ruptures. The leading edge of both main wings had traces of roughly perpendicular impact scars with deep cylindrical dents.

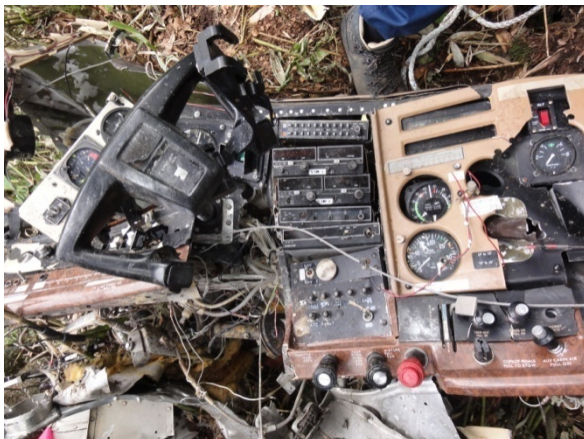
Photo 4 Instrument Panel

- (1) The engine compartment fire wall, the instrument panel, the nose landing gear, the left main landing gear and both pilot seats were detached from the fuselage. The ceiling of the cabin room, the forward cover including the windows, the cover on the left side of the fuselage including the left side door were deformed, detached or dropped off. The left side of the fuselage, including its aft part, was found more severely dented and damaged than that of the right side.

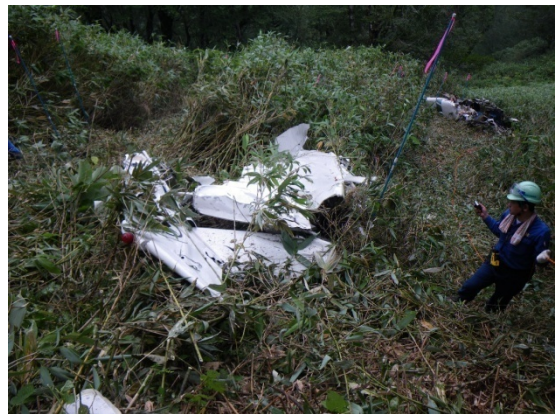
Photo 5 Empennage and Right Main Wing

(5) The empennage, including the tail cone, was detached from the fuselage. The Empennage, being damaged over the whole sections, were broken into several pieces.
