# **AIRCRAFT ACCIDENT INVESTIGATION REPORT**

**Kyoritsu Air Co., Ltd.**

**J A 3 9 5 9**

NOSE GEAR DAMAGE DURING LANDING  
KYORITSU AIR CO., LTD.  
CESSNA TU206G, JA3959  
CHOFU AIRFIELD  
AT 10:08 LOCAL TIME, OCTOBER 3, 2011

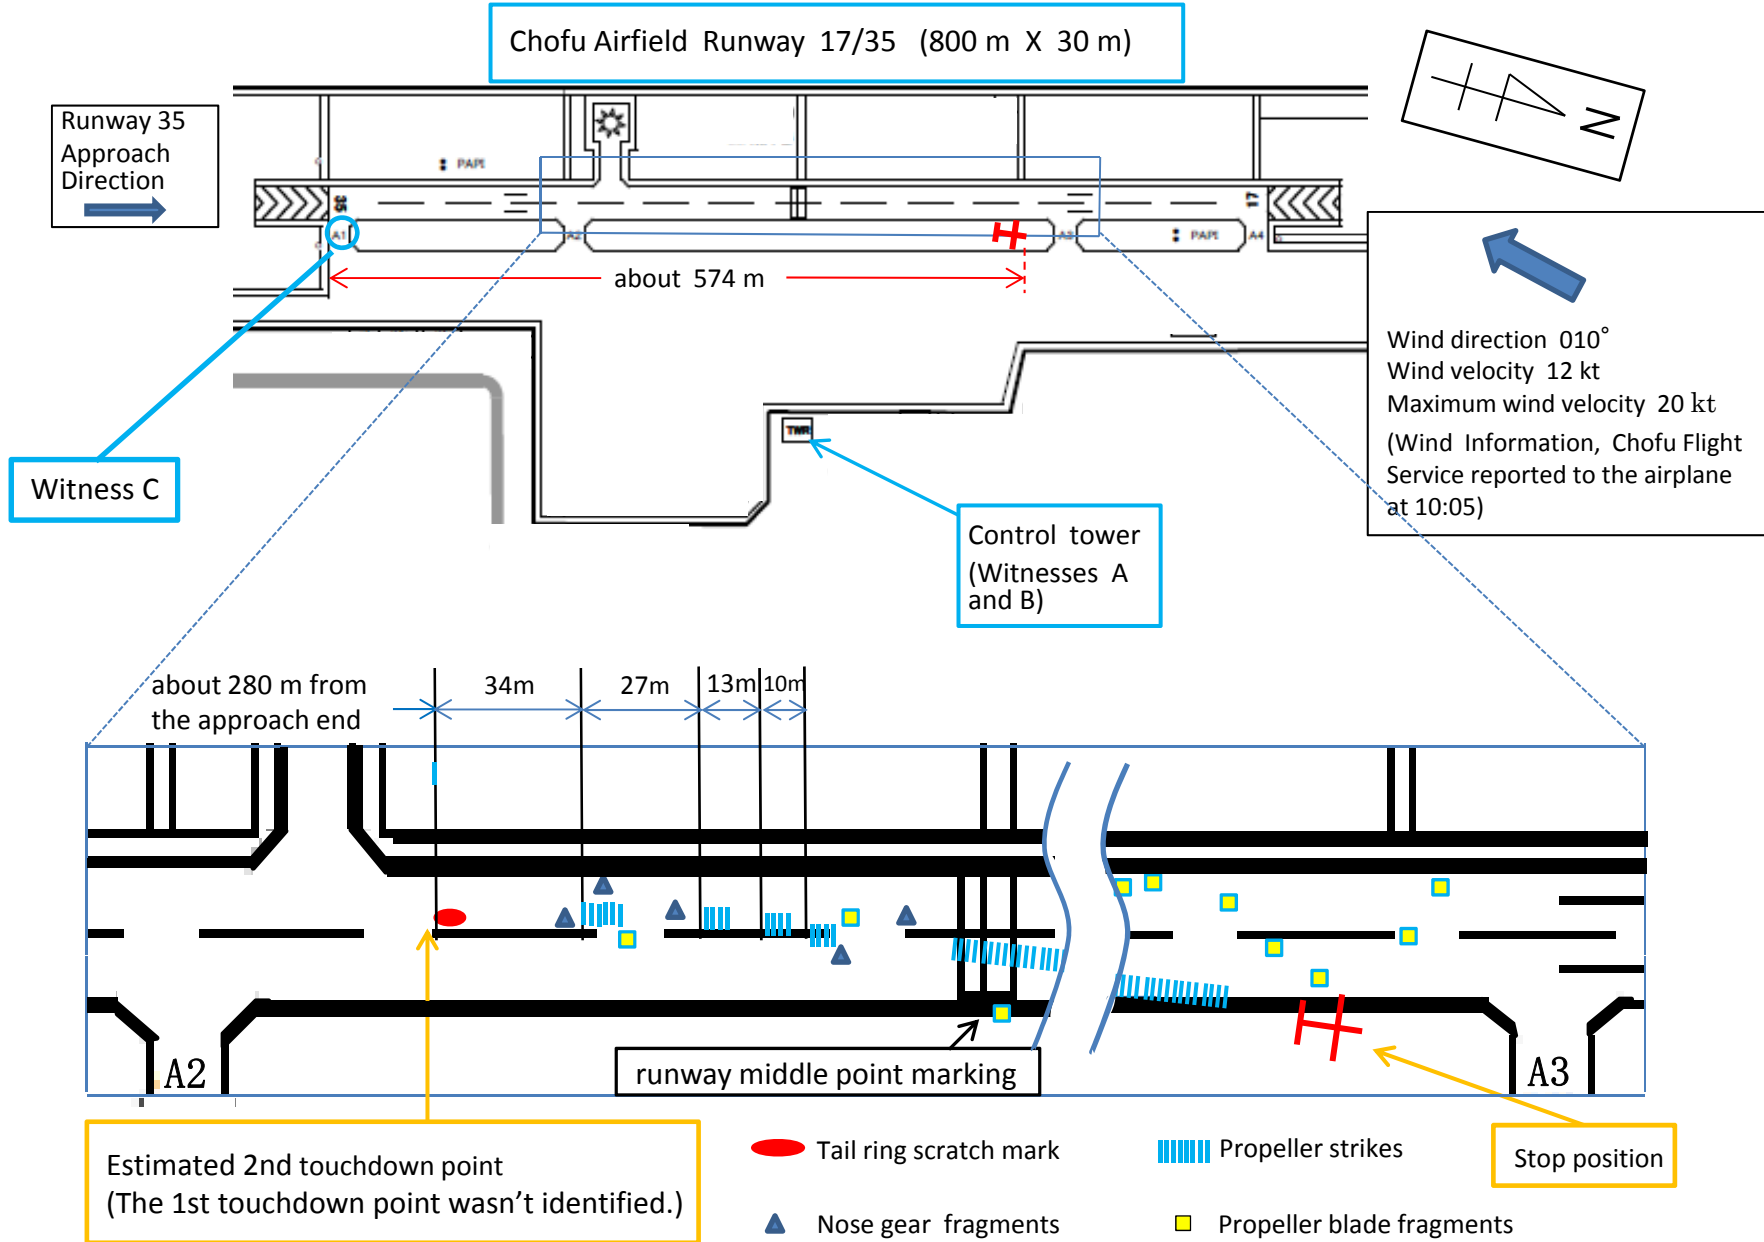
Figure 1: Accident Site Layout

The airplane approached runway 35, and came to a halt at a point about 574 meters from the runway threshold and about 18 meters to the right of the runway centerline :about 3 meters from the right edge of the runway with its fuselage almost parallel to the runway. Its nose gear was bent to the left.

There was a 1.9-meter linear scratch mark at a point 280 meters from the runway approach end. Four sets of intermittent propeller hit marks were observed in the area 314 meters from the runway threshold to the runway halfway marker :400 meters from the runway threshold . The last stretch of propeller hit marks started from the runway halfway marker to the vicinity of the airplane.

Fragments of the broken nose gear and propeller blades were found in the area between the initial propeller hit mark and the airplane.

It was unable to identify the airplane's first touchdown point due to innumerable tire marks on the runway.

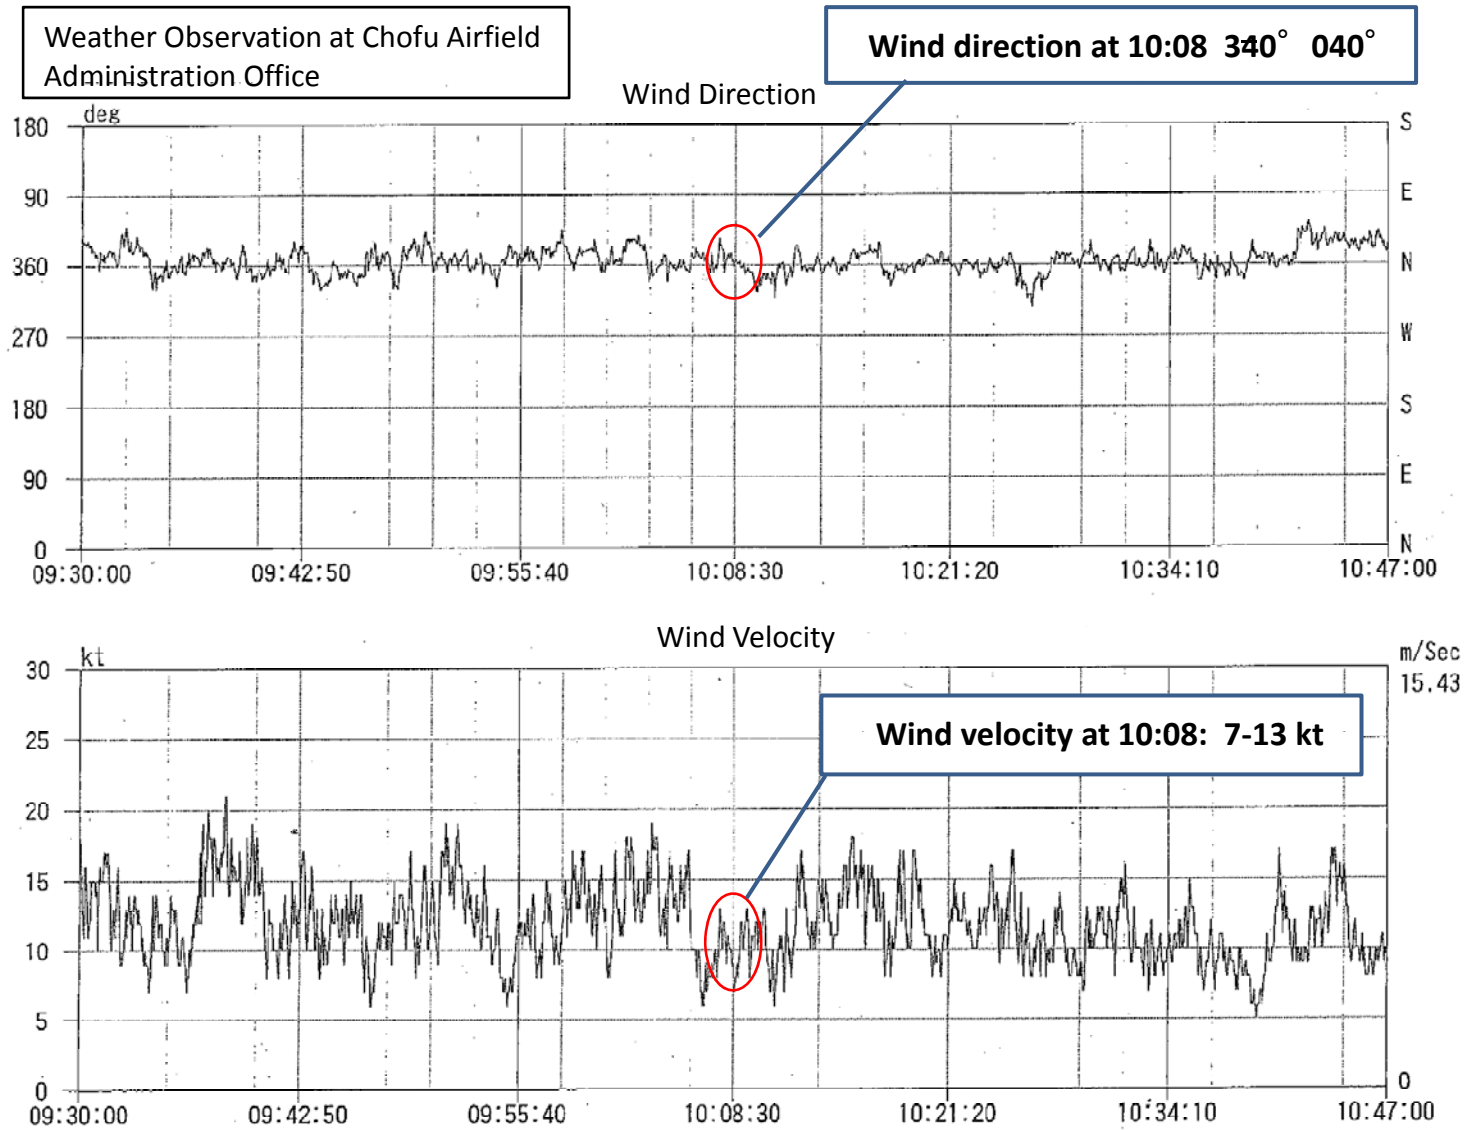
Figure 3: Instantaneous Wind Direction and Wind Velocity

According to the graphic chart showing weather observation values recorded at Chofu Airfield, the observation values of the instantaneous wind direction and wind velocity at around the time of the landing of the airplane indicated a fluctuation range of 340°-040° for the wind direction and 7-13 knots for the wind velocity.

As described in 2.6, the observed wind values around the time of the landing of the airplane were 340°-040° at 7-13 knots.

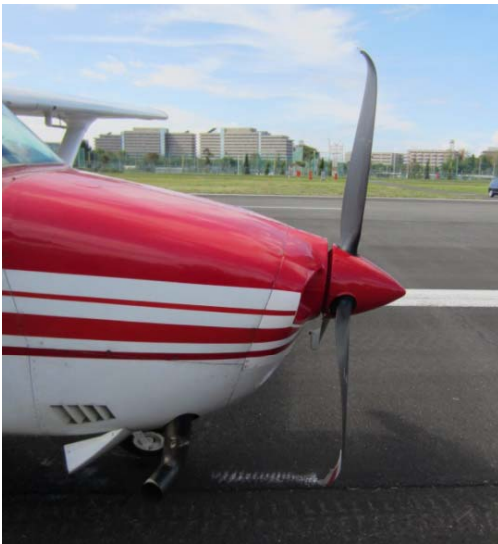
Photo 2: Propeller Blades

Each of the three blades was bent backward with chipped end.

It is highly probable that the porpoising airplane's propeller blades left hit marks when it contacted the ground with nose-low attitude, gradually damaging its nose gear, consequently lost directional control of nose gear and swerved off the runway to the right.

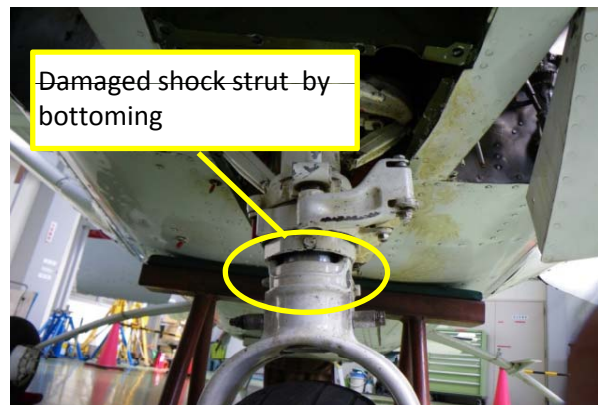
Photo 3: Nose Gear Shock Strut

The nose gear shock strut was damaged and its support fittings were partly broken.

As described above, it is highly probable that the airplane with nose-down attitude touched down from the nose gear with excessive rate of descent resulting in damage to the nose gear and its attachment structure to the fuselage.
