AIRCRAFT ACCIDENT INVESTIGATION REPORT

AIRCRAFT DAMAGE CAUSED BY FORCED LANDING

TEXTRON AVIATION 172S, JA395A

AT ABOUT 10:02 JST, APRIL 18, 2023

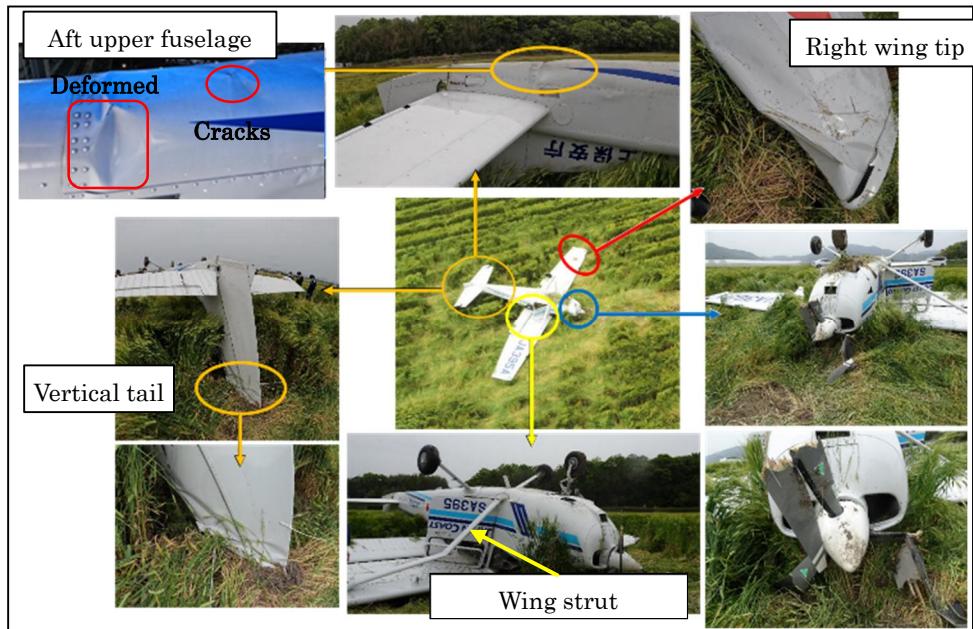
Figure 4: Damage to the Aircraft

2.2 Injuries to Persons	Two people suffered minor injuries.
2.3 Damage to the Aircraft	<p>(1) Extent of damage: Destroyed</p> <p>(2) Damage to Aircraft Components</p> <p>Propellers: All three propeller blades broken.</p> <p>Right Wing: Wing tip buckled; Upper and lower surfaces of the wing damaged and deformed.</p> <p>Left Wing: Wing strut broken; Upper and lower surfaces of the wing damaged and deformed.</p> <p>Vertical Tail: Damage to the upper part that contacted the ground</p> <p>Fuselage: Aft structure deformed; Fuselage skin cracked</p>

The JTSB concludes that according to the statements of the flight crew members, the aircraft's flight records, the damage to the aircraft and the traces left on the farmland, it is most likely that the aircraft was in a nose over^{*1}, during the forced landing on farmland in Usa City, flipped upside down, and came to a stop with its nose pointing in the opposite direction. It is highly probable that the aircraft flipped upside down because it touched down at around 37 kt with its main wheel first, then moved about 20 m, and a further 5 m after the nose wheel touched down, before the aircraft nosed over to suddenly come to a stop and rolled over forward since the nose wheel had become embedded in a mixture of dirt and wheat, making it difficult to rotate and causing the nose wheel to raise the soil to a height of about 12 cm. When the aircraft nosed over, the propeller hit the ground and broke. As the aircraft tilted to the right from an inverted position pivoting around the spinner, the tip of the right wing touched the ground first, causing it to buckle. Then, as the upper surface of the main wing touched the ground while the aircraft was tilting to the left, the left main wing strut broke. Lastly, the vertical tail hit the ground, most likely damage. In addition, it is most likely that as the vertical tail hit the ground, the lower aft fuselage was pushed up by the structure connecting the vertical tail to the fuselage. This caused deformation of the aft fuselage structure, resulting in the destruction of the aircraft.

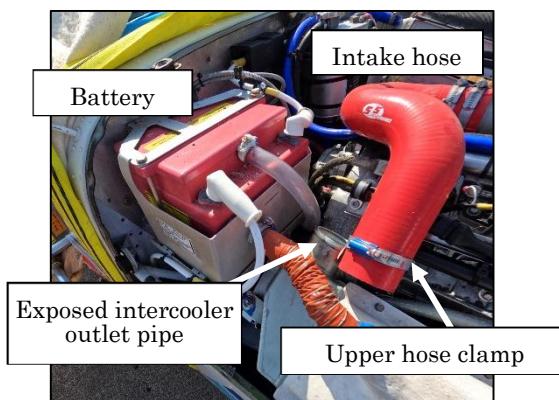
Figure 5: Intake Hose disconnected after the Accident

<p>Engine : Although there was no significant exterior damage to the engine, the intake hose connecting the turbocharger to the engine's intake manifold via the intercooler had been disconnected at the intercooler outlet side. Of the two clamps that held the hose in place, the upper hose clamp remained in the intake hose, while the lower hose clamp had been detached. The lower hose clamp that had been detached was corroded. Battery liquid from the batteries installed in the cowling had leaked.</p>
--	--

Between 15 and 16 May 2023, one month after the accident, the aircraft was moved from the forced landing site to a hangar at JCG Kitakyushu Air Station. It was then revealed that the intake hose of the engine had been disconnected and that the detached lower hose clamp had corroded.

The JTSB concluded that the engine intake hose on the intercooler outlet side had most likely been disconnected, accompanied by a banging sound, at 09:53. At this time, the MAP value dropped from a maximum of 2,375 mbar to about 900 mbar, which is almost the same as the air pressure of 889 mbar. This most likely resulted in natural aspiration conditions, causing a significant decrease in the volume of air supplied to the engine.

Regarding the disconnection of the intake hose, the accident flight of the aircraft was the first flight after the injector replacement work, during which the hose clamp and intake hose disconnected during the flight were removed and reinstalled, therefore this injector replacement works possibly have contributed to the disconnection.

It is likely that the engine intake hose was disconnected because the relevant intake hose, which had been removed during the previous day's maintenance work, was not installed properly.

5.1 Safety Actions Required	As described in 3. ANALYSIS, it is necessary for JCG and the engine's design and manufacturing company to take the following safety actions.
	<p>(1) JCG is required to conduct maintenance work on the aircraft in accordance with the instructions for maintaining the airworthiness set out in the maintenance manuals for maintaining airworthiness established by the aircraft and engine design and manufacturing companies.</p> <p>(2) The design and manufacturing company of the aircraft engine, who holds the STC, is required to change and improve engineering design so that FADEC can properly control the fuel, and so that the pilots can recognize via</p>

<p>warnings and others that the MAP has dropped due to the disconnection of the intake hose.</p> <p>Additionally, the FADEC software should be modified so that correct engine output values are displayed even when the intake hose is disconnected.</p>

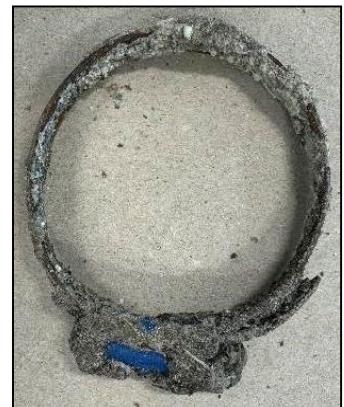
Figure 6: Lower Hose Clamp

The JTSB concludes that it is highly probable that the detached lower hose clamp had corroded because battery liquid leaked from the battery when the aircraft flipped upside down, and the detached hose clamp was immersed in this liquid, which caused corrosion until it was collected once the aircraft had been moved to Kitakyushu Airport.

As described in 2.7 (4) b., the inside diameter of another installed hose clamp with the same part number was compared with that of the detached lower hose clamp. This revealed that the inside diameter of the detached lower hose clamp was 0.3 mm wider in the measurement direction A and 1.2 mm wider in the measurement direction B. If the inside diameter differs by 1 mm, the circumferential length (i.e. the length of the fastening band) would increase by about 3 mm, which could cause the hose clamp to loosen. Based on this, it is possible that the clamp-fastening was insufficient for the two hose clamps that were removed during the injector replacement the previous day.

The hose clamp did not detach at the maximum engine output during the ground run-up after the replacement of parts, the pre-flight ground run-up, or during take-off. However, when the aircraft was climbing at maximum engine output in order to regain altitude (which had been reduced for the stall training), it is likely that the intake hose disconnected from the intercooler outlet side due to insufficient fastening of the hose clamp and the fact that the pressure inside the intake pipe at maximum output reached approximately twice the atmospheric pressure. Besides, given that the torque seal was not applied despite the instruction in the maintenance procedures, it is likely that the maintenance work and checks on the maintenance performed were not conducted properly.

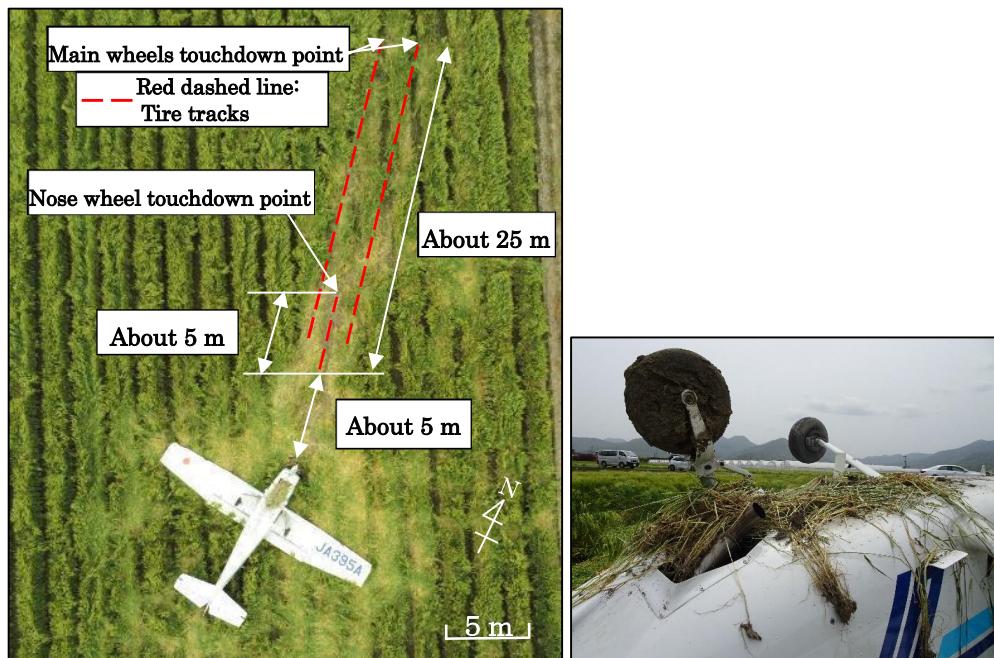
Figure 7: Forced Landing Site, and Soil and Wheat Covering Landing

2.7 Additional Information	<p>(1) Damage to the Aircraft due to Forced Landing</p> <p>The aircraft made a forced landing on farmland, coming to a stop upside down with its nose pointing in the opposite direction. Wheat up to 80 to 100 cm high was growing on the farmland where the aircraft made the forced landing. The ground was not muddy, but the soil was soft. There were tire tracks indicating that the aircraft had taxied about 20 m with its main wheels touching down first, and a further 5 m after the nose wheel touched down. The nose wheel had taxied 5 m ahead and the soil had risen to a height of around 12 cm there, and about 90 cm ahead, there was a mark where the propeller spinner seemed to have stuck into, as well as marks where the propeller had</p>

hit the surrounding area.

The aircraft was destroyed, lying upside down with its nose pointing in the opposite direction about 5 m from this raised soil (see Figure 7). The distance from the aircraft's spinner tip to the tip of the nose wheel was measured to be about 90 cm. The aircraft's landing gears were covered with wheat and soil.

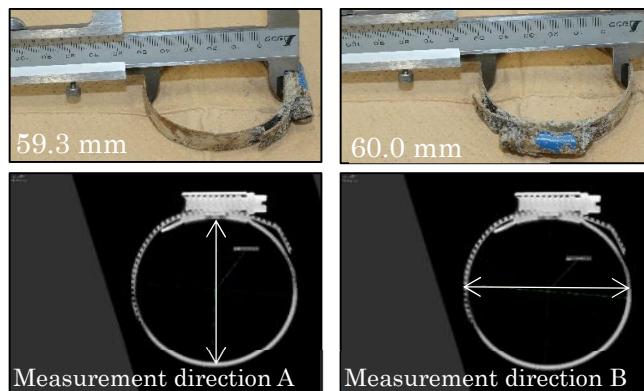
Figure 10: Measurement of the Detached Lower Hose Clamp

b. The detached lower hose clamp had corroded, but no cracks or damage were confirmed when its interior was scanned using a CT scanner. Another normal hose clamp with the same part number was installed in the position of the aircraft's lower hose clamp. The inside diameter was measured when tightened to the correct value and compared with that of the detached lower hose clamp. The results are shown in Table 1.

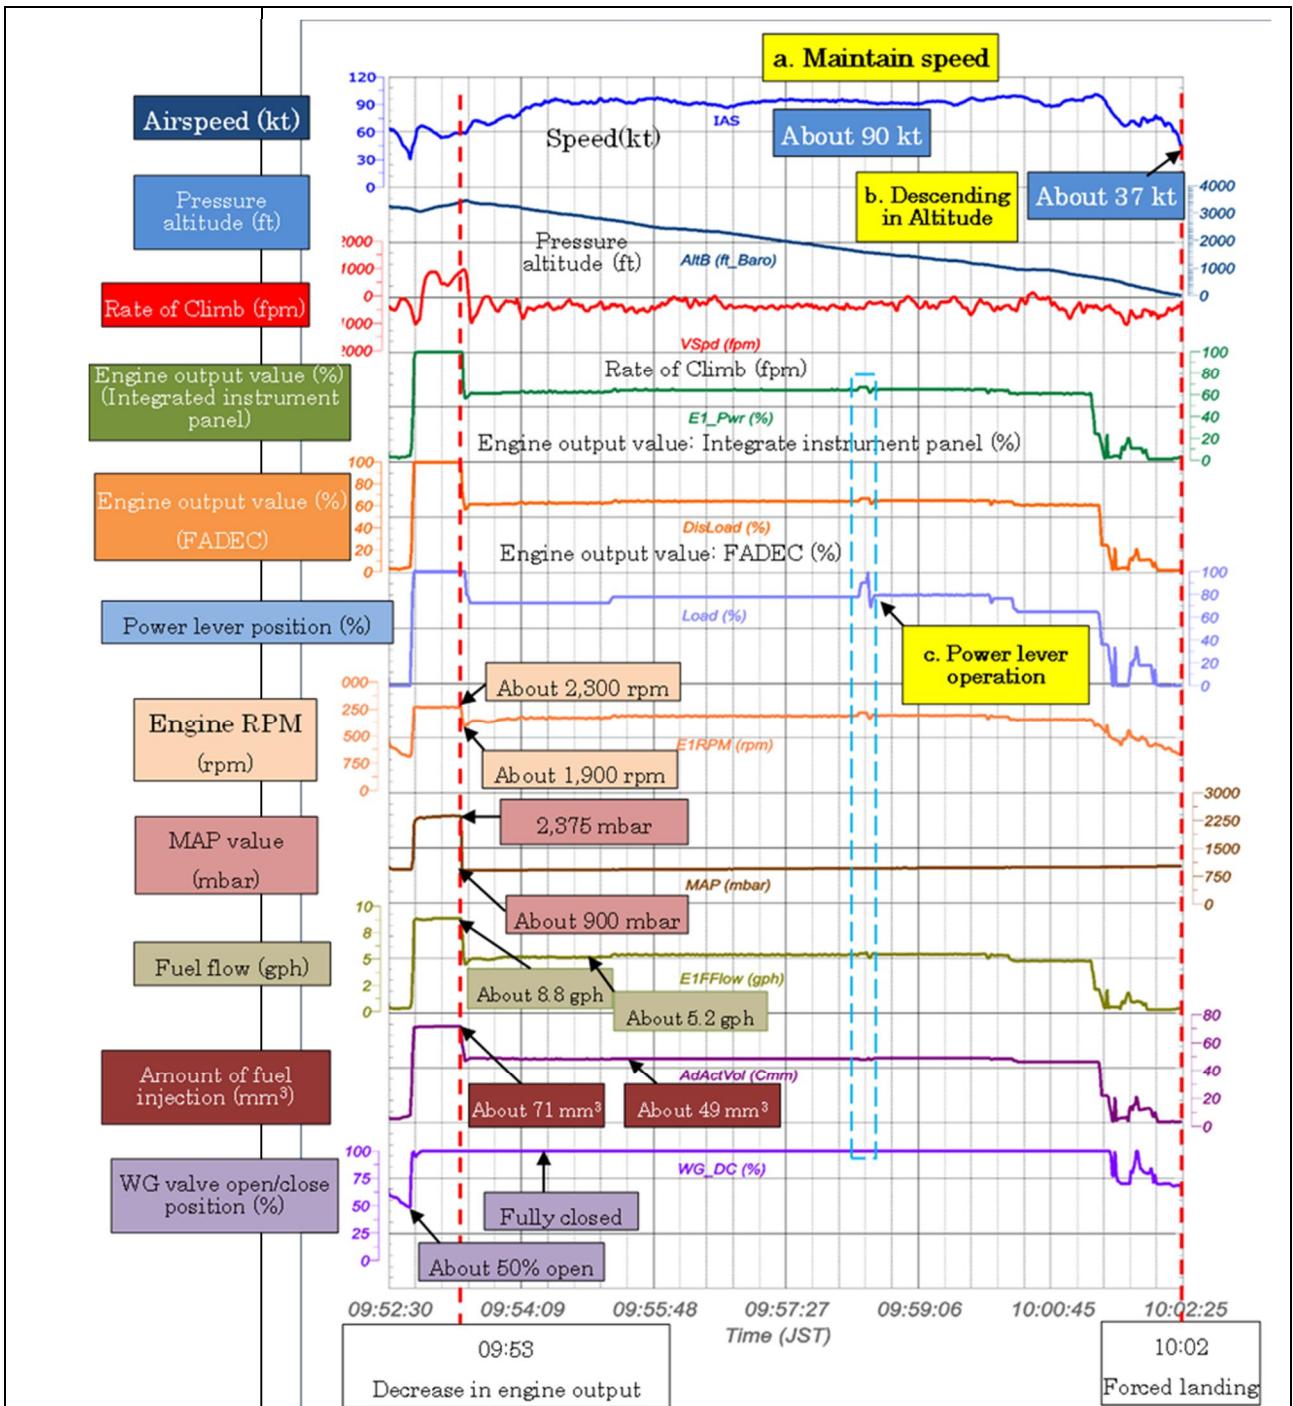
Figure 11: Flight Records

Figure 11 shows the flight recording from the start of the stall training (09:53:30) until the aircraft came to a stop (10:02:25), as recorded by the aircraft's integrated instrument panel and the FADEC. Both devices' flight recording functions were working as normal.

While the aircraft was climbing with 100% engine output, and a banging sound could be heard at 09:53, the following changes occurred to each item, as shown in Table 2. At this time, the flight altitude was 3,431 ft and the air pressure was 889 mbar.

After the engine output was lowered, the aircraft maintained a speed of around 90 kt (see Figure 11 a.). The pressure altitude changed from about 3,430 ft to about 1,430 ft over a period of about six minutes, from 09:53, when the engine output was lowered, to 09:59, when the aircraft reported making a forced landing. During this time, the aircraft descended by about 2,000 ft (see Figure 11 b.).

At about 09:58, the instructor pulled the power lever to the 100% position and then to the 68% to check the changes in the engine output display values. (see Figure 11 c.). With the power lever at its maximum position of 100%, the maximum engine output display value increased to 67% and the engine RPM increased by about 100 rpm, up to a maximum of 2,151 rpm, but no higher. When the power lever was lowered to the 68% position, the engine output display value and the engine RPM moved as if in response to operating the lever. It was the 79% position where the instructor returned the power lever after this operation. The WG valve remained fully closed and unchanged until the power lever was lowered before the forced landing. It was around 37 kt when the aircraft touched down, and the maximum vertical acceleration was -1.32 G when it flipped upside down and hit the ground. The fuel flow was about 5.0 gallon (US)/h (hereinafter referred to as "gph") at an engine output display value of 63% while the aircraft was cruising with normal engine status on that day. And it was 3.0 gph at an engine output display value of 35%.

During cruising flight with an engine output display value of 63%, the fuel flow was about 5.0 gph in normal operating conditions before disconnecting the intake hose. After disconnecting the intake hose, the fuel flow was 5.2 gph, which did not seem to be a significant difference. However, when the volume of intake air decreased significantly, about 5.2 gph of fuel was supplied, which most likely caused incomplete combustion due to the excessive fuel. In addition, as described in the Report, it is highly probable that WG valve was closed, resulting in increased exhaust pressure, decreased engine compression pressure, and reduced engine output, probably leading to "this condition in which the actual output would be around 35%" as stated by the engine's design and manufacturing company.
