**AIRCRAFT ACCIDENT  
INVESTIGATION REPORT**

**JAPAN COAST GUARD  
J A 3 9 5 A**

## DAMAGE TO AIRFRAME DURING LANDING JAPAN COAST GUARD TEXTRON AVIATION 172S, JA395A AT CHITOSE AIRFIELD, JAPAN AROUND 13:22 JST, AUGUST 21, 2018

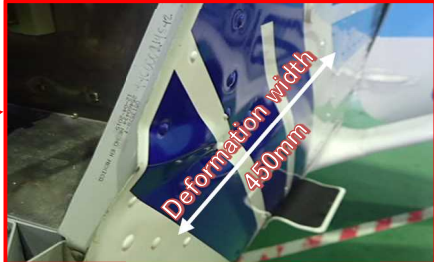
<p>mechanic during the exterior inspection after the flight, and also the deformation and others were found on the stringer of left forward fuselage by the detailed inspection later.</p> <p>The accident occurred on runway at Chitose airfield (42°47'56" N, 141°40'04" E) at around 13:22.</p>																																												
<b>2.2 Injuries to Persons</b>	None																																												
<b>2.3 Damage to Aircraft</b>	<p>Extent of damage to the aircraft: Substantially damaged</p> <ul style="list-style-type: none"> <li>(i) Outer skin of forward fuselage (both left and right): Deformed</li> <li>(ii) Stringer of forward fuselage (left): Deformed</li> <li>(iii) Stiffener in the engine room (both left and right): Deformed</li> <li>(iv) Stringer attaching rivet hole of left forward fuselage: Cracked</li> <li>(v) Fire wall: Deformed</li> </ul> <div style="display: flex; justify-content: space-around; align-items: center;"> <div style="text-align: center;">

<p>Figure 3: Deformed outer skin of forward fuselage</p> </div> </div>

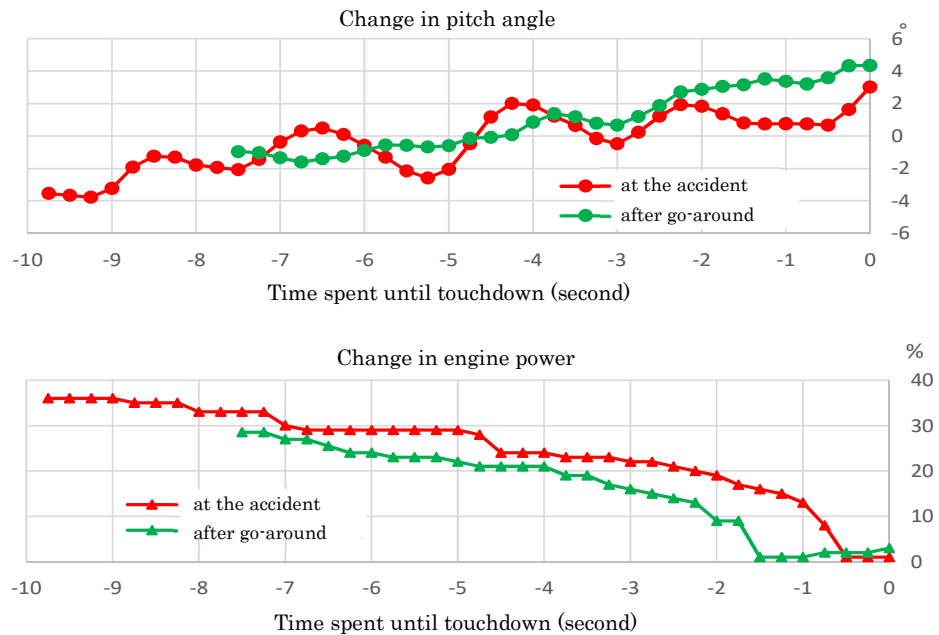
from passing over the runway threshold until touchdown were compared, respectively.

Figure 6: Situational comparison from passing over the runway threshold until touchdown

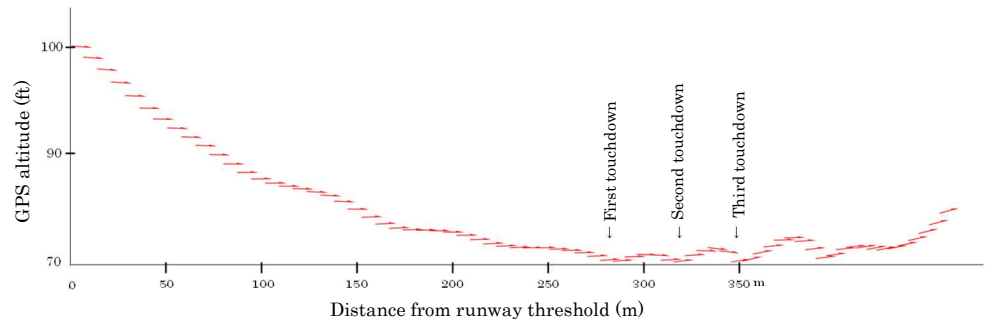
Based on the data recorded in the FDM at the time of the accident, the situation after passing over the runway threshold is illustrated in Figure 7 (the lean of arrows represents a pitch angle).

Figure 7: Situation after passing over the runway threshold

In this accident, it is highly probable that the aircraft suffered damages because it entered porpoise condition after the bounce at the first touchdown, and touched down hard on the nose gear in pitch down attitude at the third touchdown.
