**AIRCRAFT ACCIDENT
INVESTIGATION REPORT**

**PRIVATELY OWNED
J A 4 0 1 7**

December 17, 2015

COLLISION WITH REVETMENT WALL DURING GO-AROUND A PRIVATELY OWNED MOONEY M20K, JA4017 KITAKYUSHU AIRPORT, JAPAN AROUND 17:22 JST, NOVEMBER 16, 2014

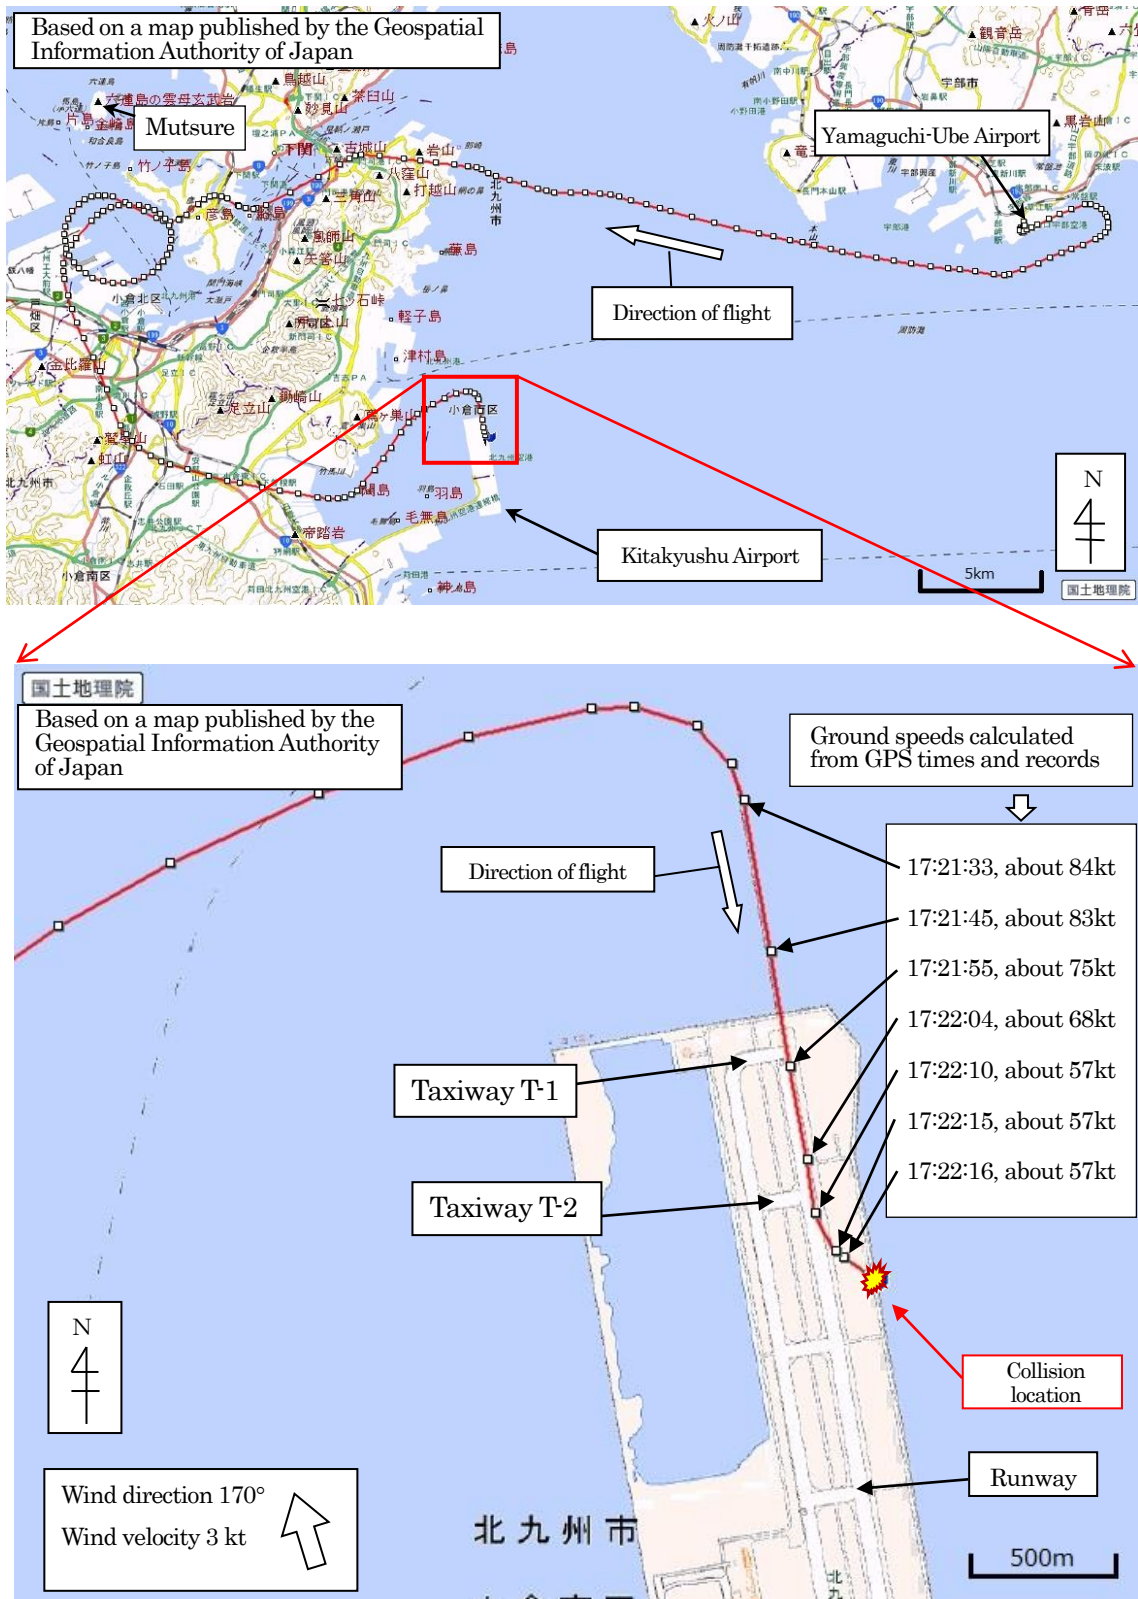
Figure 1: Estimated Flight Route Captured from GPS Records

Aircraft lifted off again, was about 57 kt. From passing T-2 onwards, in the records for 17:22:10, the Aircraft was flying near the runway centerline, but in the records for 17:22:15, it had yawed from the runway to the left. If the Aircraft flew at this speed after veering, the time of collision is estimated to have been about 17:22:21.

- (5) According to the GPS records as described in 2.10.2, it is somewhat likely that the movement direction of the Aircraft yawed to the left some time after 17:22:10 and that the collision with the revetment wall occurred at 17:22:21. Therefore, it is somewhat likely that there were about ten seconds from the time when the Aircraft started the go-around until it collided with revetment wall. In addition, since the flaps of the Aircraft were FULL UP after the accident as described in 2.9, and the time needed for the flaps to change from FULL DOWN to FULL UP is about six seconds as described in 2.8, it is somewhat likely that it yawed to the left from the runway while retracting its flaps, and that they had been FULL UP by the time of the collision.

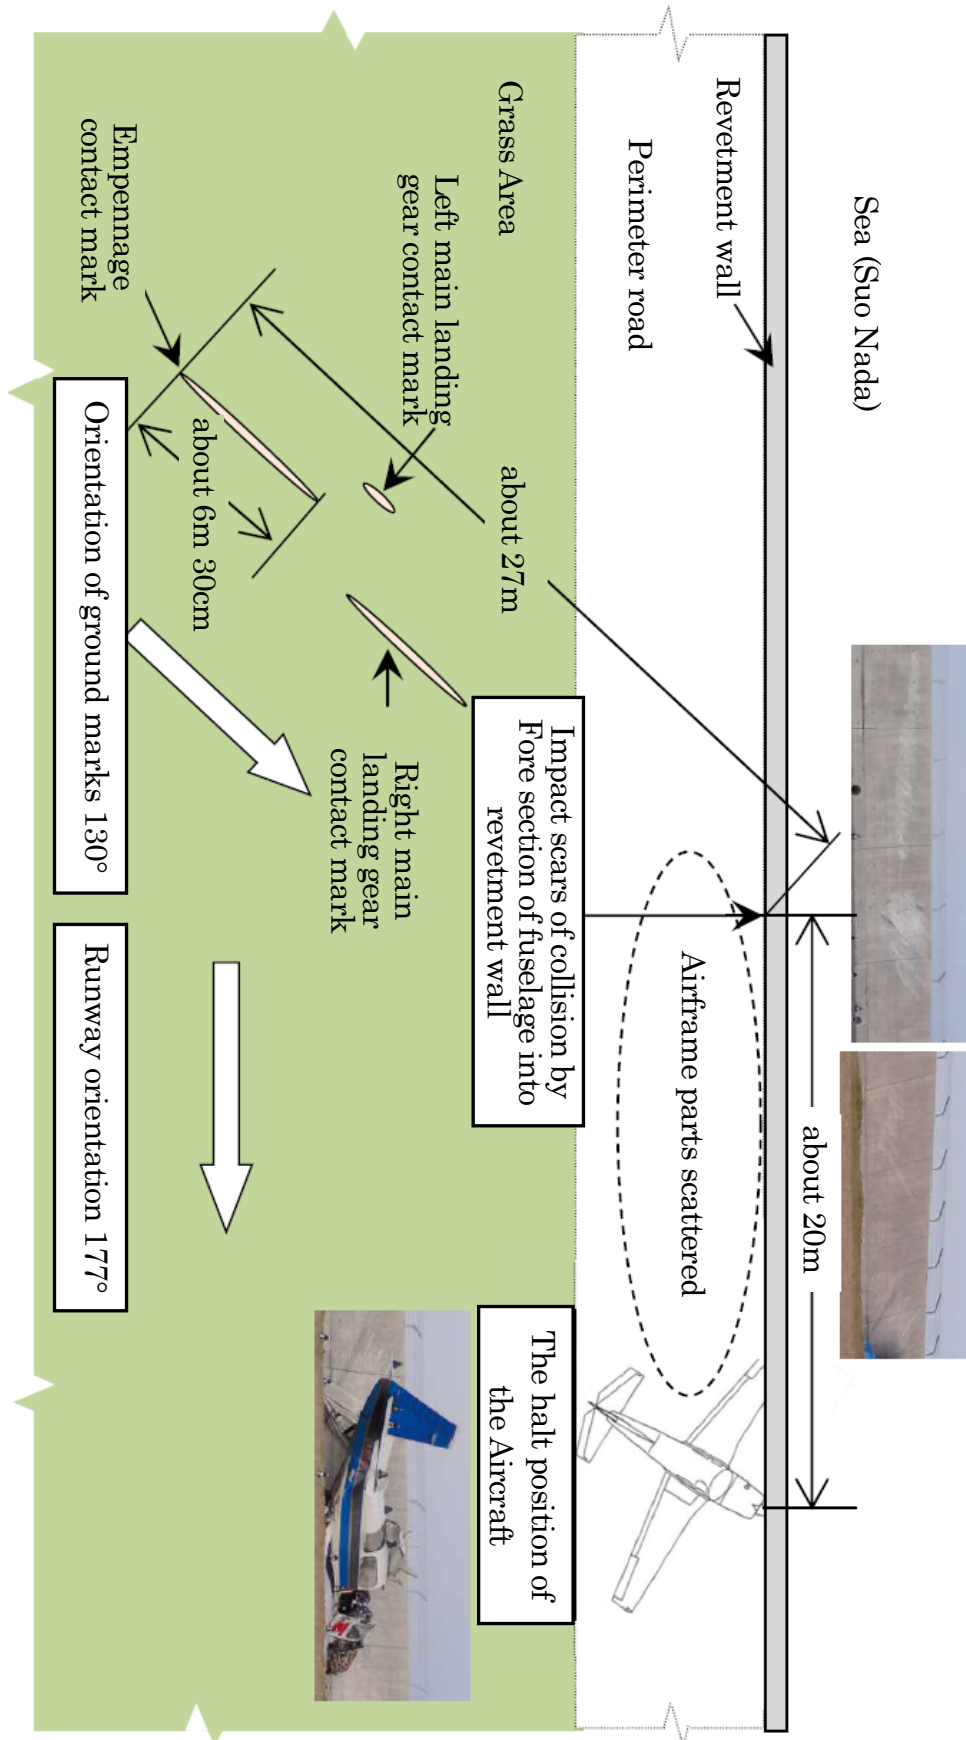
Figure 2: Schematic View of the Accident Site

Trace marks left when the empennage and the right and left main wheels touched down were confirmed on the grass area just in front of the revetment wall with which the Aircraft collided. There were impact scars on the surface of the revetment wall on the extension of the empennage contact mark, and the direction from the contact mark to the impact scars was 130°. In addition, the surface of the revetment wall was also scored by marks left when the Aircraft collided from the left wing tip and slid to the right along the revetment wall while maintaining its heading at the time of the collision, and by propeller slash marks. The revetment wall with which the Aircraft collided stood at a height of about two meters from the ground, was made of concrete and ran parallel to the runway at a distance of about 160 m east of the runway centerline.

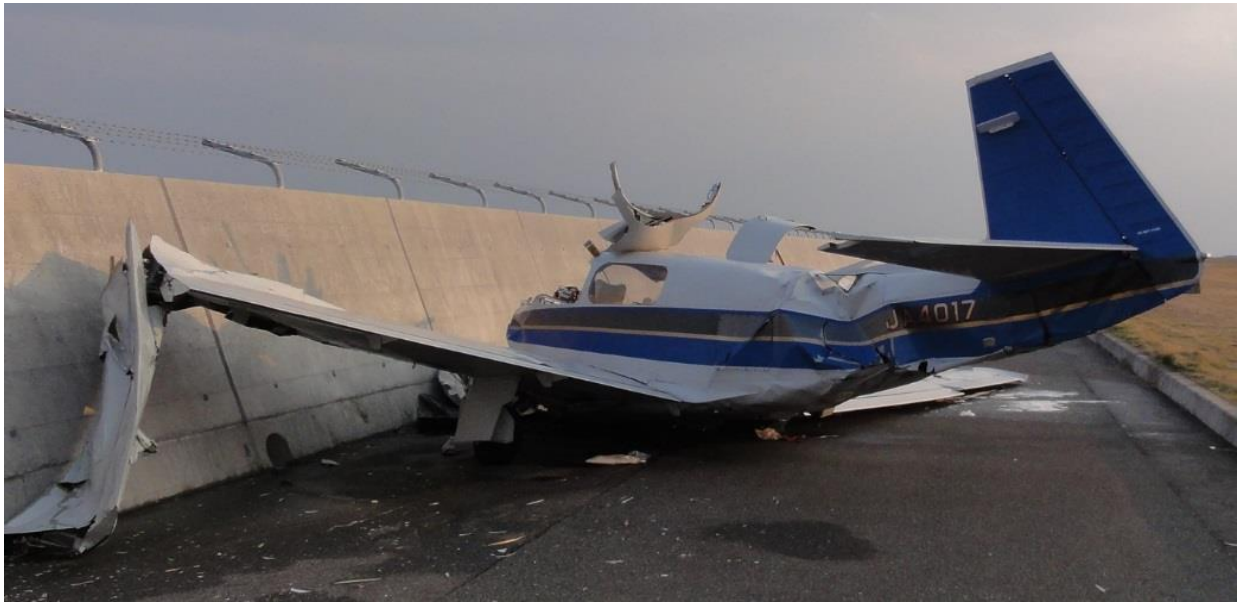
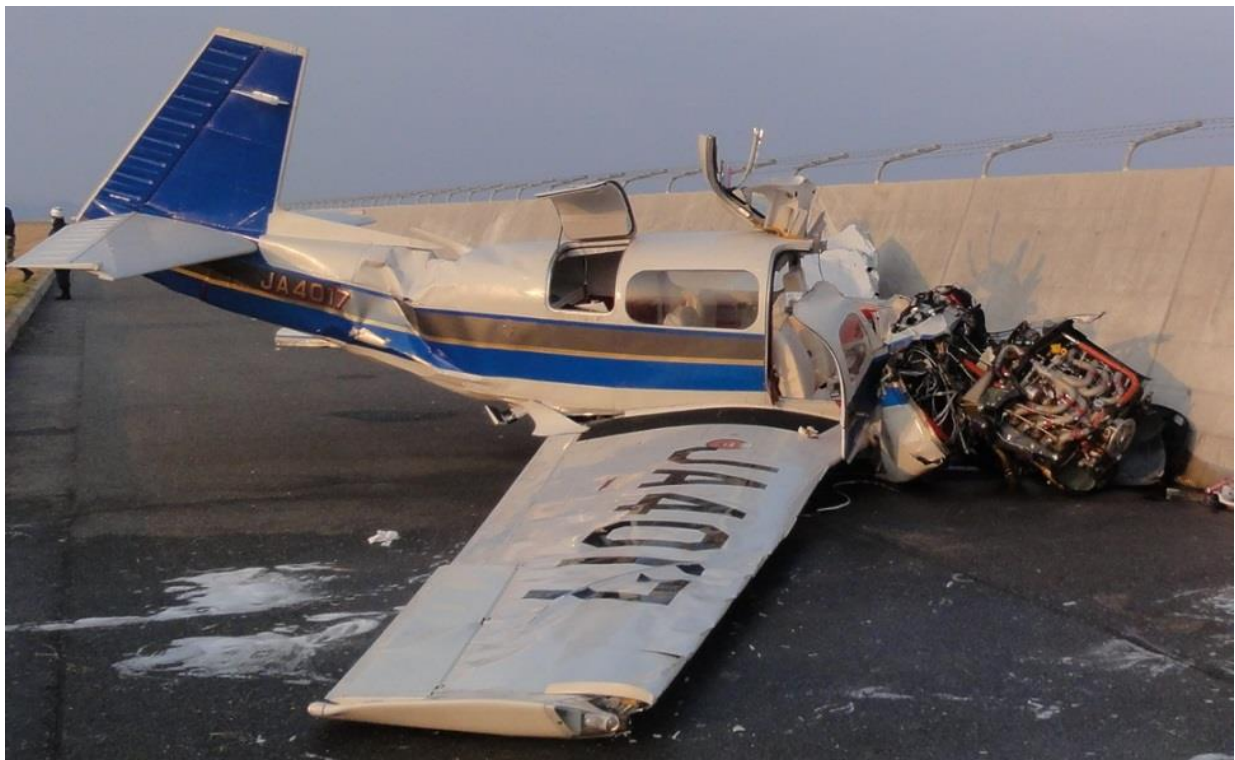
Photo 1: The Accident Aircraft

Entire fuselage:	Distorted and cracked
Front of fuselage:	Broken
Left main wing:	Broken off
Engine:	Mount broken
Propeller:	Detached
Right main landing gear:	Down lock mechanism damaged
Nose landing gear:	Down lock mechanism damaged

The three control knobs for the throttle of the Aircraft, the mixture and the propeller pitch were all at the most fore and in the full power positions. There were signs that the engine spark plugs had been firing normally. The flap switch was in the Up position, and the flaps were FULL UP. As for the elevator trim, the switch / circuit breaker for the electric trim were on, and the trim screw nut beneath the cabin floor was in the nose up position. In addition, circuit breakers related to the flight control system including the electric trim remained on. While push-pull rods and torque tubes are used for the steering force transmission mechanism of the flight control system, the operational status of the flight control system could not be confirmed as these were bend and refraction together with the airframe. As for the landing gears, the operating switch was in the landing gear down position and the left main landing gear had extended normally, but the down lock mechanisms of the right main landing gear and the nose landing gear were damaged.

Additionally, the cockpit roof and the left control wheel had been cut away to assist the rescue operation.

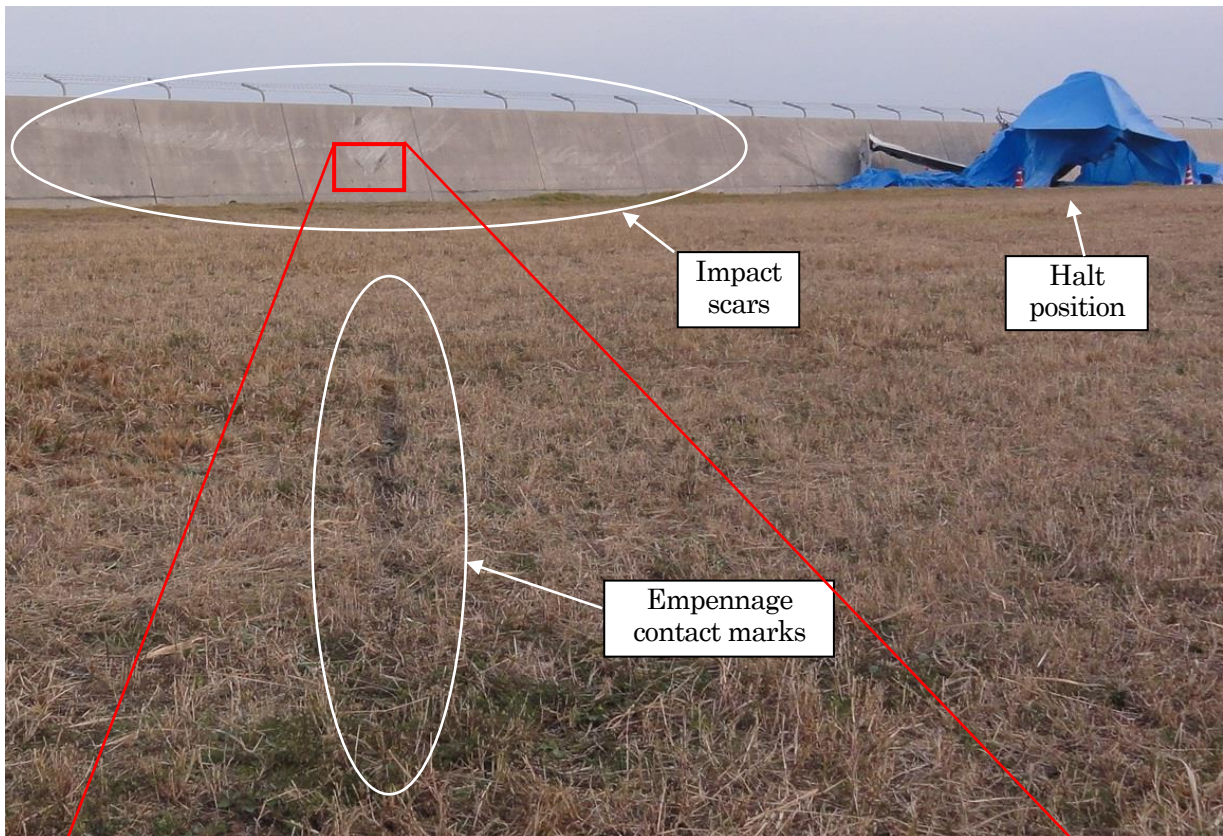
Photo 2: Empennage Contact Marks, Impact Scars and Halt Position

- (3) As described in 2.9, the throttle knob of the Aircraft had been pushed to the most fore position, and the flaps were FULL UP which were confirmed at the accident site. In addition, the surface of the revetment wall also scored marks left when the Aircraft collided from the left wing tip and slid to the right along the revetment wall while maintaining its heading at the time of the collision.
