# AIRCRAFT SERIOUS INCIDENT INVESTIGATION REPORT

August 8, 2025

Adopted by the Japan Transport Safety Board

<b>Company</b>	Privately owned
<b>Type, Registration Mark</b>	SOCATA TB21, JA4022
<b>Incident Class</b>	Dragging during landing of any other part of the aircraft other than the landing gears. Item (iii), Article 166-4 of the Regulation for Enforcement of the Civil Aeronautics Act of Japan.
<b>Date and Time of the Occurrence</b>	At about 13:45 Japan Standard Time (JST: UTC+9 hours), May 15, 2024
<b>Site of the Serious Incident</b>	Fukui Airport, Sakai City, Fukui Prefecture (36° 08' 46" N, 136° 13' 25" E)

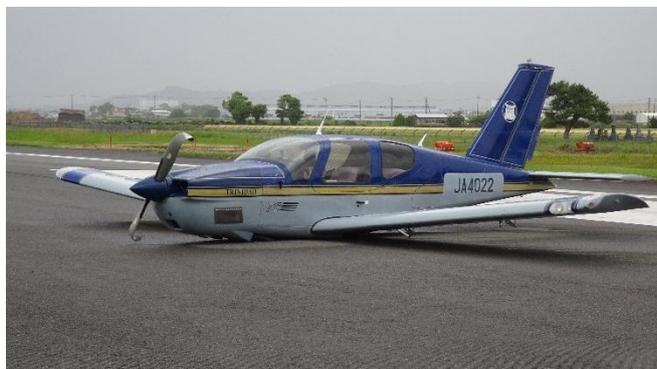
Figure 1: The Aircraft after the Stop

Minor: Scratch marks were observed on the main wheels, the trailing edge of the flaps and the lower fuselage. The two propeller blades were also damaged.

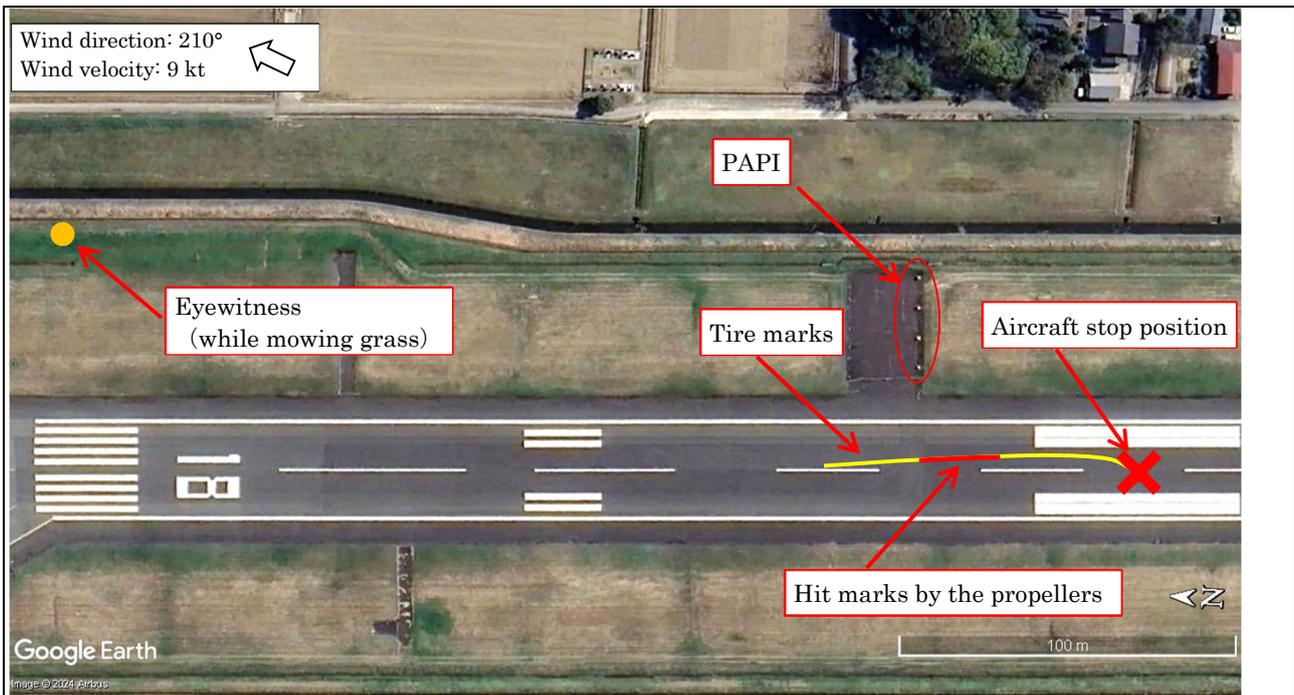
Figure 2: Estimated Skidding Route

When operating the throttle lever prior to landing, the pilot recognized the landing gear warning (see (2) d.), and immediately lowered the landing gear lever, setting the flap lever to the landing position (40°). At 13:45, the aircraft landed touching down on Runway 18 with the main wheels first, and then with its nose wheel. Immediately after that, all the landing gears were returned to the retracted position, its lower fuselage touched the ground. After skidding by inertia to the aiming point marking, the aircraft came to a stop.
