# AIRCRAFT SERIOUS INCIDENT INVESTIGATION REPORT

April 4, 2025

Adopted by the Japan Transport Safety Board

Company	Privately owned
Type, Registration Mark	Cessna 172P, JA4059
Incident Class	The case where any component of the aircraft other than the landing gear had contact with ground surface during landing Item (iii), Article 166-4 of the Regulation for Enforcement of the Civil Aeronautics Act of Japan
Date and Time of the Occurrence	At about 13:54 Japan Standard Time (JST: UTC+9 hours), September 17, 2023
Site of the Incident	Bibai City Farm Road Airfield, Hokkaido Prefecture (43° 23' 33" N, 141° 51' 35" E)

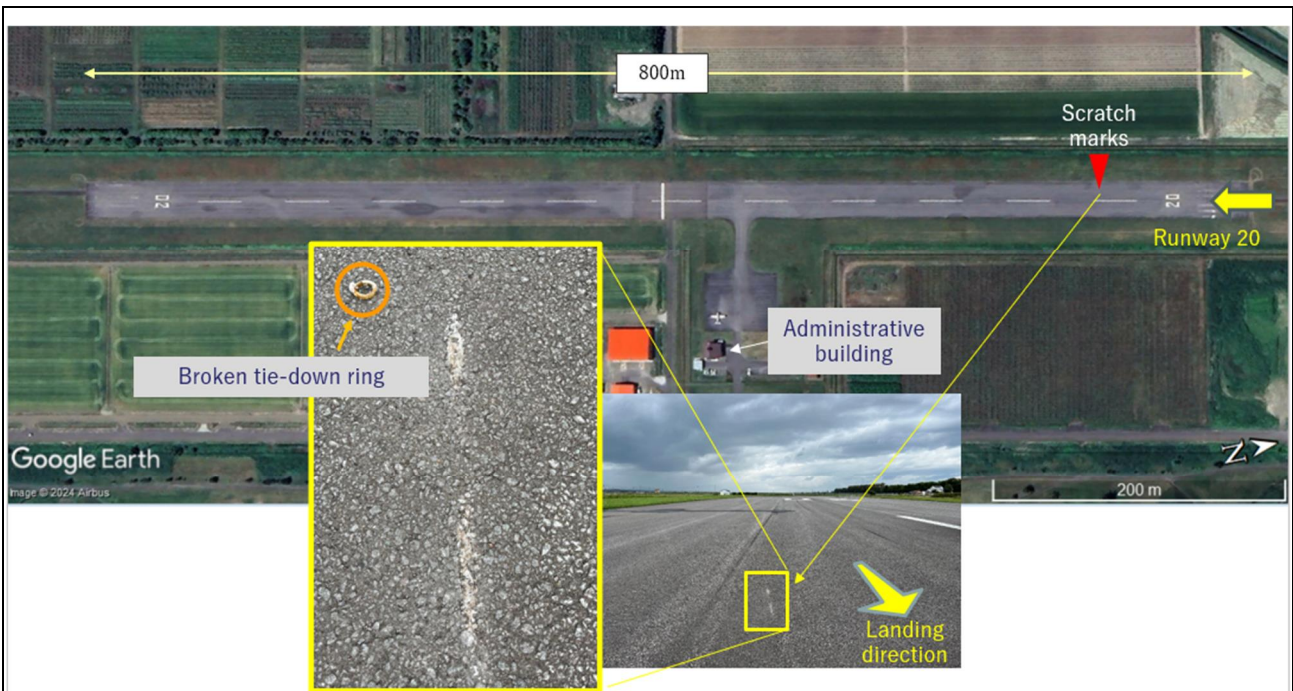
Figure 1: The Serious Incident Site

(The position of the broken tie-down ring was replicated by Passenger C who found it and took this photo.)

Passenger C, who visited Bibai Airfield in the morning of the same day, found the tail tie-down ring on the runway at Bibai Airfield, and next to the tie-down ring (at a position about 100 m from the Runway 20 threshold), there were scratch marks, probably made by the aircraft. The damage to the aircraft was as follows:

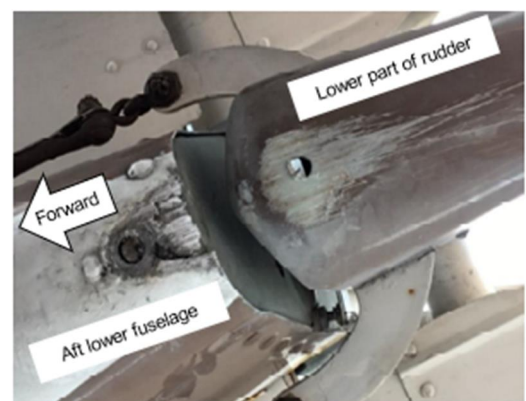
Figure 2: Damaged Condition

- Scratch marks and damage to the aft lower fuselage skin
- Scratch marks on the tail cone bulkhead
- Breakage of tail tie-down ring
- Scratch marks on the fairing of lower part of the rudder and its partial damage
- Damage to the fixed tab of the rudder

The JTSCB concludes that the probable cause of this serious incident was that it is more likely that the aircraft made an unstable approach at a low speed and touched down in a high nose-up attitude, resulting in its tail contacting with the runway surface.

During landing approaches, it is important to comply with the procedures specified in the Flight Manual, especially to pay attention to precise control of airspeed.

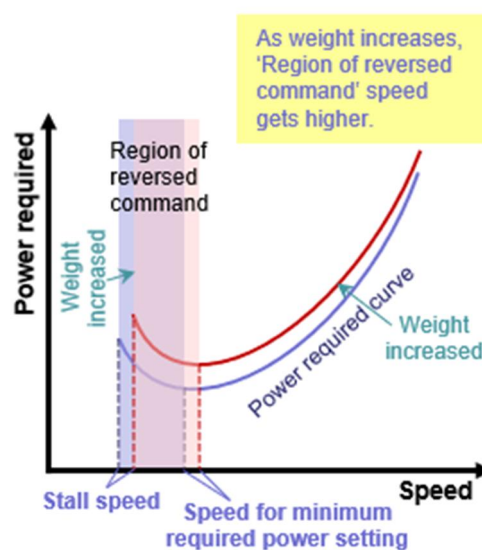
Figure 3: Power Required Curve

The regime of flight speeds between the speed for minimum required power setting and the stall speed is termed the region of reversed command since more power is required as its speed decreases to maintain steady flight. If an unacceptably high sink rate should develop, it may be possible for the pilot to reduce or stop the descent by applying power. But without further use of power, the airplane would probably stall or be incapable of flaring for the landing. Merely lowering the nose of the airplane to regain flying speed in this situation, without the use of power, would result in a rapid sink rate and corresponding loss of altitude.

- c. The design and manufacture company of Cessna 172P made a best estimate calculation, and the airspeed where the region of reversed command first being encountered would be approximately 60 kt at Mean Sea Level, ISA (International Standard Atmosphere) conditions, flaps retracted, at a gross weight of 2400 lb. It was also added that this estimated speed would be valid for Cessna 172P with the basic optional equipment package installed (e.g. anti-collision lights and various antennas).

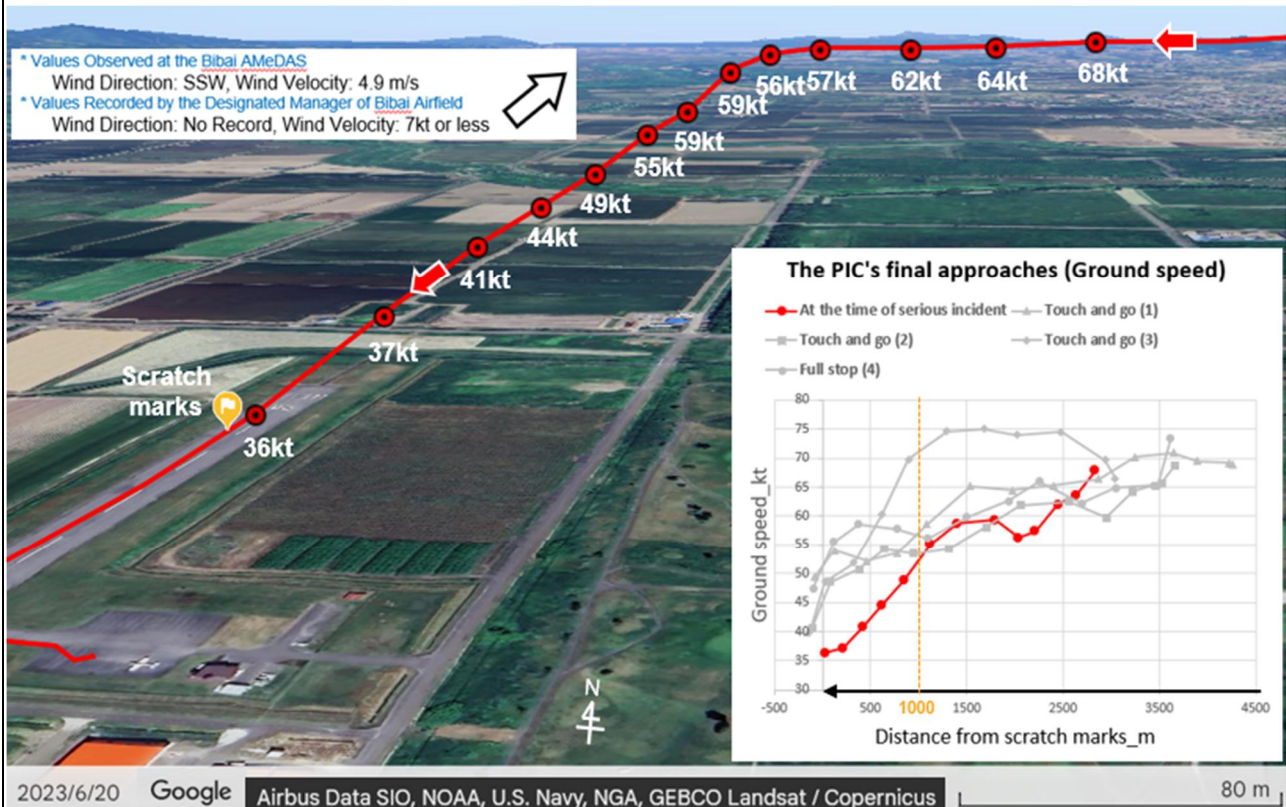
Figure 4: Ground Speed at the time of the Serious Incident and Comparison with That at the time of Touch-and-Go Training

time of the serious incident is estimated to have been as shown in Figure 4. At this time, there was probably a headwind of about 7 kt, therefore the airspeed would be the ground speed plus about 7 kt, which would be less than the value in the PIC's statement. In addition, it was compared with those of the final approaches at the time of touch-and-go training the PIC had conducted on the same runway at Bibai Airfield about 1 hour after the occurrence of the serious incident (about 14:50 to 15:20 on the same day). As shown in the graph in Figure 4, at the time of the serious incident, the speed on the short final was 10 to 15 kt lower than at the time of the touch-and-go training. Besides, as shown in Figure 5, at the time of the serious incident, the point where the aircraft intercepted the final approach course was closer to the approach end of the runway and the approach angle was greater than at the time of the touch-and-go training. Furthermore, as shown in Figure 6, the aircraft touched down with an increasing descent rate at the time of the serious incident, but the descent rate prior to touchdown was reduced at the time of the touch-and-go training.

The approximate airspeed would have been the ground speed in Figure 4 plus about 7 kt, as the wind at that time was almost headwind on the final approach course of Runway 20.

According to the information gained from the eyewitness and the aviation GPS device records, the aircraft most likely made an unstable final approach at a lower speed than the airspeed specified in the Flight Manual. It is possible that the aircraft continuously reduced the speed from a point about 1,000 m before the touchdown and entered the region of reversed command. As the descent rate increased with decreasing speed, the aircraft gradually raised the nose to reduce the descent rate without using power, and touched down in such a high nose-up attitude that it was unable to flare as its speed continued to decrease, more likely resulting in its tail contacting with the runway surface.
