AIRCRAFT SERIOUS INCIDENT INVESTIGATION REPORT

AN ATTEMPT OF LANDING ON A RUNWAY

KAGOSHIMA AIRPORT

AROUND 14:53 JST, JANUARY 8, 2022

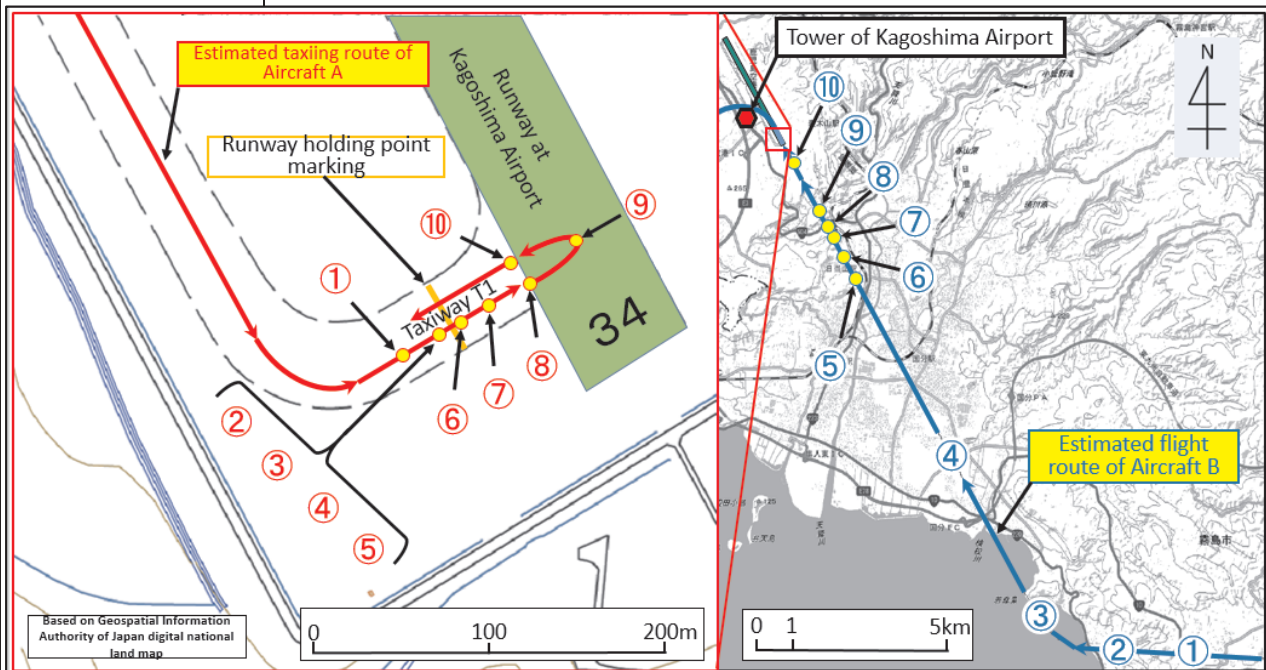
Figure 3: Situation at the time of the occurrence of the serious incident

Aircraft A continued to move forward, and around 14:53:05, it passed the runway holding point marking (Position ⑥ in Figure 3-left). Before long, the several Controllers at the control tower, including Tower D, made assertions that Aircraft A was moving, and Tower C also visually recognized that Aircraft A passed the runway holding point marking of Taxiway T1. Aircraft A had not entered the runway yet, however, judging that letting Aircraft B go around would be safer and surer way than issuing a new instruction to Aircraft A, at 14:53:12, Tower C instructed Aircraft B to go around (Position ⑦ in Figure 3-right). Around 14:53:17, Aircraft A entered Runway 34 (Position ⑧ in Figure 3-left, the distance between both aircraft was about 2,510 m (about 1.36 nm)).

Captain B and the FO B were listening to a series of radio communications between Tower C and Aircraft A, thus paid their attention to Aircraft A’s movement as assuming that Aircraft could mistakenly enter the runway, and visually recognized that Aircraft started to move forward to the runway. For this reason, Aircraft B was thinking by itself of executing a go-around, but then, received the go-around instruction from Tower C, and thus at 14:53:23, executed a go-around (Position ⑨ in Figure 3-right, the distance between both aircraft was about 2,160 m (about 1.17 nm)).

At 14:53:20, Tower C instructed Aircraft A to turn on the runway and go back to Taxiway T1. Aircraft A immediately turned on the runway, around 14:53:48, vacated the runway (Position ⑩ in Figure 3-left). After the go-around, Aircraft B turned to the west side of the Airport, its radio communication was transferred to Kagoshima Radar Approach Control Facility, then cleared for visual approach to Runway 34 by the control facility, and landed at 15:01.

This serious incident occurred around 14:53:17 on January 8, 2022 (Position ⑧ in Figure 3-left), on Runway 34 at Kagoshima Airport (latitude 31° 48' 12" north, and longitude 130° 43' 10" east).
