# AIRCRAFT SERIOUS INCIDENT INVESTIGATION REPORT

Jan 10, 2025

<b>Company</b>	Privately owned
<b>Type, Registration Mark</b>	Christen Industries A-1, JA4083
<b>Incident Class</b>	Dragging during landing of a wing tip or any other part of the aircraft other than the landing gears Article 166-4, Item (iii), of the Regulation for Enforcement of the Civil Aeronautics Act of Japan.
<b>Date and Time of the Occurrence</b>	At about 14:10 Japan Standard Time (JST: UTC+9 hours), October 7, 2023
<b>Site of the Incident</b>	Hida Airpark (Operation Site), Takayama City, Gifu Prefecture (36° 10' 46" N, 137° 18' 48" E)

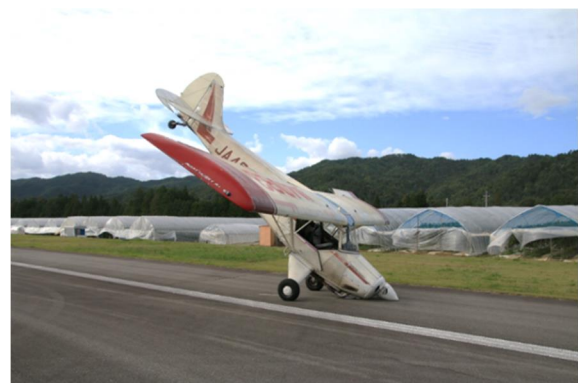
Figure 1: The Aircraft in Nose Over

After the aircraft touched down, the pilot kept the elevators fully up by pulling back the control stick to its rearmost position while keeping the ailerons in neutral and did not apply the brakes with the engine power at idle, allowing the aircraft to coast. As the aircraft began to veer to the left during the landing roll, the pilot applied the right rudder pedal to correct the direction and allowed the aircraft to continue rolling down. Initially, the pilot was able to maintain the direction of the aircraft with the rudder control, but as the speed decreased, it became impossible for the pilot to correct the deviation to the left, even by depressing the right rudder pedal fully. The aircraft veered greatly to the left, rolled to the right, and with the right-wing tip contacting the runway surface, rolled down to near the left edge of the runway. After that, the aircraft tilted forward slightly, causing the propellers and spinner to contact the runway surface, and came to a stop in a nose over.

The aircraft sustained the scratch marks to the right wing tip and damage to the propeller blades (two) and the spinner, but the pilot did not sustain any injury.

It is possible that when the aircraft slowed almost to a stop, the horizontal tail, whose left wing was lifted as the aircraft had been rolled to the right, floated due to the crosswind from the left and the aft fuselage was lifted gradually, causing the aircraft to tip forward and to a nose over.

The JTTSB concludes that the probable cause of this serious incident was that it is probable that due to deceleration, it became difficult for the aircraft to control its direction into the crosswind during landing roll, and as the aircraft yawed due to the weathervane effect, a ground loop occurred and the aircraft veered sharply to the left, but due to centrifugal force and the crosswind, the aircraft rolled to the right, probably causing the right wing tip to contact the runway surface.

The small, light and especially tailwheel-type aircraft are susceptible to the effect of the wind conditions during ground roll, it is important for the pilot to carefully judge whether or not to fly by checking the weather information prior to departure and to pay attention to the changes in weather phenomena during flight, as well as to carefully judge whether or not to land, including runway selection, by not only visually confirming the windsock, but also by obtaining weather information from the Piste and others where such cooperation is available.

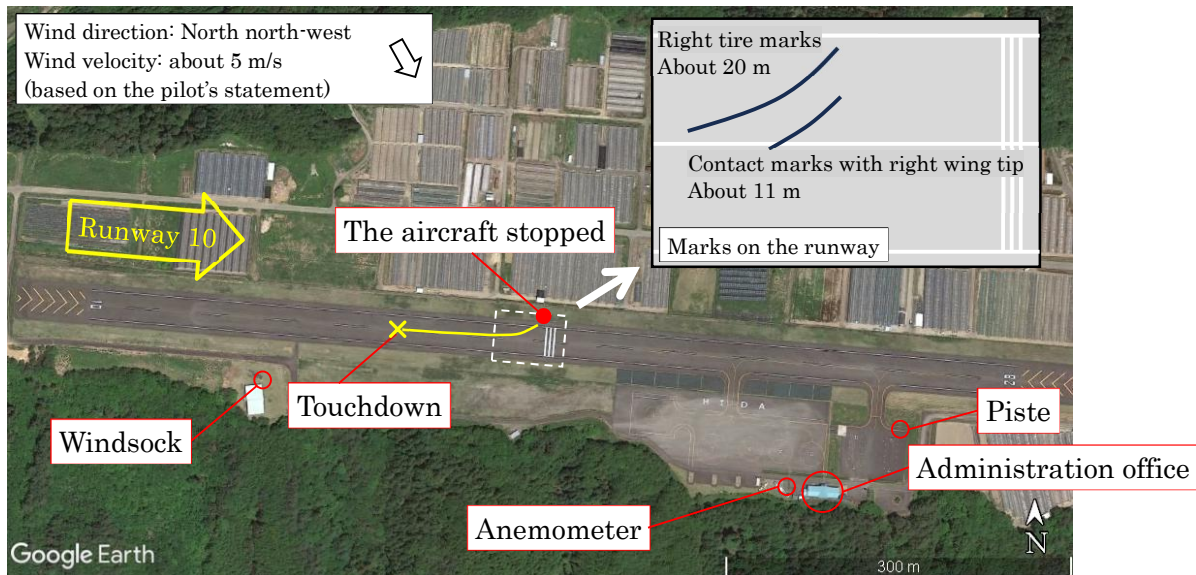
Figure 2: Estimated Landing Roll Route

It is most likely that immediately after the touchdown when the speed was still higher, the aircraft was able to control its attitude aerodynamically through the control surface because of the headwind on the aircraft, and to control the direction of the aircraft by operating rudder pedals and tailwheel. However, it is probable that as the speed decreased, the less the headwind affected the aircraft, the more the control surface's ability to control the attitude was reduced, reduced was the effect by the elevators kept in the UP position that helped to hold the tailwheel down on the runway surface, and steering effectiveness also decreased, making it more difficult to correct the yaw due to the weathervane effect, resulting in the aircraft veering to the left. It is more likely that when the aircraft yawed due to the weathervane effect, a ground loop probably occurred, and the aircraft rolled to the right due to centrifugal force caused by left turn and the crosswind blowing from the left, causing the right wing tip to contact the runway surface.

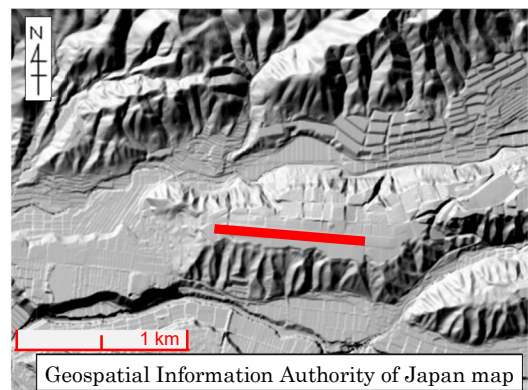
Figure 3: Location of the Operation Site

As shown in Figure 3, the Operation Site is located on a hilly ridge, and according to the pilot, the wind direction and velocity could vary depending on the location, even on the runway.
