# AIRCRAFT ACCIDENT INVESTIGATION REPORT

| <b>Type, Registration Mark</b> | Cessna 172P, JA4098 |
| <b>Accident Class</b> | Aircraft damage due to overrunning during landing |
| <b>Site of the Accident</b> | Semine Operation Site, Kurihara City, Miyagi Prefecture<br>(38° 40' 43" N, 141° 01' 25" E) |

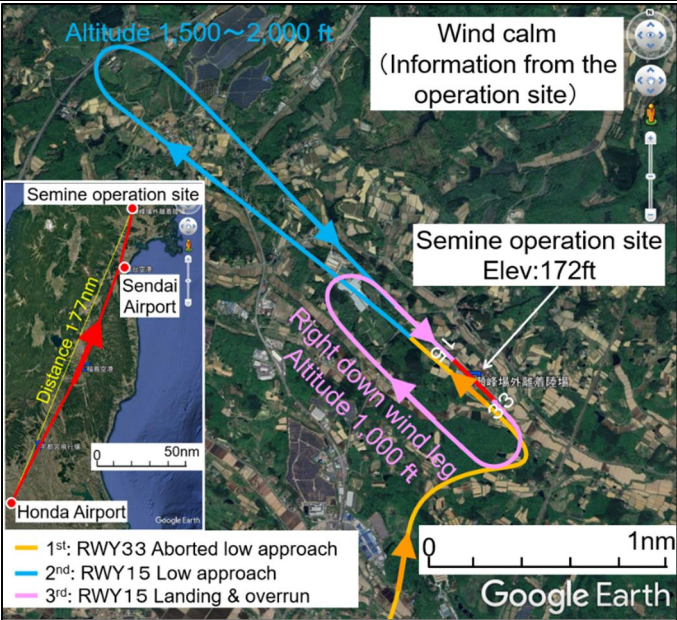
Figure 1: Estimated Flight Route

| <b>Event Occurred and Relevant Information</b><br><p>(1) History of the Flight (see Figure 1)</p> <p>At about 09:10, the aircraft took off from Honda Airport in Okegawa City in Saitama Prefecture under the pilot's control, with the pilot in the left pilot seat and the passenger who hold a private pilot certificate (Airplane) in the right pilot seat, in order to participate in an event at the operation site. During the pre-take-off inspection, brake checks were also conducted while taxiing. Neither check revealed any abnormalities, nor were there any issues with the pilot's physical condition.</p> <p>The pilot obtained information about the active runway was Runway15 and the calm wind through radio communication with the operation site. As it was the first landing at the operation site for the pilot, the pilot attempted to make a low approach (passing over the runway with low altitude) over Runway 33 as a familiar and demonstration flight, however aborted the low approach when a person crossed the runway. After that, the aircraft flew straight for about 2 nm, made a 180° turn at an altitude of between 1,500 and 2,000 ft to head towards Runway 15, and made an approach. It then flew the right downwind leg of Runway 15 at an altitude of 1,000 ft and a speed of 90 to 100 kt. The flaps were set at 15° and the downwind leg was extended to maintain a safety margin. The aircraft made a base turn while reducing its speed, resulting in a shallower approach angle when entering the final leg.</p> <p>The pilot made corrections using the throttle and attitude control so that the approach angle would be at 3°, set the flaps to 30°, made an approach by aiming to touch down at the designation marking of Runway 15, and moved the throttle to the idle position at the runway threshold. Usually stall warnings are often activated before touchdown, but did not activate even once at the time of the accident. The aircraft touched down almost on the centerline of the aiming point (1st time).</p> <p>As feeling the aircraft speed up and momentarily float, the passenger said, "Should we go around?" The pilot hesitated for a moment about whether to do so, but soon the aircraft made a touchdown again (2nd time). This position was about 210 m from the runway threshold. The pilot decided not to make a go-around and started by applying the brakes intermittently, as usual, before applying them continuously and firmly. The pilot thought that the pilot was firmly applying the brakes, but the pilot did not feel the usual deceleration and saw the runway threshold gradually</p> | |

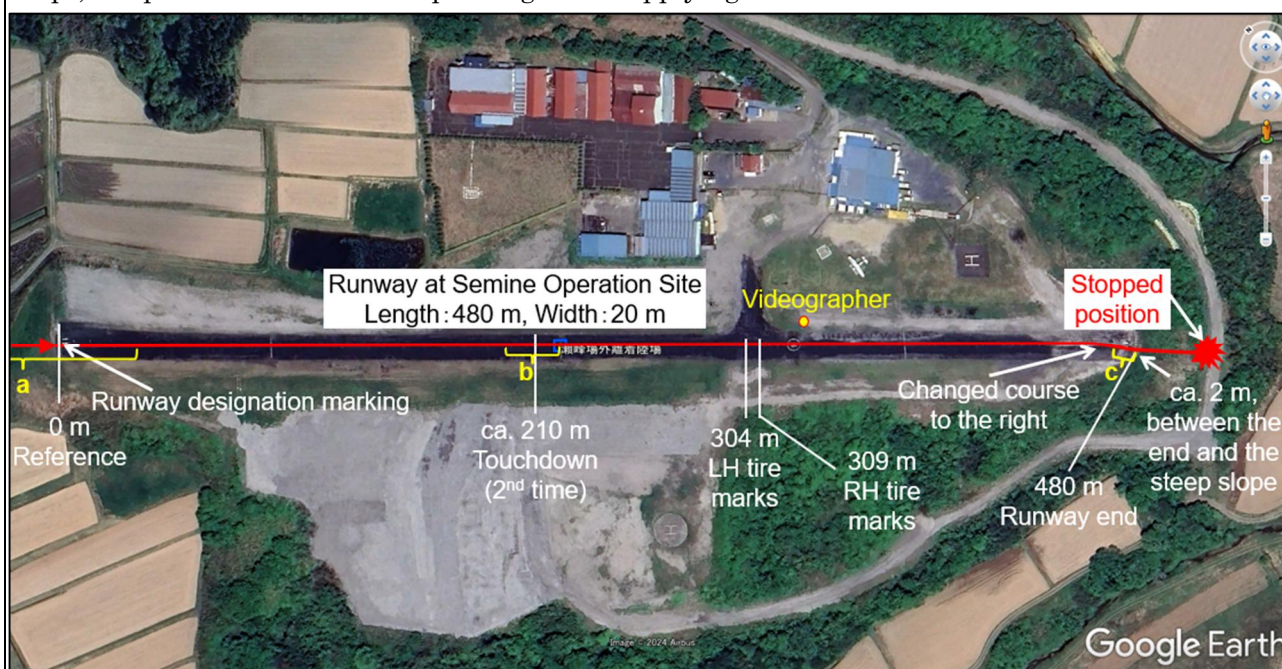
Figure 2: Estimated Touchdown Position and Stop Position

Although the aircraft slowed down, it was unable to stop at the runway end and slid down the steep slope just ahead of it from its nose. As the aircraft entered the grass and shrubs, the pilot was completely unable to make out the aircraft's attitude at all. The aircraft finally hit a tree at last, rolled forwards and came to a stop upside down facing the opposite direction. The engine also shut down. The passenger said, "Let's get out at once", and the pilot unfastened the harness, opened the left door and escaped from the aircraft. The passenger turned off the master switch, the ignition switch and the fuel shutoff valve, then attempted to exit. However, the right door would not open. The passenger therefore escaped through the left door. Neither of them sustained injuries. Although no fire broke out, they found fuel leaking. The police and fire brigade then rushed to the scene and laid down fuel-absorbent mats.

And the aircraft speed was calculated based on changes in the length of the aircraft's wing tip over a certain period, as well as the distance between the videographer and the aircraft. The results are shown below (see Figure 2 for the videographer's position and the range from which the still images were extracted). This calculation was performed in cooperation with the Japan Aerospace Exploration Agency (JAXA).

The JTSCB concluded that it is highly probable that, after touchdown, the aircraft floated once when it passed at a speed exceeding the short field landing speed near the threshold of Runway 15 at the operation site and touched down again around 210 m from the threshold (runway remaining distance: 270 m), and that after that, the brakes were applied during ground roll around 304 m from the threshold (runway remaining distance: 176 m), resulting in the aircraft overrunning. It is highly probable that the aircraft overran the runway, and slid down mowing down the grass and shrubs on the steep slope about 2 m ahead before hitting a tree at the bottom of the slope and rolling forward. It is certain that the aircraft was damaged by the impact of hitting the grass and shrubs, and by rolling forward.

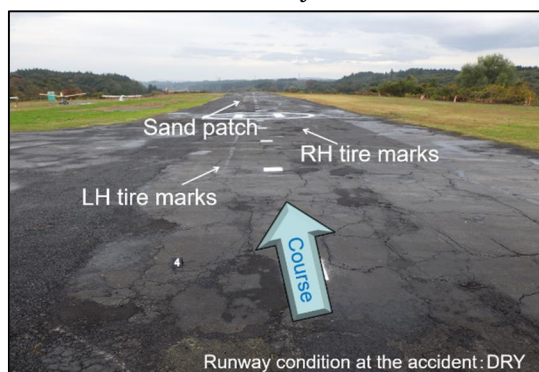
Figure 3: Tire Marks on the Runway

Tire marks, likely from both main landing gears, were found in an area extending from 304 m from the threshold of Runway 15 at the operation site to the end of the runway. The tire marks gradually changed course to the right, short of the end of the runway,

and continued onto the steep slope (see Figures 3 and 4). The left tire mark passed sand patch on the runway. Between the runway surface and the aircraft's stop position was a steep slope with a difference in altitude of about 17 m. This slope was covered in grass and shrubs, some of which were mowed down as the aircraft slid down it. A tree at the bottom of the slope had fallen from its root (see Figure 5).

Judging by the condition of the tire marks and the marks left by the worn main landing gear on the runway, it is certain that the aircraft's brakes continued to function normally from the moment they were applied until the aircraft overran the runway and onto the slope.

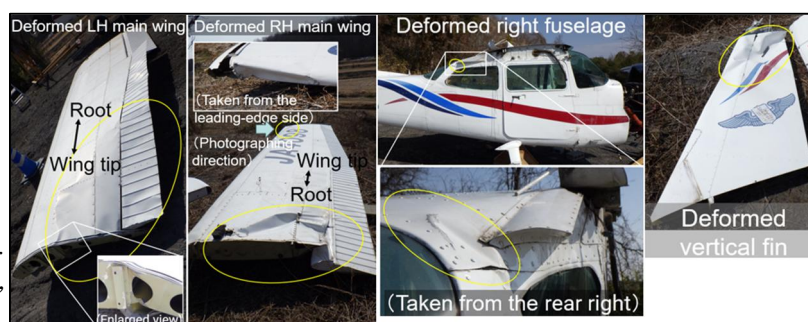
Figure 6: Damage to the Aircraft 1

Left main wing: Deformed near the wing tip

Right main wing: Deformed at the wing tip and near the root

Fuselage: Deformed

Vertical fin: Deformed

Nose landing gear mount: Broken

Spinner: Deformed

Propeller: One propeller was deformed.
