AIRCRAFT SERIOUS INCIDENT INVESTIGATION REPORT

May 16, 2025

Company	Corporate body
Type, Registration Mark	Cessna 172P JA4101
Incident Class	Dragging during landing of any other part of the aircraft other than the landing gears Item (iii), Article 166-4 of the Regulation for Enforcement of the Civil Aeronautics Act
Date and Time of the Occurrence	At about 10:14 Japan Standard Time (JST: UTC+9 hours), July 7, 2024
Site of the Serious Incident	Fukushima City Temporary Operation Site (for agricultural use) (Fukushima Sky Park), Fukushima City, Fukushima Prefecture (37° 49' 24N, 140° 23' 26E)

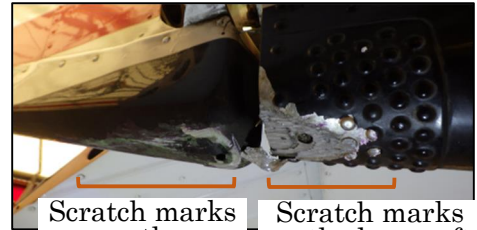
Figure 2: Scratch Marks on
the Airframe

Damage to the aircraft: There were scratch marks on the lower aft section of the fuselage and on the underside of the rudder, and the tie-down ring was broken at its root.

Scratch marks
on the
underside of
the rudder

Scratch marks
on the lower aft
section of the
fuselage

As described in the Event Occurred and Relevant Information (3) in 2. FACTUAL INFORMATION, it is more likely that around the time that the aircraft began to flare, the direction of the wind blowing over the runway changed from north-west to south, blowing from the rear left, causing the aircraft to lose airspeed and lift rapidly with the nose up, touching down at a higher rate of descent than normal, and the lower aft section of the fuselage touching the runway surface.

The JTSCB concludes that the probable cause of this serious incident was that around the time that the aircraft began to flare, as the direction of the wind blowing over the runway changed from north-west to south, the aircraft rapidly lost lift with the nose up, touched down at a higher descent rate than normal, and the lower aft section of the fuselage probably touched the runway surface.

It is difficult for a pilot to observe the movement of the windsock and understand the change of wind direction from that movement just before landing. It is effective for the pilots to obtain information from the Operations Assistants and others about the wind conditions in the circumstances of the change in wind direction in order for the pilots to understand the change in wind direction.

The Operations Manual for Fukushima Flight Service, for which the Fukushima Sky Park staff provide services, had been revised to state that they should actively provide pilots with information on change in the specific surface wind conditions, especially when there is a crosswind from the northwest side and changes in wind direction and velocity.

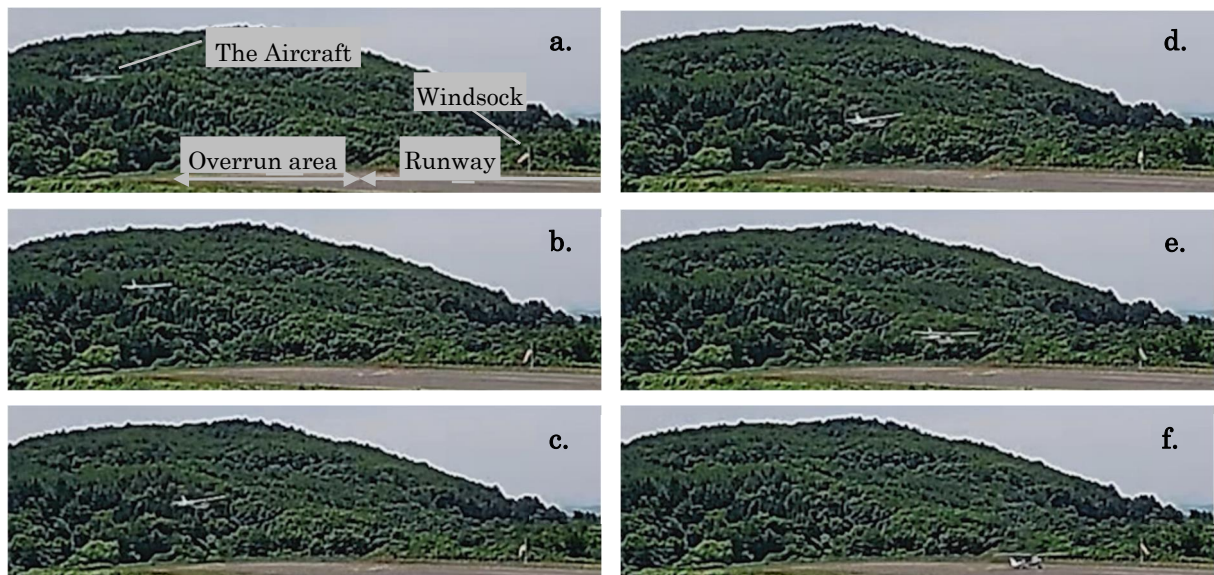
Figure 3: Movements of the Aircraft and the Windsock Five Seconds
before Touchdown to Touchdown (from Surveillance Camera Records)

- a. Five seconds before touchdown, the aircraft was just short of the south end of the runway and the windsock indicated that the wind was blowing from the northwest at 10 kt (5.1 m/s).

- b. Four seconds before touchdown, the aircraft was just short of the south end of the runway, and compared to the wind conditions in a., the change in the wind direction was smaller, but the windsock indicated that the wind velocity had dropped to about 5 kt (2.8 m/s).

- c. Three seconds before touchdown, the aircraft passed the south end of the runway, and compared to b., the windsock indicated that the wind velocity had dropped to 5 kt or less.

- d. Two seconds before touchdown, the aircraft was flying over the overrun area, and the windsock indicated that the wind was blowing from the southwest at about 5 kt.

- e. One seconds before touchdown, the aircraft began to flare, and the windsock indicated that the wind was blowing from the south at about 5 kt.
- f. The main wheel of the aircraft touched down and the lower aft section of the fuselage touched the runway surface, and the windsock indicated that the wind was blowing from the south at about 10 kt.
