# AIRCRAFT SERIOUS INCIDENT INVESTIGATION REPORT

January 15, 2026

<b>Company</b>	Privately owned
<b>Type, Registration Mark</b>	PIPER PA-28RT-201T, JA4128
<b>Incident Class</b>	Dragging during landing of any other part of the aircraft other than the landing gears Item (iii), Article 166-4 of the Regulation for Enforcement of the Civil Aeronautics Act
<b>Date and Time of the Occurrence</b>	At about 12:46 Japan Standard Time (JST: UTC+9 hours), March 20, 2025
<b>Site of the Serious Incident</b>	Oshima Airport, Tokyo Metropolis (34° 47' 12" N, 139° 21' 44" E)

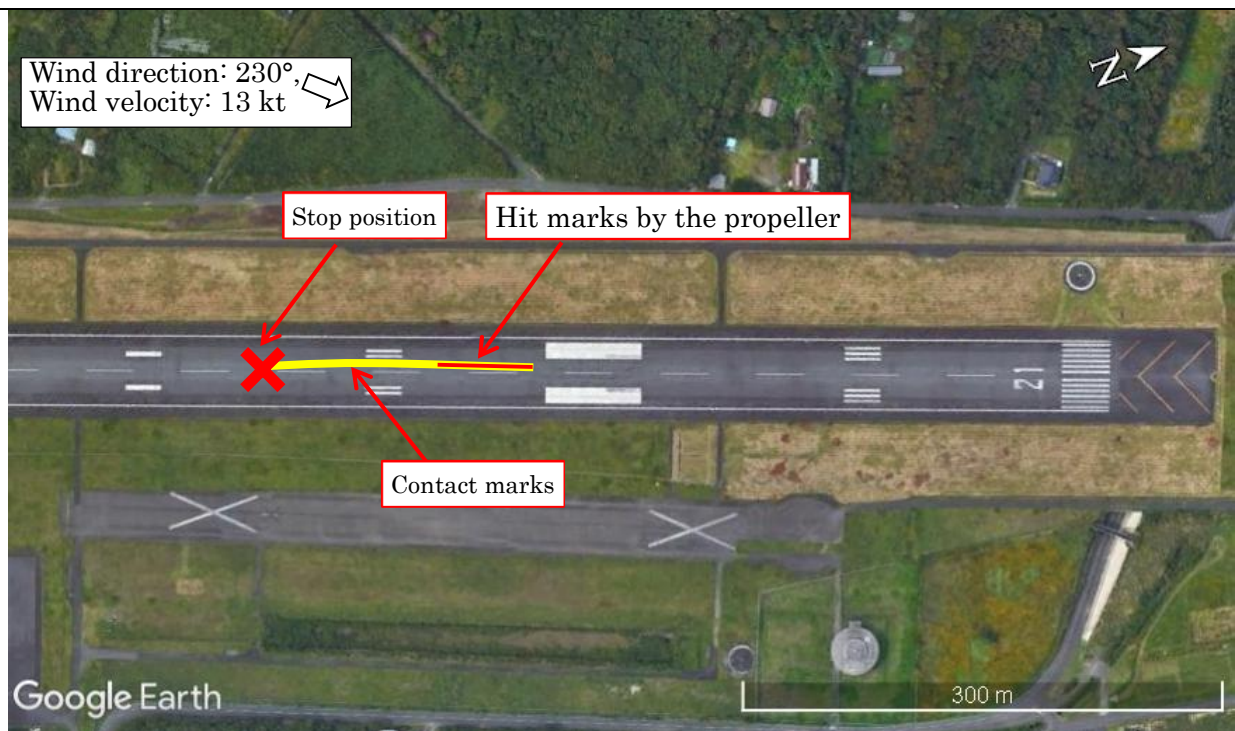
Figure 1: Estimated Skidding Route

After turning the aircraft onto the final approach, the pilot extended the flaps by one notch, but did not perform the landing gear down operation and continued the approach. At 12:46, the aircraft landed with its landing gear retracted, resulting in a belly landing. It then skidded, with its fuselage underside in contact with the runway surface before coming to a halt on the runway.

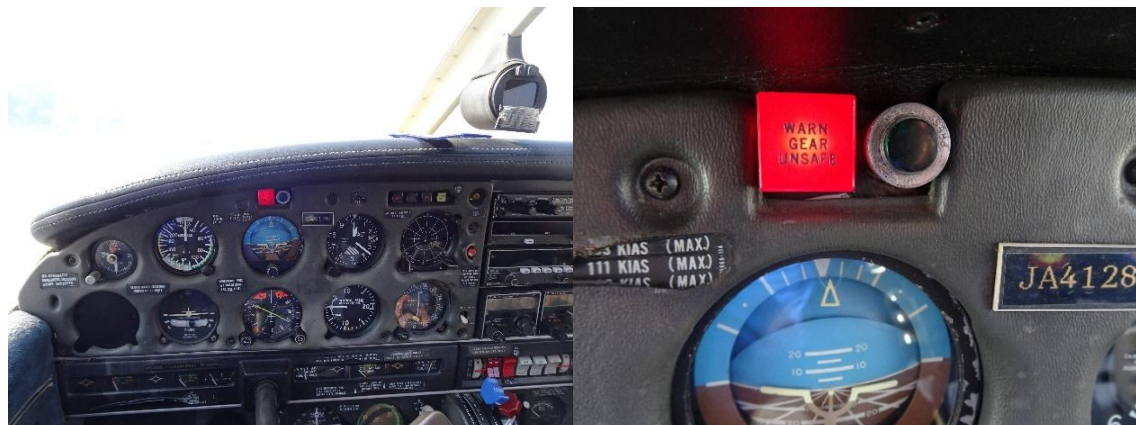
Figure 2: Landing Gear Warning Light (Illuminated State)

The aircraft is equipped with a retractable landing gear powered by a hydraulic power system. When the landing gear is not down and locked, and the throttle lever is pulled back beyond the position corresponding to an engine intake manifold pressure of 14 inHg, the warning horn (intermittent sound) is activated and the warning light located on the instrument panel illuminates.

The examination of the aircraft conducted after the serious incident confirmed that the landing gear warning system, including its horn and light, could function normally according to the position of the throttle lever.

- f. Immediately before the landing (the above ground level (AGL) altitude about 3 m), the pilot noticed that the warning light on the instrument panel had illuminated, but thought that it was a stall warning and continued the landing, maintaining an airspeed of between 70 and 75 kt. At this time, the pilot neither recognized the sound of the warning horn nor knew when the warning light had illuminated.

The JTTSB concludes that it is certain that the pilot had misidentified the landing gear warning light for a stall warning and did not have a sufficient understanding of the aircraft's various warning functions.

In order to correctly recognize the situation at once, it is important that pilots have a thorough understanding of the various warning functions of aircraft, become thoroughly proficient in aircraft specifications, performance, and flight characteristics, and familiarize themselves with their own aircraft.
