**AIRCRAFT SERIOUS INCIDENT  
INVESTIGATION REPORT**

**PRIVATELY OWNED  
J A 4 1 4 0**

June 26, 2009

PRIVATELY OWNED  
PIPER PA-46-310P, JA4140  
YAMAGUCHI-UBE AIRPORT, YAMAGUCHI PREFECTURE, JAPAN  
AT ABOUT 14:47 JST, SEPTEMBER 23, 2008

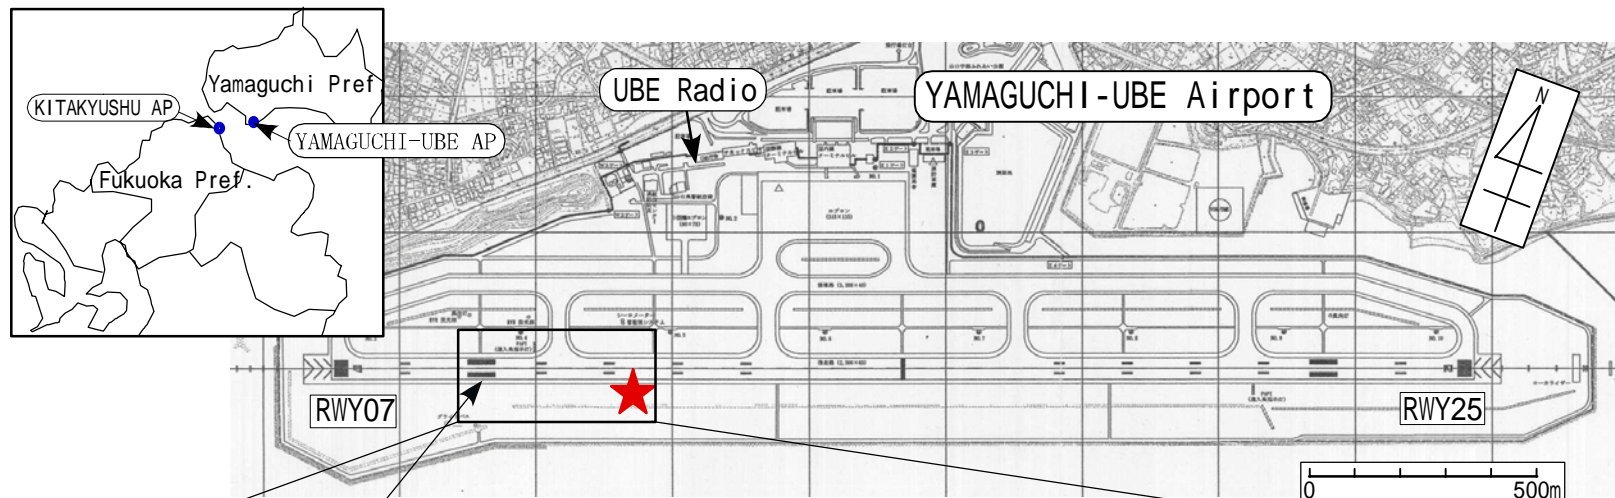
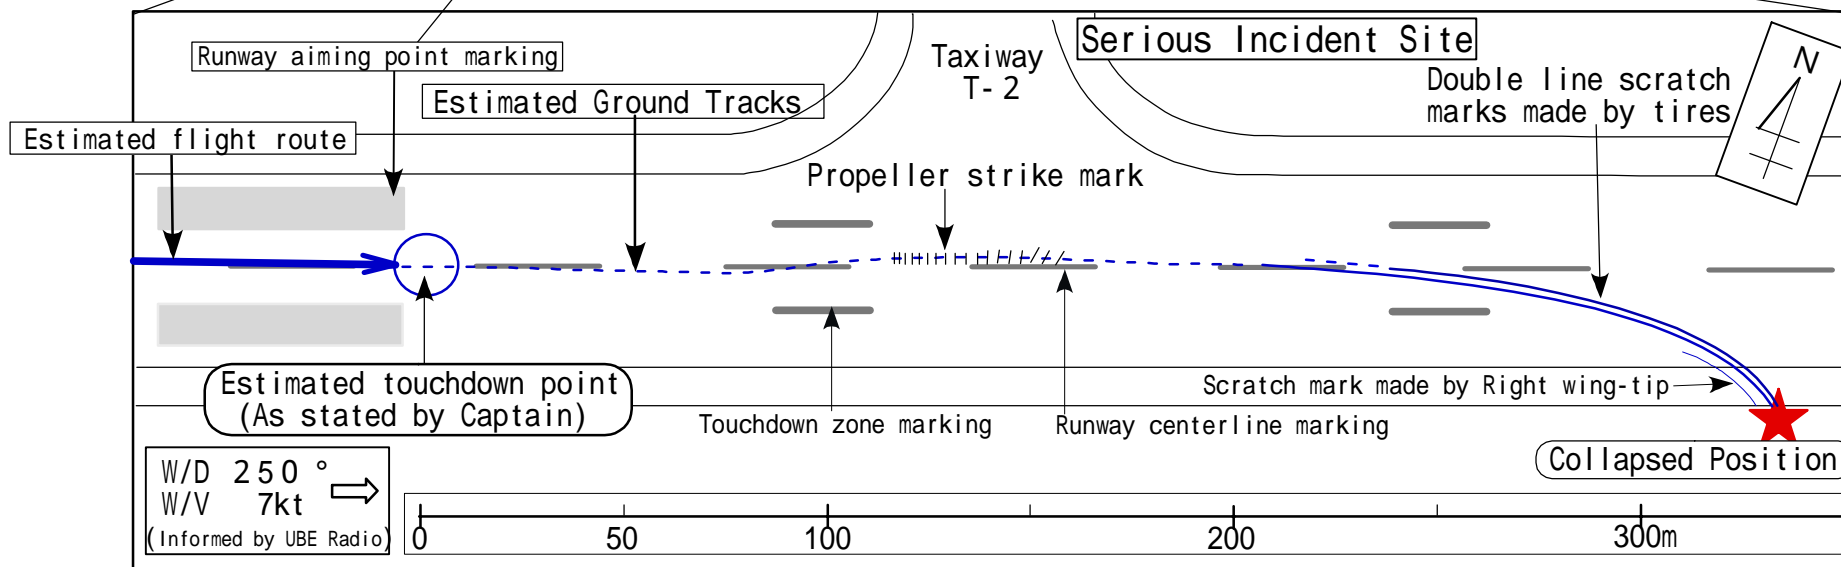
Figure 1 Sketch of the Serious Incident Site

The serious incident occurred at about 14:47 at a grassy area on the south side of Runway 07 at Yamaguchi-Ube Airport, which corresponds to a point about 700 m east of the runway threshold. (See Figure 1 and Photos 1, 2, and 4)

Starting from a point at about 120 m in the Aircraft movement direction from the touchdown point, there were propeller strike marks over a distance of about 30 m along the runway centerline marking. The interval between marks was 72 cm at the beginning of marks, but it gradually became greater as the distance increased and the last several marks consisted of longer, slanted line segments.

Starting from a point at about 40 m in the Aircraft movement direction from the end of the trail of propeller strike marks, there were double line scratch marks made by tires forming rightward arcs that originated at the runway centerline marking. Just beside the right tire mark, there was a white scratch mark of a wider width.

beyond the runway shoulder and ran on to the grassy area where the Aircraft lay on its belly. In addition, a scratch mark made by the right wing tip was found running from a point about 20 m before the grassy area.

The Aircraft collapsed in the grass at a point about 12 m from the runway shoulder edge, with its nose pointed in the direction of about 080°. This direction is about 60° counterclockwise relative to the direction of the tire marks entering the grassy area.

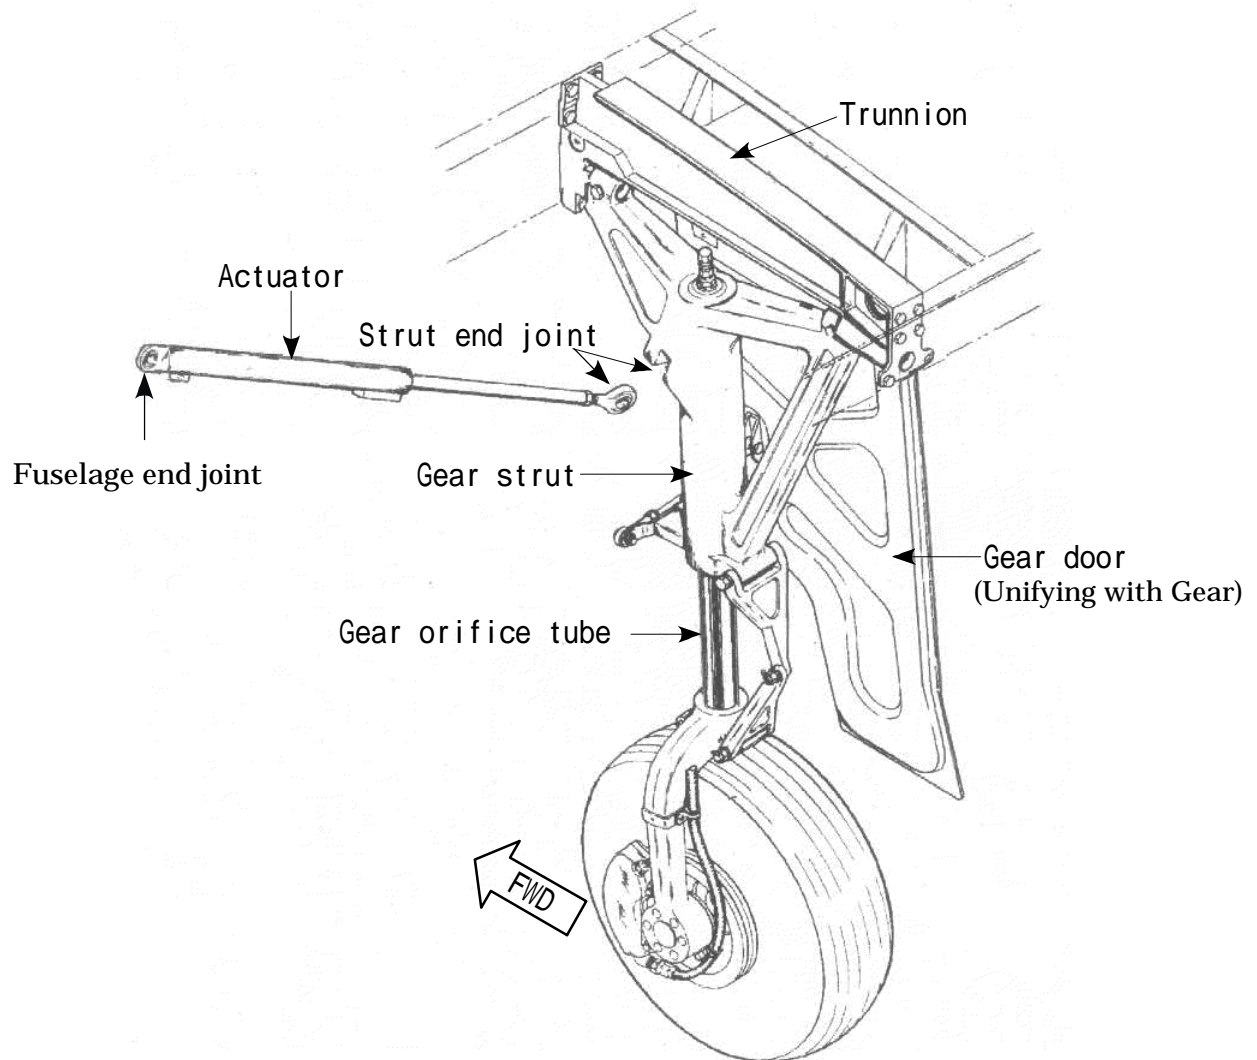
Figure 3 Right Main Landing Gear

During landing gear extension, the Aircraft's left and right main landing gears swing down from the fuselage side toward the wing tip side while the nose landing gear swings down in the forward direction. The strut of each landing gear is installed on the airframe in a way that allows free movement in both the extension and retraction directions of the gear. The gear is moved between the stowed and downlocked positions by a single actuator, which also serves to retain the gear in the stowed or downlocked position.

The landing gears are not designed to support the Aircraft on the ground if the gears are not downlocked. It could not be ascertained whether the landing gears were able to support the weight of the Aircraft under the conditions, i.e., the gears were not downlocked, the gear selector lever was in the DOWN position and the hydraulic pump was operating normally to feed the actuators with gear extending pressure, and the gears were in a slanted position.

The downlock mechanism causes a lock pin to engage with a groove in the actuator's piston rod when the rod has reached the downlock position. The lock pin is designed to disengage only when gear retracting pressure is applied to the actuator so that it will not disengage by external impact or any other force.

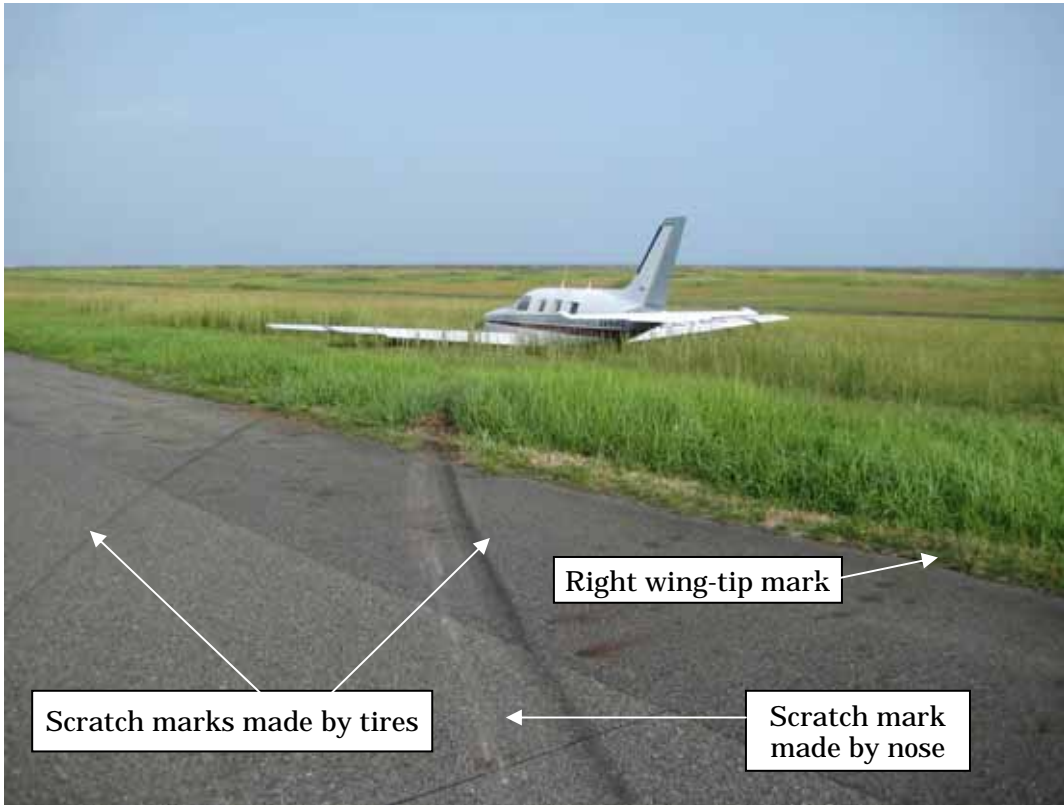
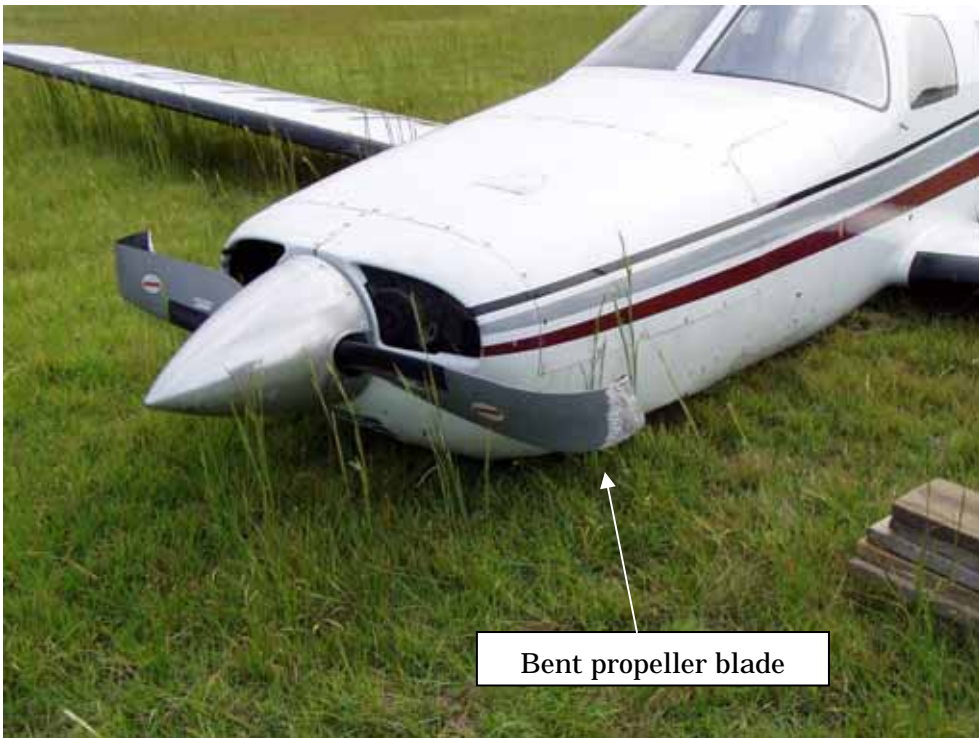
# Photo 1 The AIRCRAFT

- (1) Propeller blades: Both blades were bent at the tip
- (2) Nose portion of Aircraft: Bottom of engine cowls were deformed, scratched and worn
- (3) Right wing: Wing tip was scratched and otherwise damaged
- (4) Nose landing gear doors: Scratched and worn (The scratches and wear were only on the external surfaces; the door edges were free of deformation, scratches or any other damage.)
- (5) Right main landing gear: Outboard side (the side facing the right wing tip) of the tire/wheel was scratched

The Aircraft collapsed, with all three landing gears normally stowed and the flaps retracted.

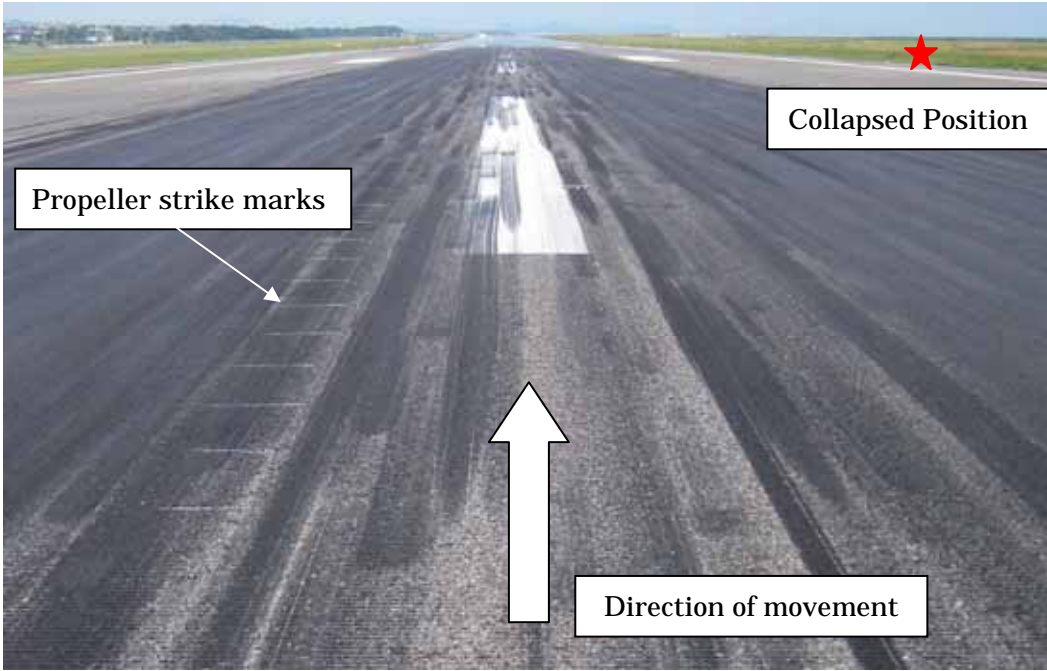
Propeller strike marks

Considering that scratches were the only damage to the bottom surfaces of the Aircraft's nose, it is considered highly probable that the propeller blades worked as a cushioning material, which prevented the nose from tilting rapidly and directly contacting the runway surface.

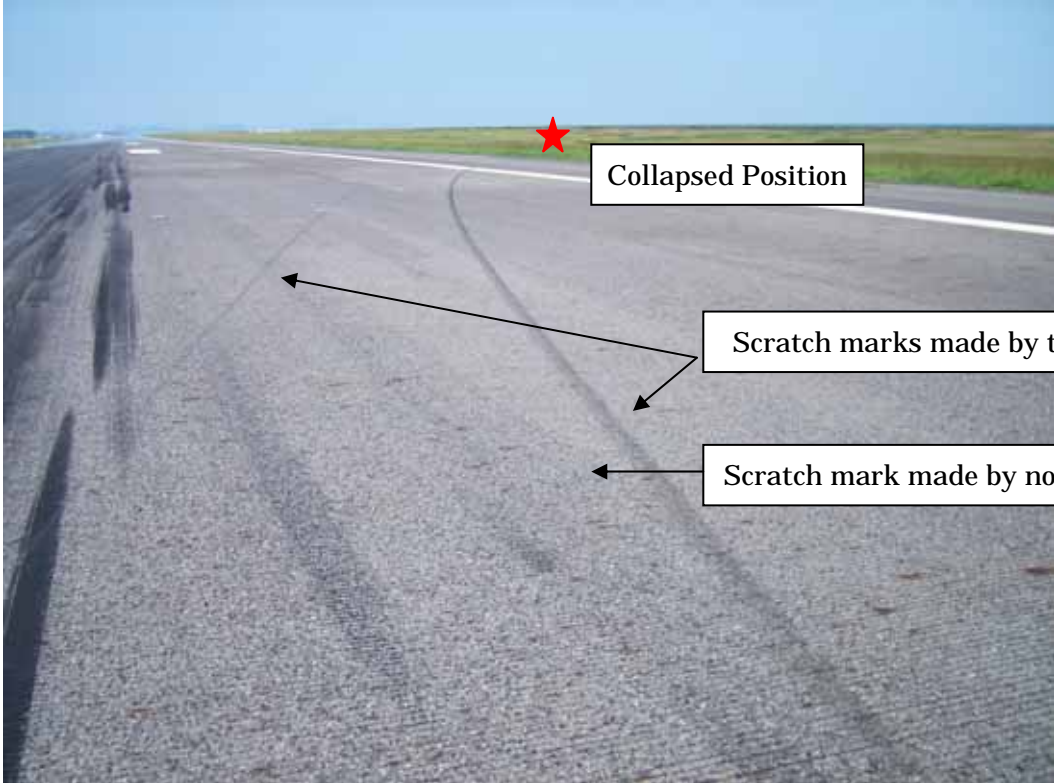
Scratch marks made by Tires

The right tire mark line was thicker than the left tire mark line. These marks extended

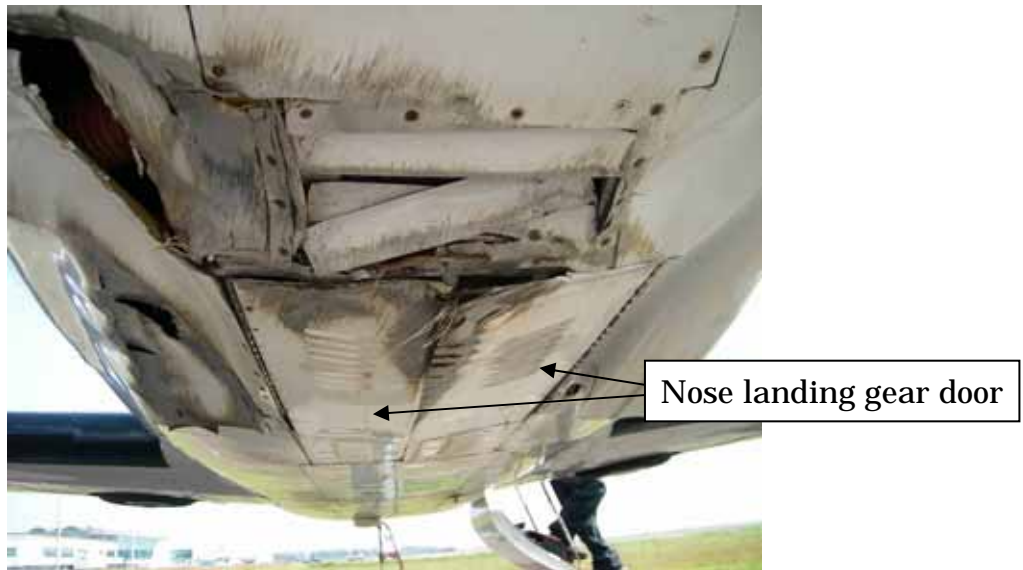
Nose landing gear door (Viewed from the nose)

It is presumed that the door, which had opened due to the spring force, closed under the weight of the Aircraft's nose and came into contact with the runway surface in a closed condition after stowage of the gear considering that the door sustained only external surface damage with no damage to the edges, as described in 2.2.2 (4) and the description in 2.7.4.

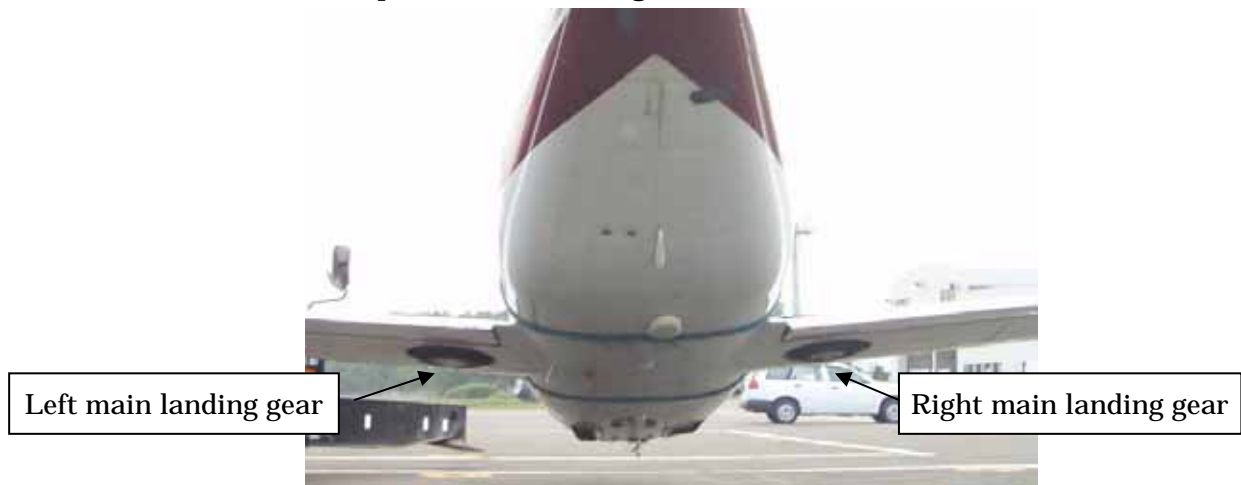
Bottom part of the fuselage (Viewed from the tail)

There was no damage to the gear strut, gear-strut-to-actuator joint or actuator on any of the three landing gears. Except for the nose portion, the bottom surfaces of the Aircraft were free of

scratches and other damage both in the fuselage portion and the doors of the left and right main landing gears.

However, considering that the bottom surfaces of the Aircraft were completely free of scratches or other damage and not soiled with any mud at all, that all landing gears were stowed normally, and that the captain felt no large tilt when the Aircraft came to a stop as described in 2.1 (1), it is considered highly probable that the left main landing gear tilted with its downlock disengaged at the time that the Aircraft came to a stop.

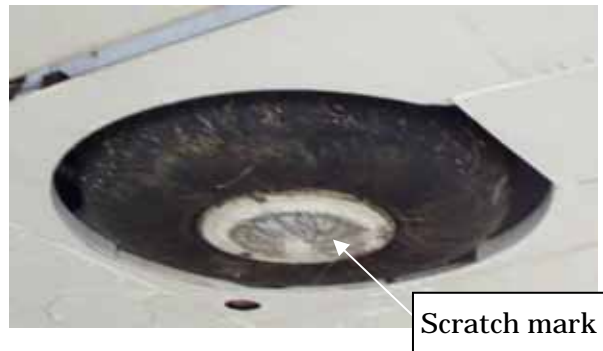
Right main landing gear

The actuator arm for the right main landing gear was removed from the Aircraft and subjected to a teardown examination in order to inspect the downlock mechanism. No abnormalities were found.

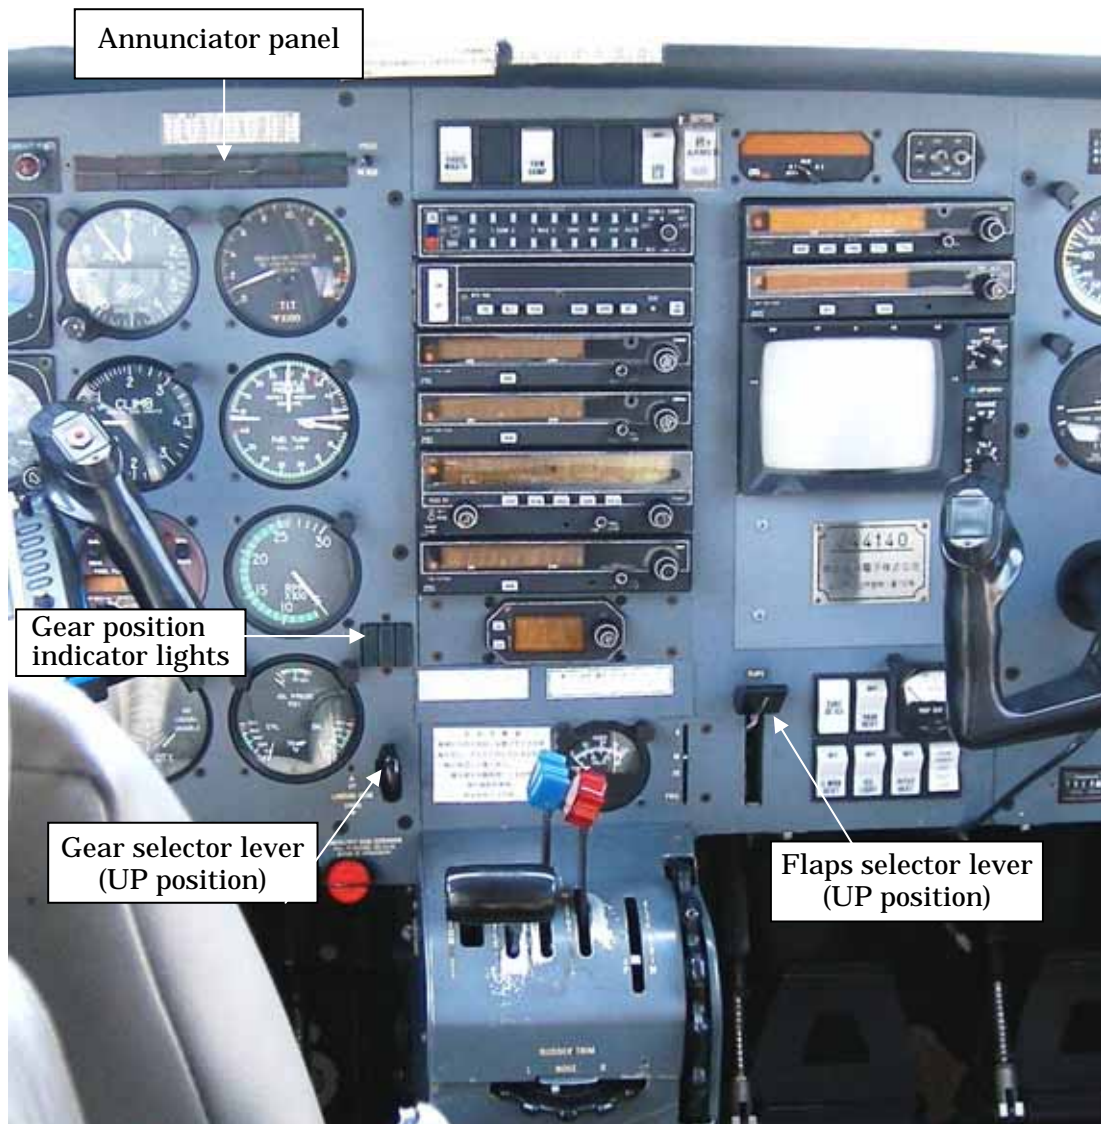
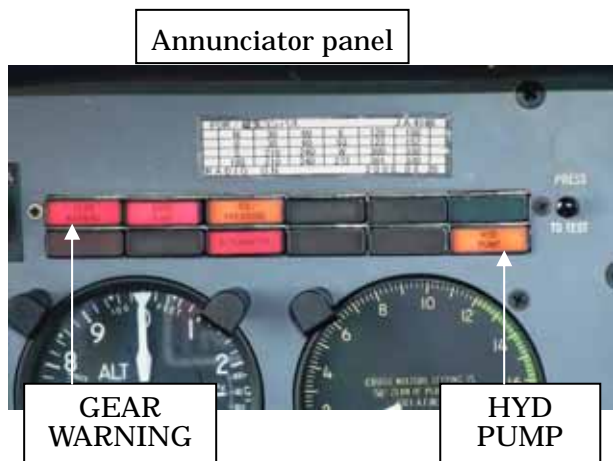
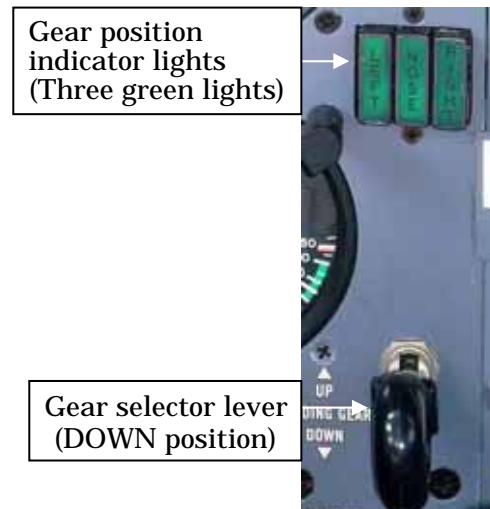
# Photo 4 Cockpit

\*<sup>1</sup> : The annunciator refers to the panel of lights located on the instrument panel in front of the pilots' seats. After the gear selector lever is operated, the red "GEAR WARNING" lights and orange "HYD PUMP" lights remain illuminated until the landing gears are stowed in the UP position or downlocked in the DOWN position. (See Photo 4)

The squat switch described in c) above is installed on the left main landing gear and operates upon contraction of the gear orifice support tube.

With regard to the disengagement of the landing gear downlocks, it is considered possible that the captain mistakenly operated the gear selector lever rather than the flaps selector lever.
