**AIRCRAFT ACCIDENT  
INVESTIGATION REPORT**

## PRIVATELY OWNED BEEHCRAFT A36, JA4159 DAMAGE DURING LANDING ON THE RUNWAY AT MATSUYAMA AIRPORT AT AROUND 18:27, OCTOBER 26, 2013

June 5, 2015

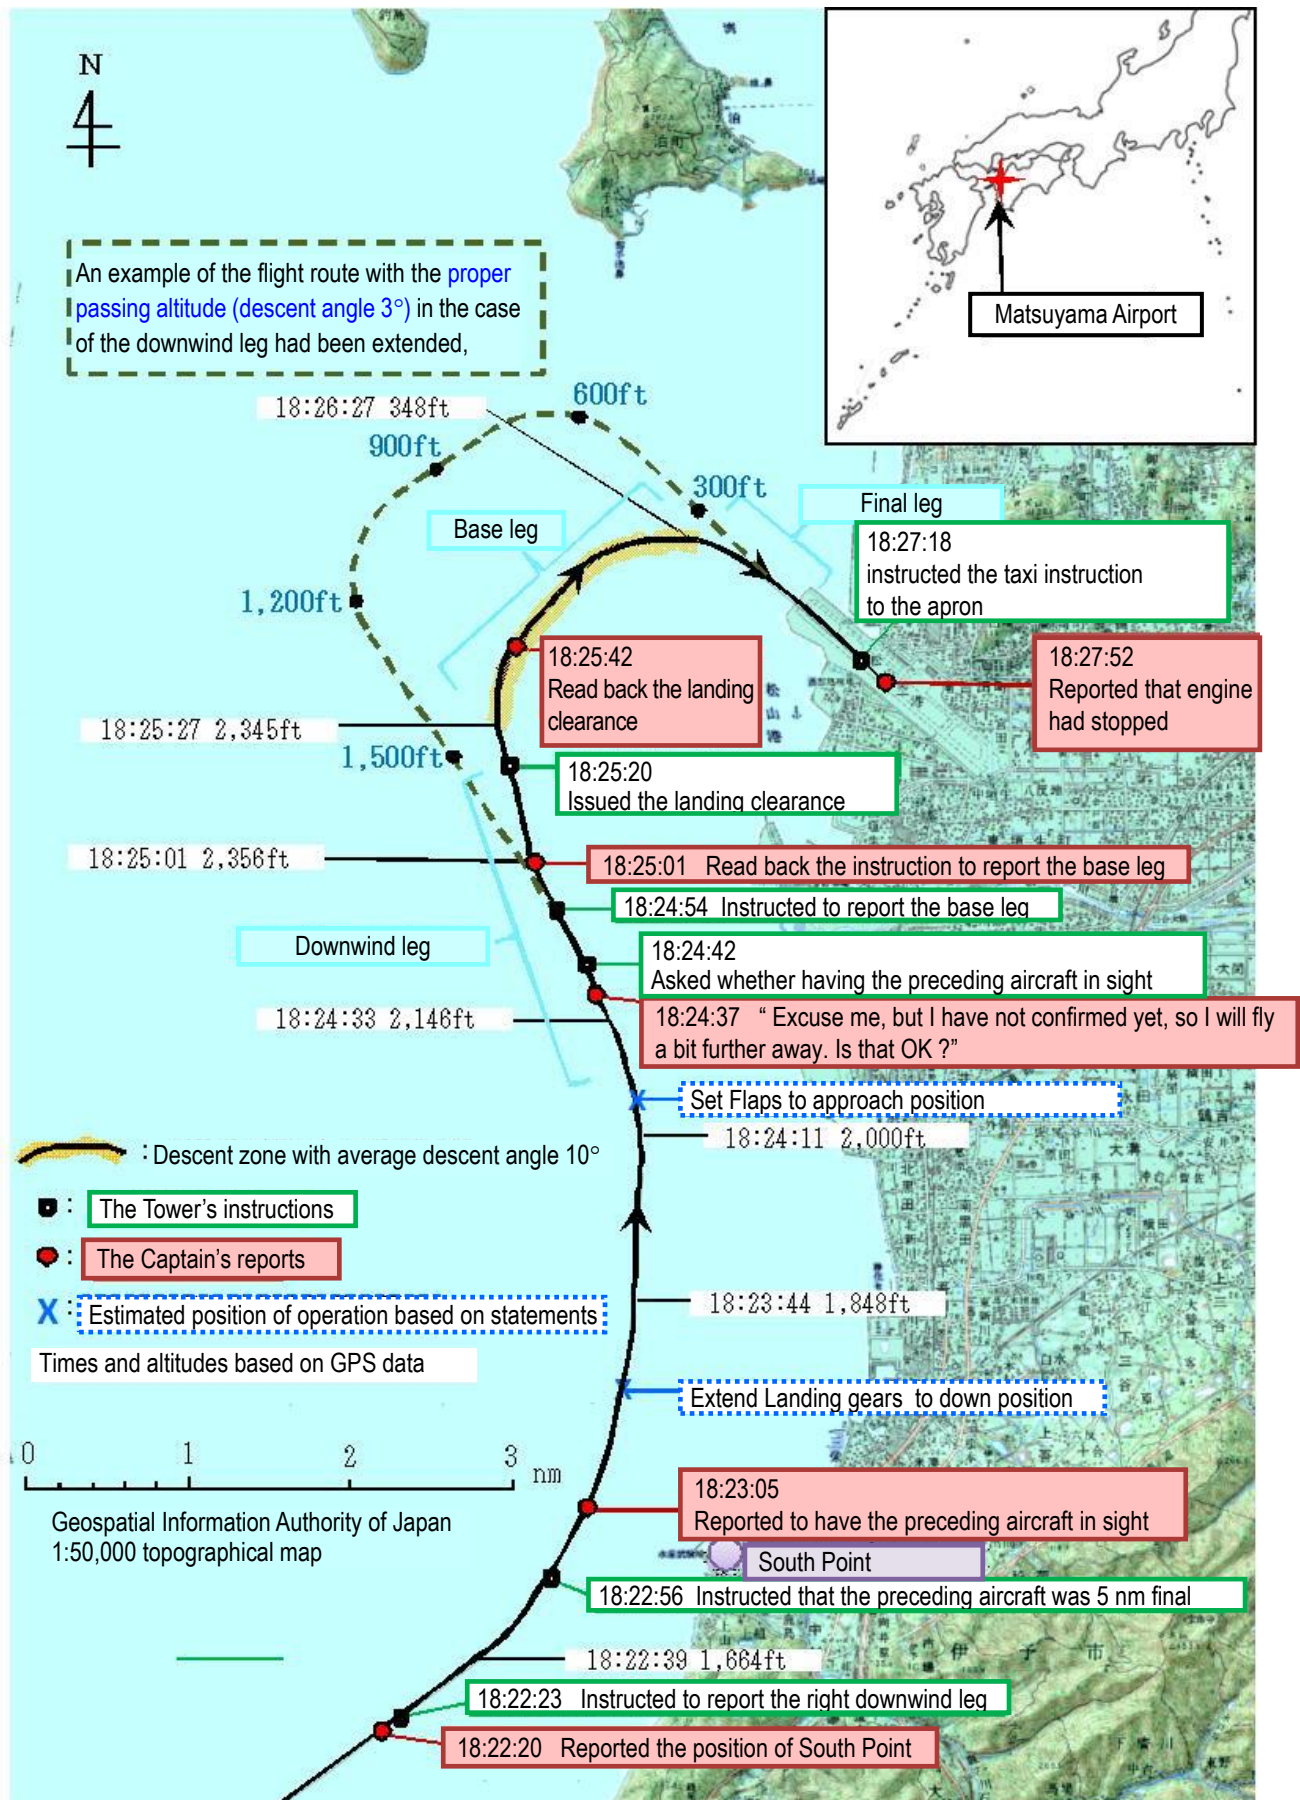
Figure 1: Estimated Flight Path on the Approach to Matsuyama Airport

As described in his statement, it is probable that the Captain intended to enter the downwind leg at an altitude of about 1,500 ft. However, as shown in Figure 1, the Aircraft's altitude, which shown about 1,800 ft near South Point, was increasing little by little and climbing to about 2,100 ft at 18:24:33. It is somewhat likely that this gradual increment of the Aircraft's altitude was caused by the Captain's unintentional pulling of the control wheel, not only because he would not afford to check the altimeter using the Waterproof Portable Light, but also because he wanted to confirm the position of the Runway at this time.

As described in 2.1.1, at 18:24:37, the Captain said to the Tower, "Excuse me, but I have not confirmed yet and I will fly a bit further away. Is that OK?" As described in the statement, it is probable that the Captain at this time wanted to extend the downwind leg in order to confirm the position of the Runway exactly. An example of estimated flight route imaged by the Captain at that time is shown by the broken line in Figure 1.

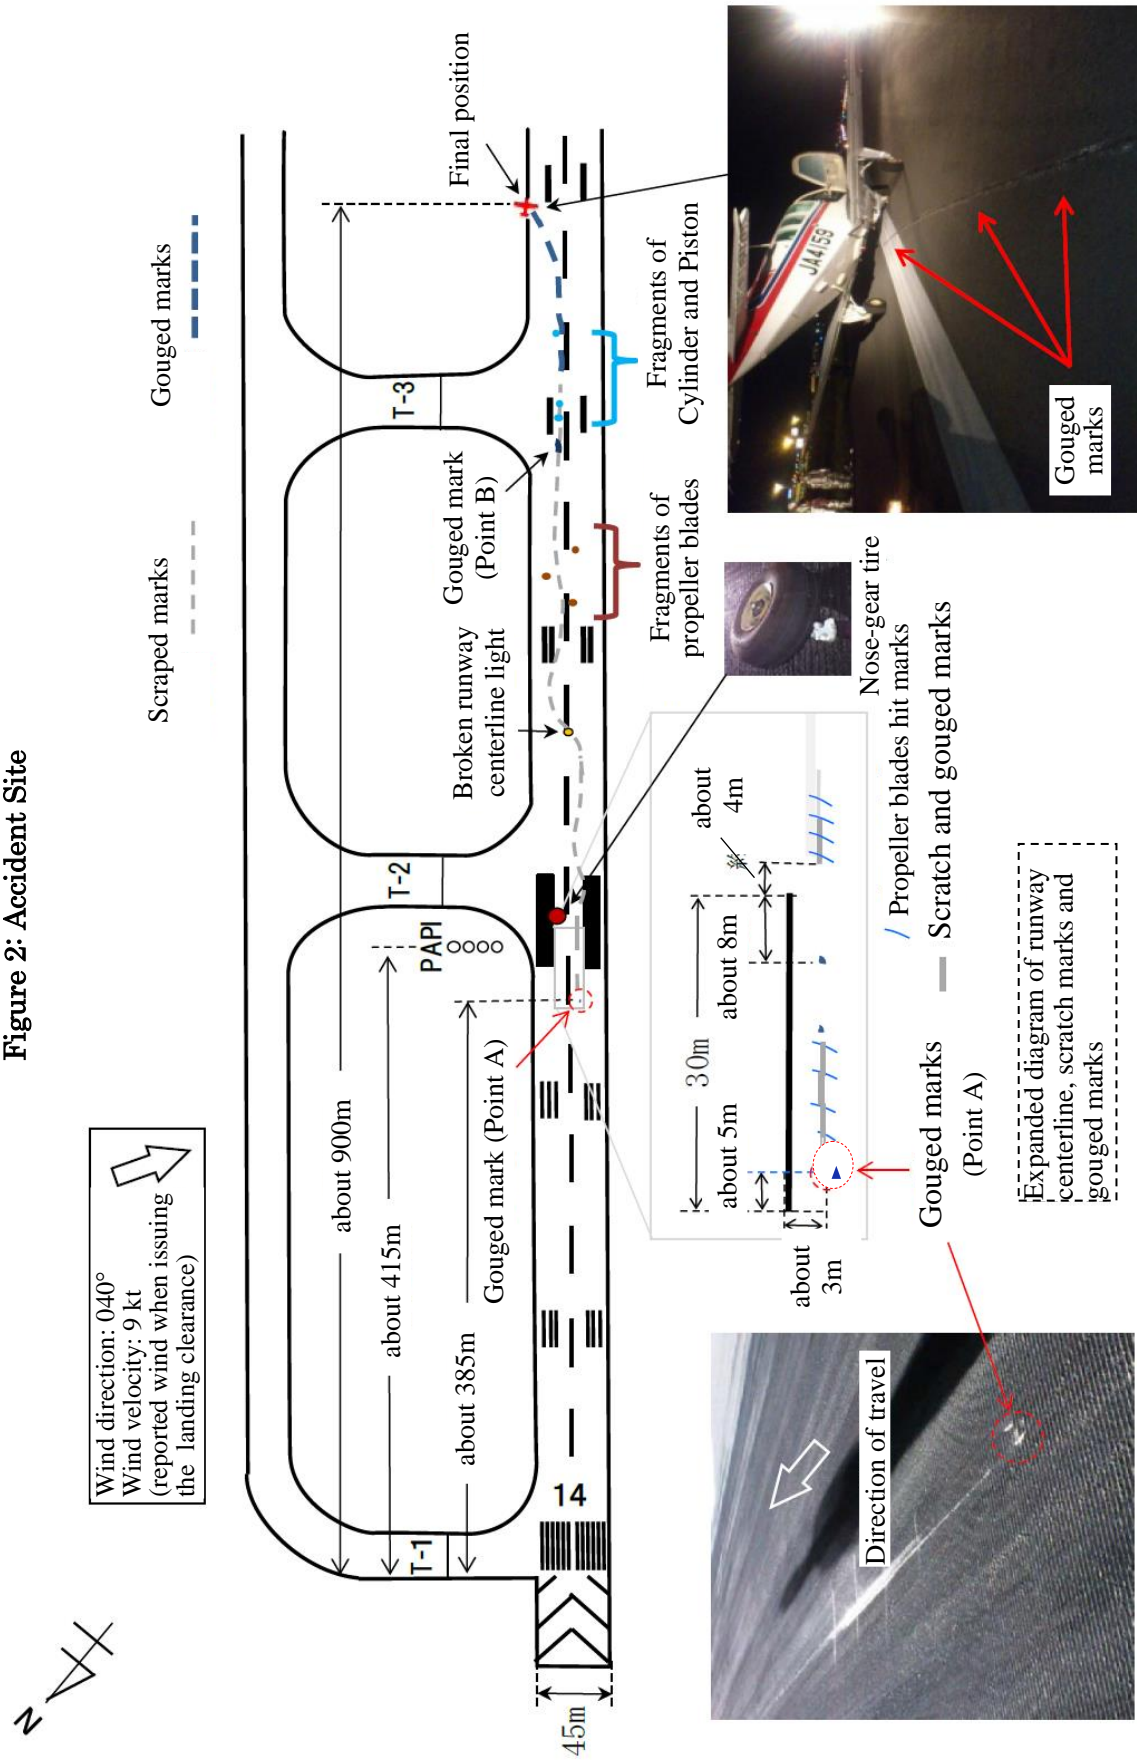
Figure 2: Accident Site

There was a gouged mark about 385 m from the Runway threshold and 3 m of the right of the Runway centerline (Point A), followed by scratch marks, propeller hit marks, another gouged marks and such. One of the Runway centerline lights was damaged, and another gouged mark was remained in the intersection of the taxiway T-3 and the Runway (Point B), and beyond that point, continual gouged marks followed up to the Aircraft stop point.

Besides these, a nose-gear tire attached with a broken fork\*<sup>17</sup> was found around the entrance of taxiway T-2. Beyond that position, fragments of the propeller blades and metal pieces, which appeared to be debris of the cylinder of nose gear shock strut (hereinafter referred to as "Cylinder") and the piston of the nose gear shock strut (hereinafter referred to as "Piston"), were scattered around.

It is probable that the Aircraft touched down from the nose gear without securing pitch-up attitude around the position just before Point A shown in Figure 2, and that the hard impact in landing broke the fork and tore the nose-gear tire down. After that, it is highly probable that the Aircraft bounced once as described in the Captain's statement, and that the Aircraft continually moved with shooting sparks caused by hard contact between the nose gear and the runway surface as described in the mechanic's statement in 2.1.2 (3). Finally, it is highly probable that the Aircraft came to a stop breaking down at the point of the left-side runway edge of about 900 m from the Runway threshold.

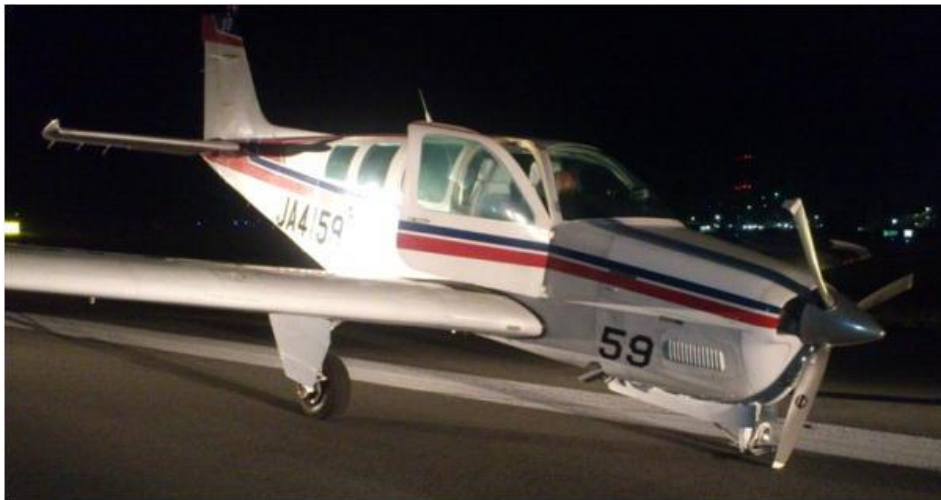
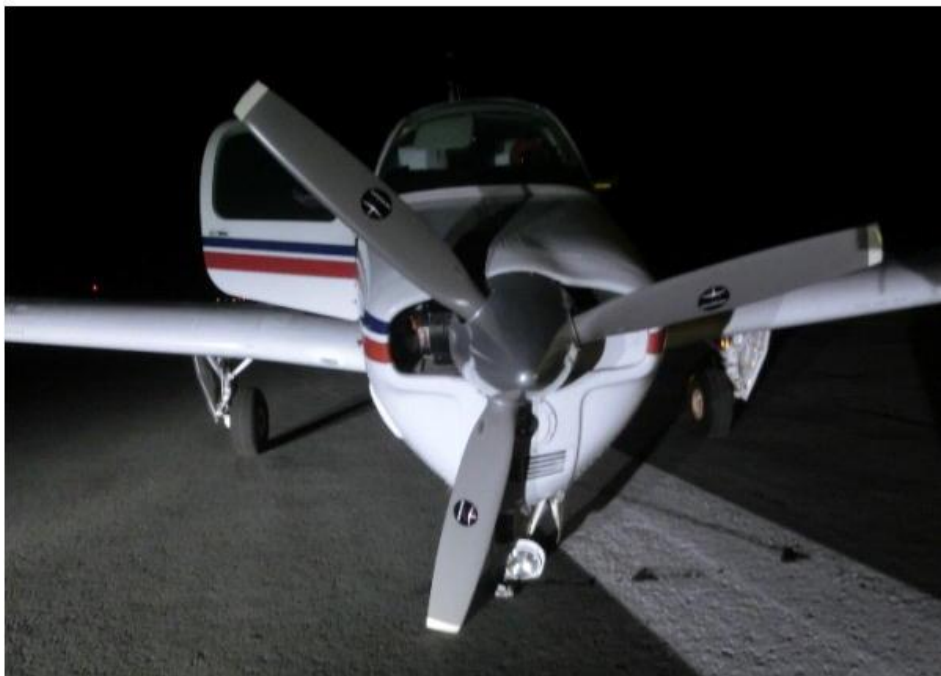
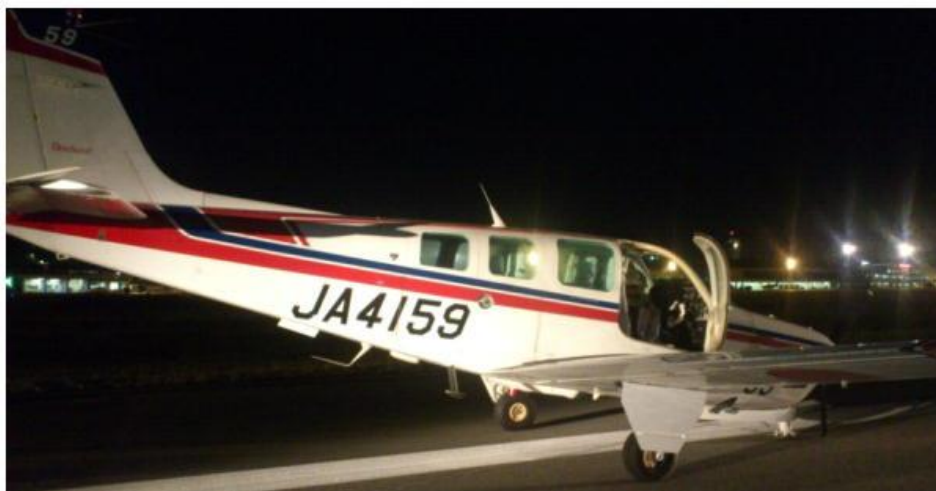
Photo 1: Accident Aircraft

- (1) Fuselage : Damaged
- (2) Propeller : Blades damaged
- (3) Landing gear : Nose gear damaged

- (1) Fuselage : Wrinkling on lower outer plate of engine left-side access panel and lower outer plate in the center of the fuselage, two through-holes in the lower outer plate aft of the nose gear
- (2) Propeller : Bending and partial breakage of the tips of three propeller blades
- (3) Landing gear : Breakage of fork, damage in Cylinder and Piston, bending in nose gear door
- (4) Control systems : Jamming of Rudder pedal

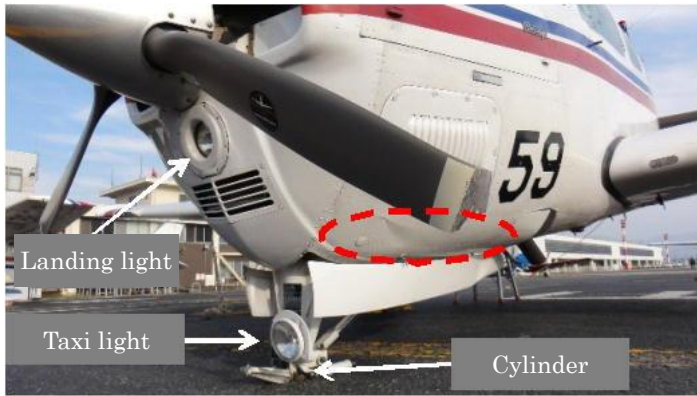
Photo 2: State of Damage to Various Parts

- Propeller blades (all three): Bent, partly broken
- Lower outer plate of engine left-side access panel: Wrinkled
- Taxi light: Not working
- Cylinder: Bottom broken

[ Piston had slotted into Cylinder ]

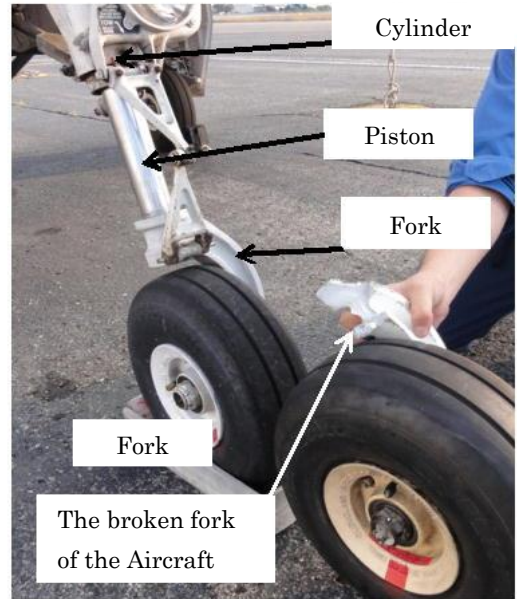
Nose gear structure of the type of the Aircraft and the Aircraft's nose-gear tire tore down

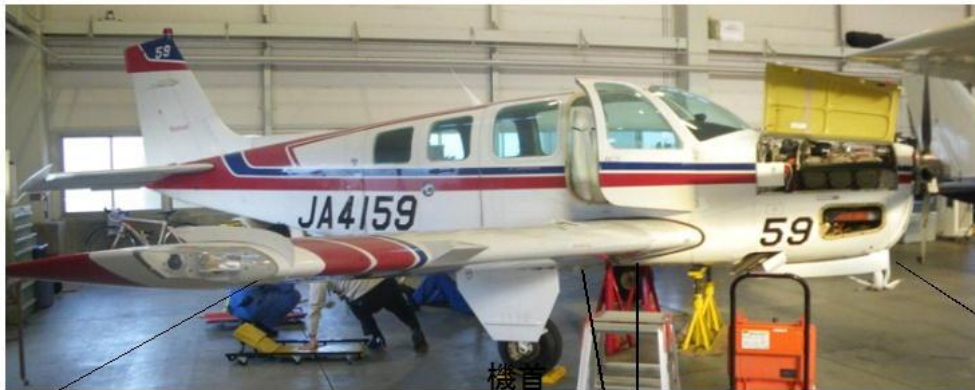
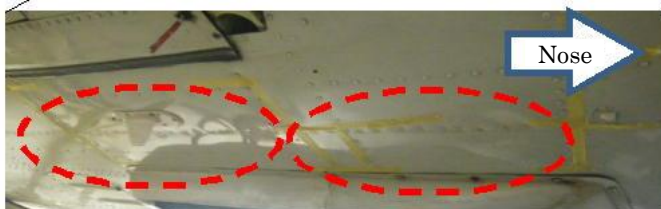
Wrinkling on lower outer plate in center of fuselage

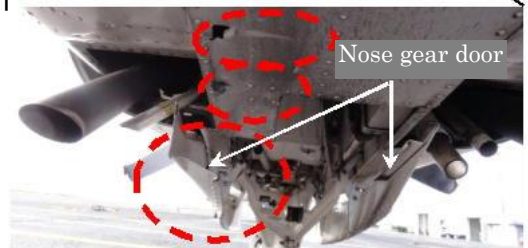
View towards nose gear from the center of fuselage

- Bending on nose gear door
- Penetration marks (holes)
