**AIRCRAFT ACCIDENT  
INVESTIGATION REPORT**

**J A 4 1 6 5**

**February 25, 2011**

CIVIL AVIATION COLLEGE  
BEEHCRAFT A36, JA4165  
ON THE RUNWAY OF KAGOSHIMA AIRPORT, JAPAN  
AT ABOUT 15:29 JST, OCTOBER 30, 2009

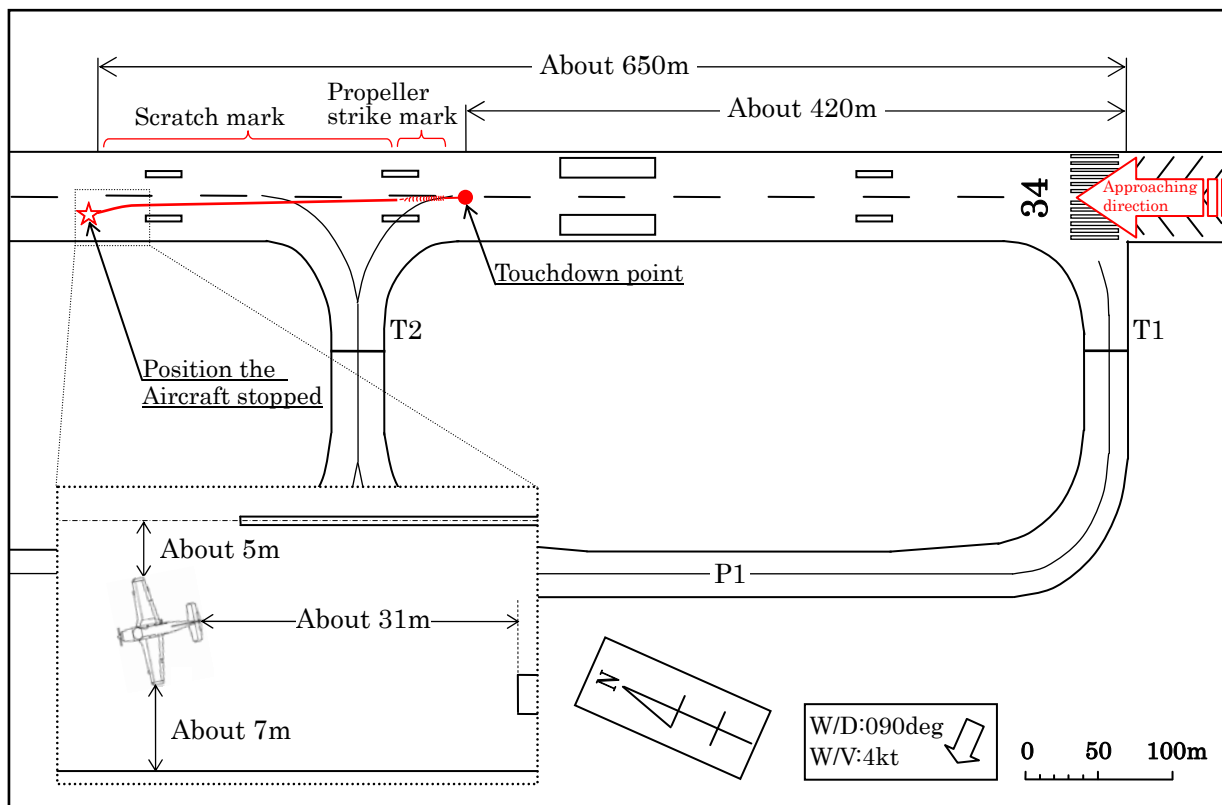
Figure 2 Accident Site Sketch

The runway at the Airport is 3,000 meters long and 45 meters wide with its direction at 16/34. The Aircraft landed on its belly and stopped at a point about 650 meters from the threshold of runway 34 and about 5 meters left of the center line, with its nose veered to the left by about 10°. Hit marks with propellers and traces of scratch made by the fuselage were found in a strip of about 230 meters gradually leaning to the left, running from the point about the centerline about 420 meters from the threshold of runway 34 to the point where the Aircraft stopped. Plastic and metallic pieces of the anti-collision light, the landing gear doors and other damaged parts were found scattered around in the area.

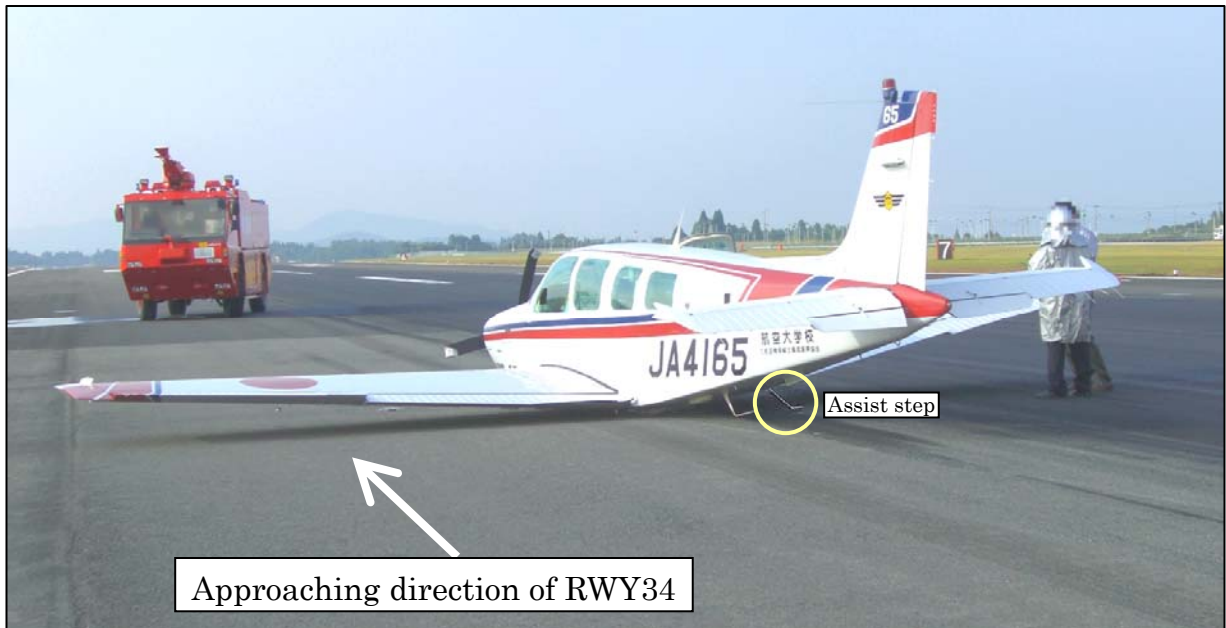
Photo 1 Accident Aircraft

On October 30 (Friday), 2009, a Beechcraft A36, registered JA4165, operated by Independent Administrative Institution Civil Aviation College, took off from Kumamoto Airport for solo flight training at about 14:47 Japan Standard Time (JST: UTC+9hr, unless otherwise stated all times are indicated in JST based on a 24-hour clock). When the aircraft arrived at Kagoshima Airport at about 15:29, it landed on its belly and stopped on the runway.

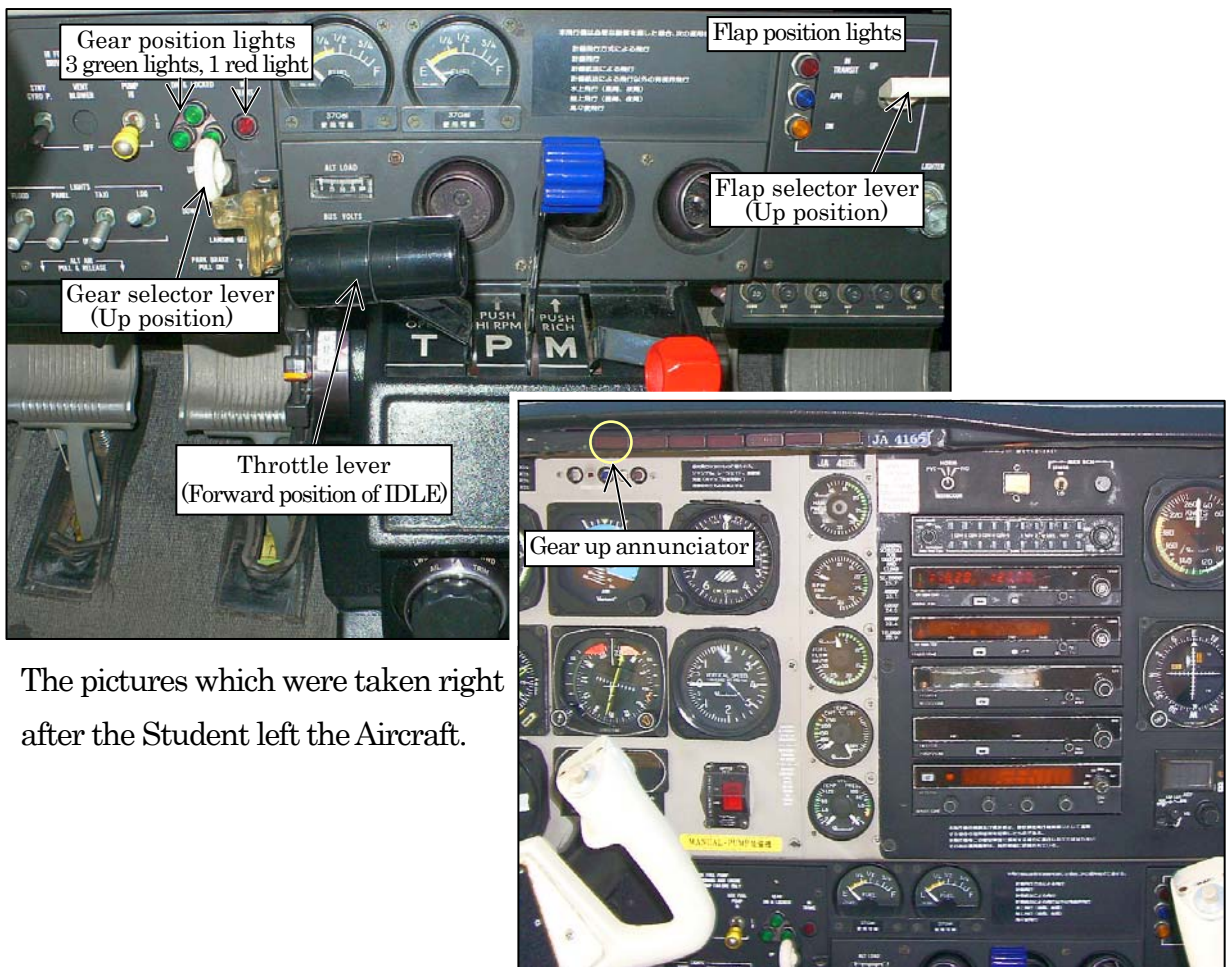
Photo 2 Instrument Panel at Cockpit

Regarding the condition of the instrument panel of the Aircraft stored at the hangar, the throttle lever was in a position forward of IDLE, the flap and landing gear selector levers were in

the Up position. The master battery switch was off, while the ground communication switch was on, with the radio communication frequency selected for the Tower.

The pictures which were taken right after the Student left the Aircraft.

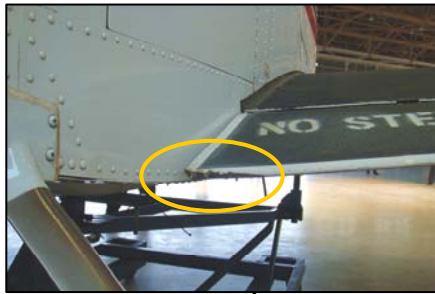
The inner rear edges of the right and left flaps were worn and deformed. The pitot tube attached to the lower part of the left wing was deformed from the bottom.

Damaged RH flap

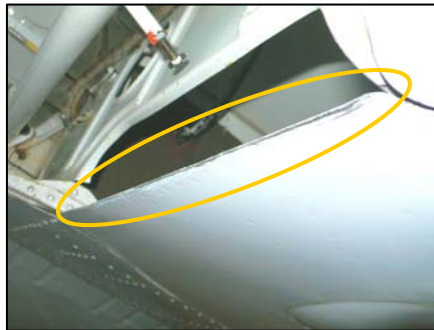
The outer edges of the inner doors for the main landing gears on both sides and a projecting part of the inner door for the left main landing gear were worn and deformed.

Damaged RH main/landing gear door

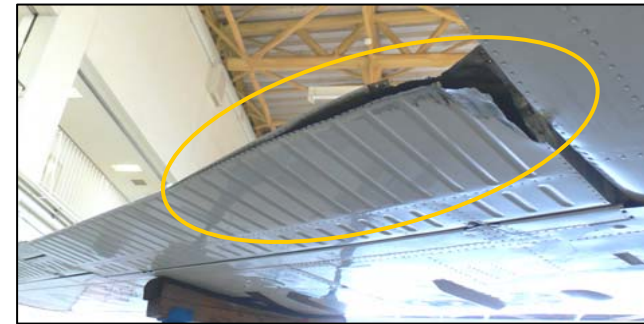
Damaged LH flap

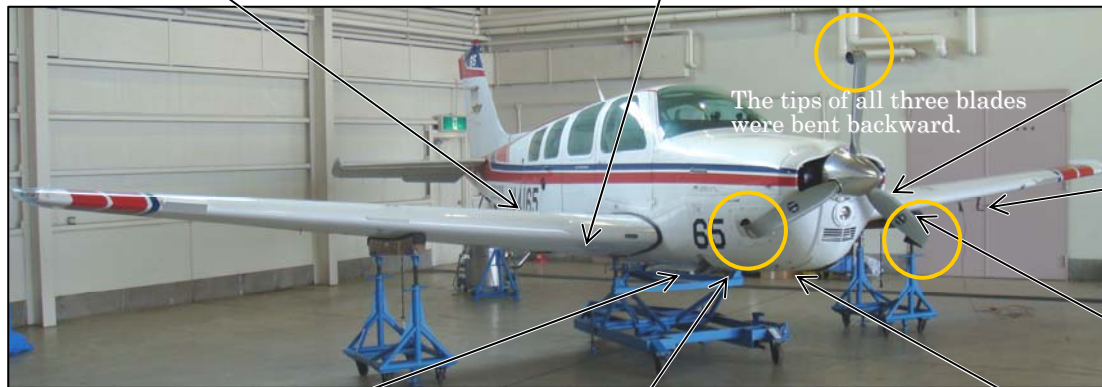
The tips of all three blades were bent backward.

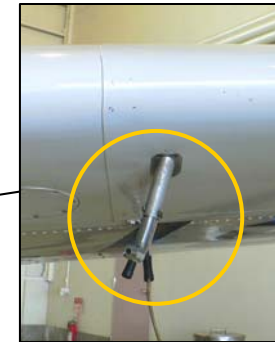
In the lower surface of the forward section of the fuselage, the exterior panels were worn from the nose landing gear bay to the air-conditioner condenser at the root of the main wings. The keel structure of the nose was partially worn.

The exhaust pipes on the left and right sides were deformed and their tips were worn.

Damaged keel and exhaust pipes

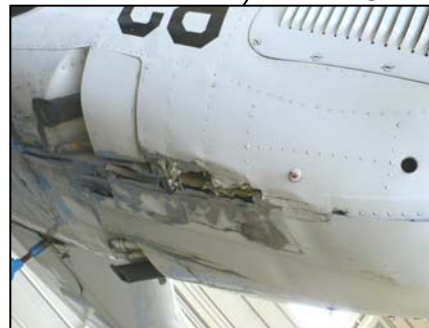
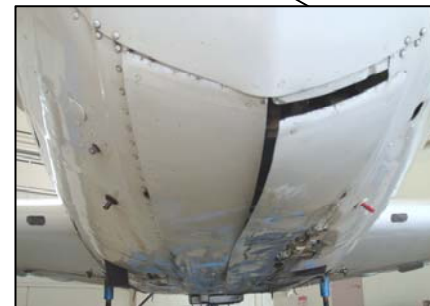
The assist step built in the lower right section in the middle of the fuselage, the bottom of the air-conditioner condenser attached to the lower surface of the fuselage and the lower part of the DME antenna were worn, while the anti-collision light was damaged.

Damaged anti-collision light and air-conditioner condenser

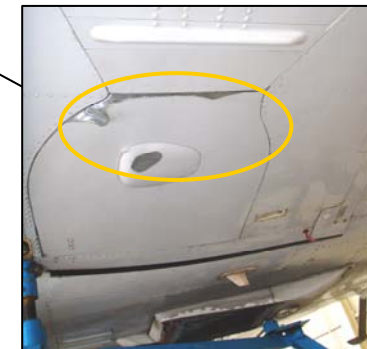
Judging from the statement described in 2.1 (2), it is considered highly probable that the landing gears had not been extended until touchdown, but as described in 2.8.2(4), the inner main landing gear doors were worn and deformed. When the landing gear doors are closed, the doors are neither worn nor deformed. Further, according to Photo 1, with the assist step attached to the right side of the Aircraft, the right side of the fuselage becomes higher, and it makes the Aircraft lean to the left. Photo 3 shows the Aircraft sustained severe damage to the left side compared with the right side. And the landing gear doors open only when the landing gears are in operation. Judging from above, it is considered highly probable that the landing gears were operated downward while the Aircraft was sliding on the runway with its body leaned to the left after it landed on its belly.

Damaged LH main landing gear door

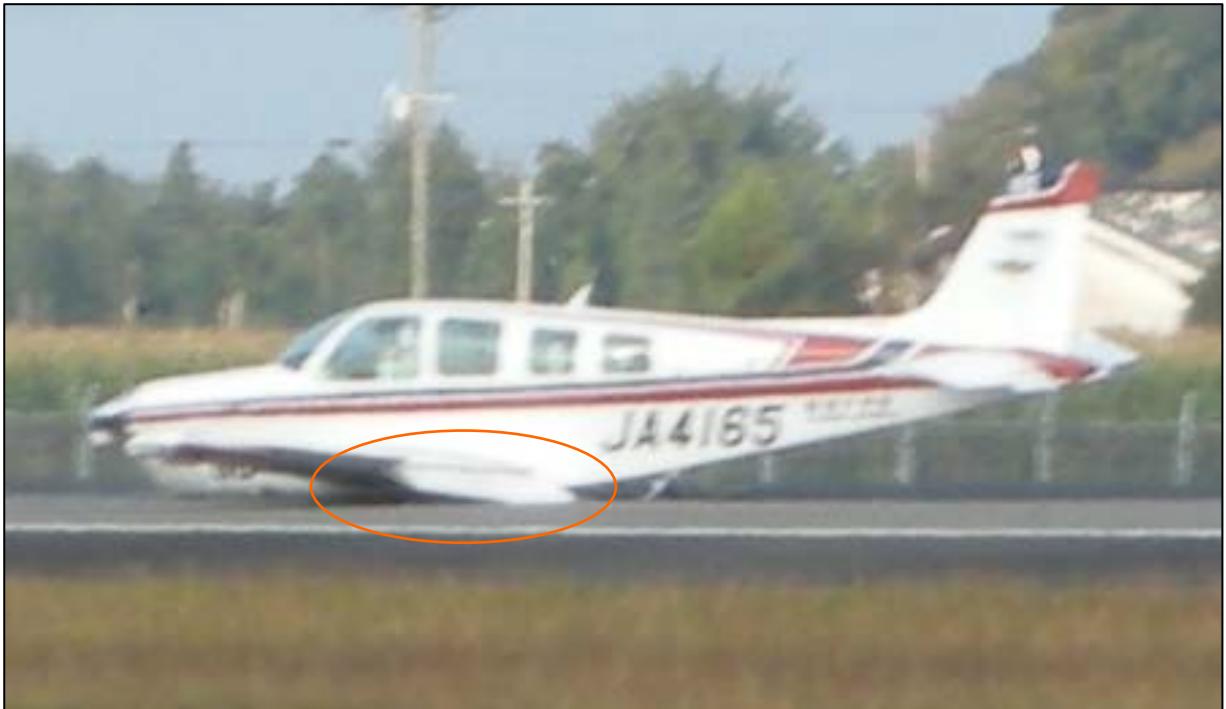
About 15:30(Just after the Aircraft stopped)

A picture shot just after the Aircraft stopped by a mechanic who happened to be at maintenance work at the hangar next to the runway shows the flap position was full down, but another picture shot later shows the flaps had been retracted.

Flaps were in full down position.

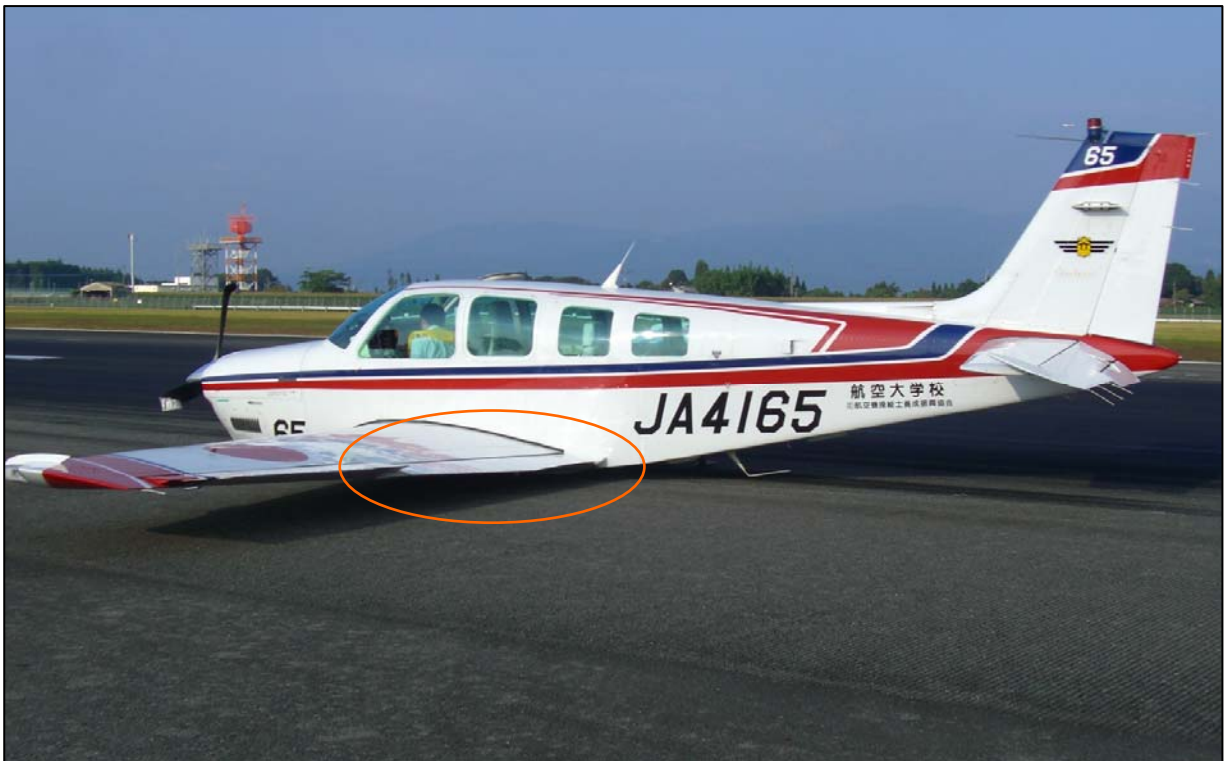
About 15:40

If the flap selector lever and the landing gear selector lever are operated before turning off the master battery switch, the motors to move the flaps and the landing gears will be activated. If fuel has leaked out, it may catch fire and cause an extremely dangerous consequence. Therefore, this kind of operation should not be made.

Flaps were retracted.
