**AIRCRAFT SERIOUS INCIDENT
INVESTIGATION REPORT**

**PRIVATELY OWNED
J A 4 1 7 8
JAPAN AIR COMMUTER CO., LTD.
J A 8 4 7 C**

April 26, 2013

BOMBARDIER DHC-8-402, JA847C

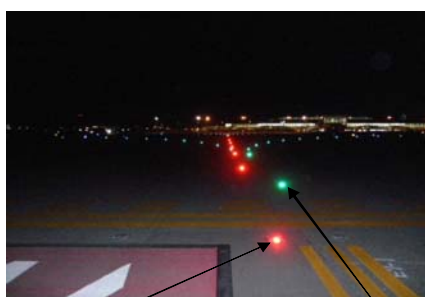
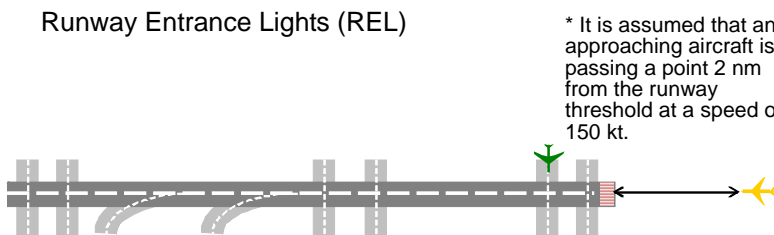
RWSL System

At Fukuoka Airport, the runway status light (RWSL)^{*5} system is designed so that it turns on runway entrance lights (RELs) when an arriving aircraft comes within about 2 nm of the runway approach end. Since the PIC did not report that there was a discrepancy between the RWSL system and the instruction to wait, the Tower assumed that any of the RELs had not been turned on (see 2.10.4).

- An REL is installed near the center line of a taxiway that intersects a runway. The REL is turned on when there is an aircraft that is going to take off from or land on the runway.
- Lighting requirement
When an arrival aircraft approaches a point from which it takes a certain period of time (parameter specification) before the aircraft reaches the runway threshold

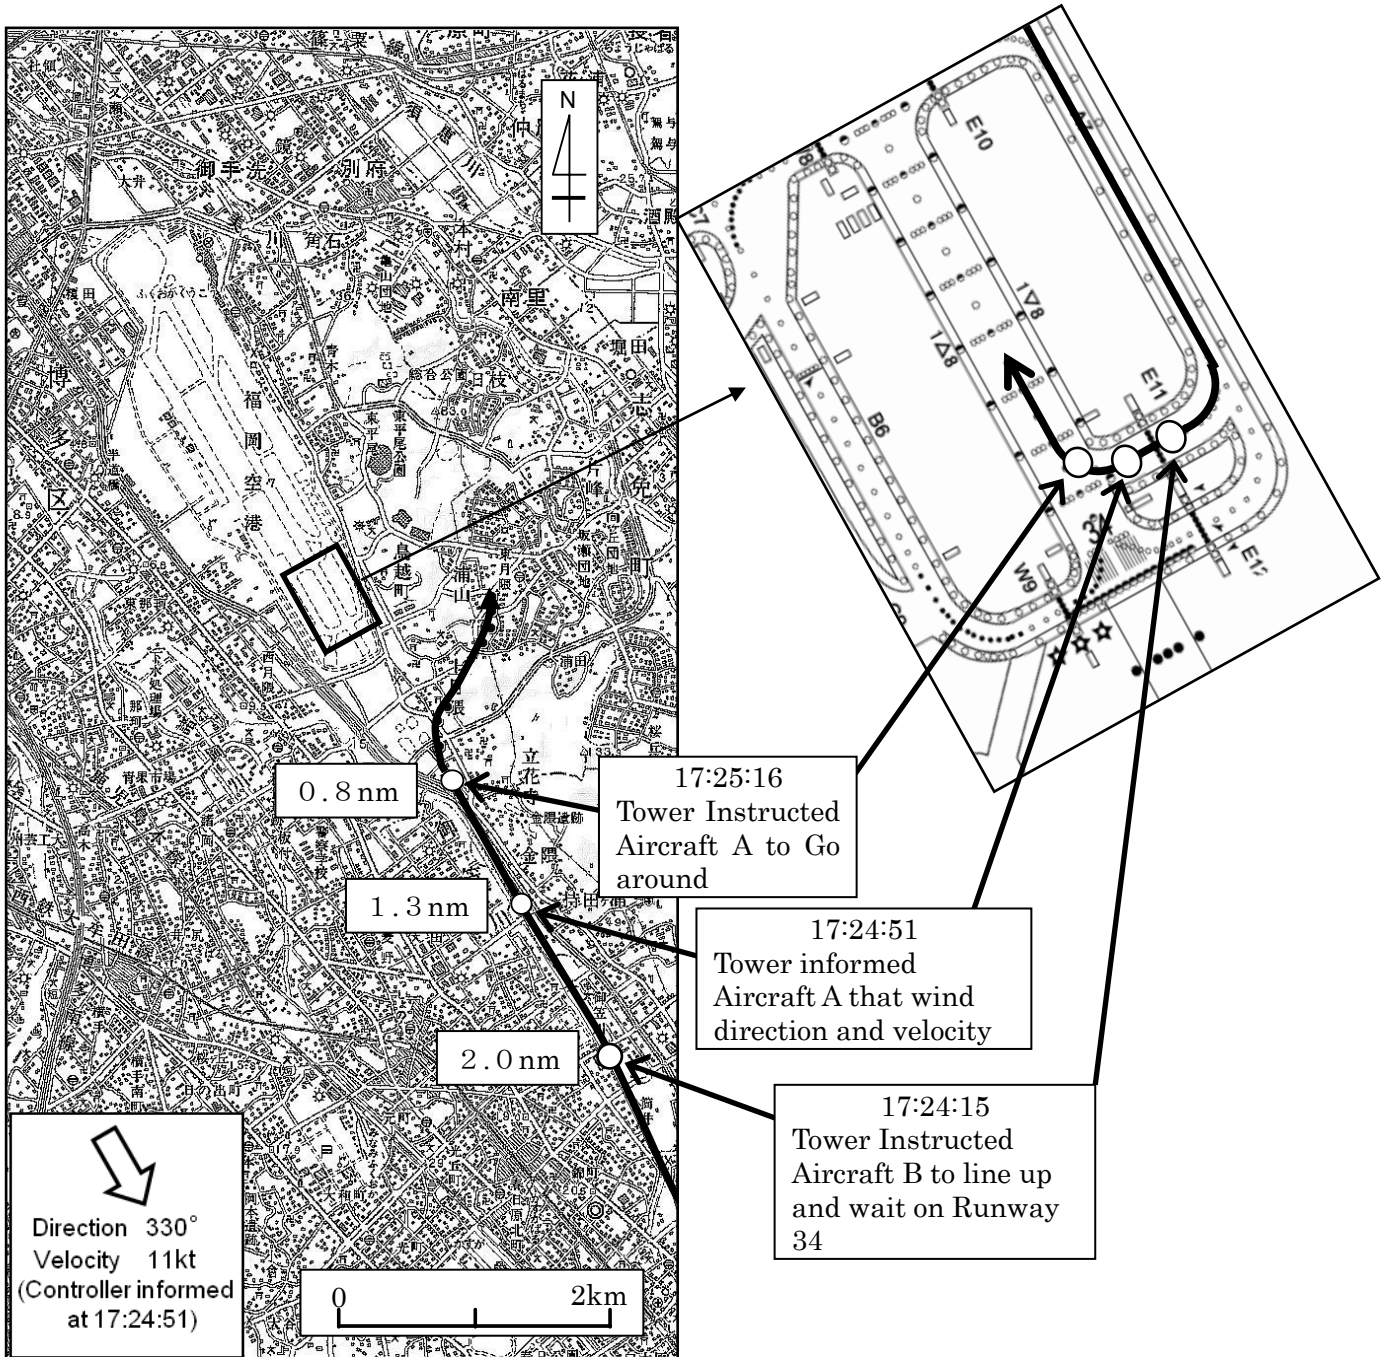
Figure 2 Estimated Traffic Conditions Just Before the Occurrence of Serious Incident

(See Figure 2 “Estimated Traffic Conditions Just Before the Occurrence of the Serious Incident.”)

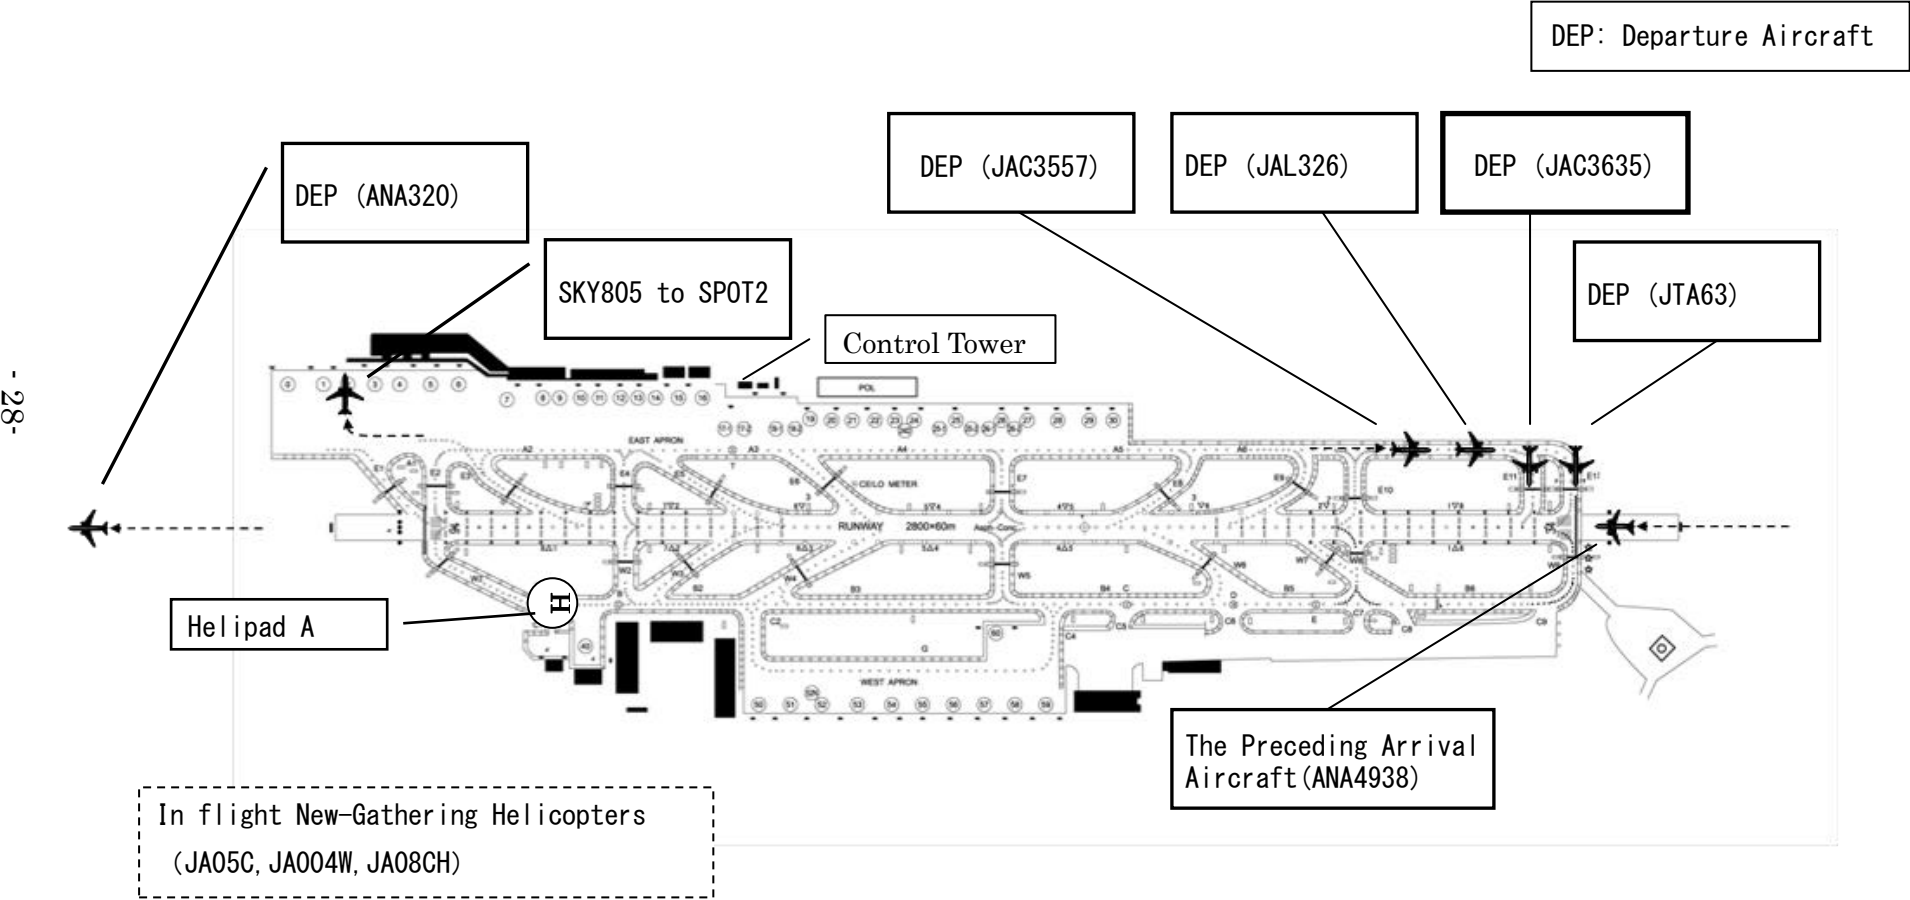
Figure 3 Layout of the Control Tower and View of the Runway

Usually, since arrival aircraft approach Runway 34 using the left traffic pattern, they are visually confirmed when they fly from the turning base leg to the final approach course, but the Tower failed to confirm Aircraft A in the final approach course. Small aircraft can easily be recognized when they are circling around, but are difficult to spot if they are in other positions. Nor could Aircraft A be confirmed on the screen of the Tower Display Subsystem (TDS). Furthermore, the strip bay^{*4} was also confirmed.

When it let Aircraft A wait 1 nm east of the airport, however, the Tower removed the strip for Aircraft A because the strip bay was full, and later, when Aircraft A returned to the final approach course, the Tower failed to confirm Aircraft A in the strip bay because the existence of the aircraft had slipped his mind, which caused the Tower to forget to return the strip to the strip bay though he should have done so.
