**AIRCRAFT ACCIDENT
INVESTIGATION REPORT**

**PRIVATELY OWNED
J A 4 4 A T**

April 23, 2015

DAMAGE TO AIRCRAFT CAUSED BY CONTACT WITH TREE PRIVATELY OWNED ROBINSON R44II (ROTORCRAFT), JA44AT THALASSA TEMPORARY HELIPAD, URAMURA TOWN, TOBA CITY, MIE PREFECTURE, JAPAN AROUND 14:45 JST, JULY 26, 2014

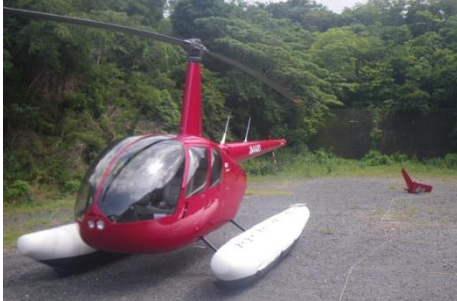
<p style="text-align: center;">Estimated figure of the accident scene based on the statements of the captain and the landowner</p>								
2.2 Injuries to Persons	None								
2.3 Damage	Extent of damage: Substantially damaged <ul style="list-style-type: none"> • Bent of the lower fuselage frame • Partial fracture of main rotor blades • Broken tail cone 								
2.4 Personnel Information

The helicopter involved in the accident and broken tail cone

3.1 Involvement of Weather	No
3.2 Involvement of Pilot	Yes
3.3 Involvement of Helicopter	No
3.4 Analysis of Findings	<p>(1) Judging from the damage to the helicopter and the situation regarding obstacles around the accident site, it is highly probable that the tail cone of the helicopter had come into contact with the trees on the east side of the helicopter when the captain had been turning the helicopter to face its nose to the north side, resulting in damage to the tail cone.</p> <p>(2) The captain stated that he had turned the helicopter after checking the distance between the helicopter and the trees on the east side. However, as it is highly probable that the helicopter had come into contact with the trees, it is highly probable that the captain failed to</p>

It is highly probable that this accident occurred because the helicopter did not land at the takeoff and landing area, but hovered in a place where there was insufficient distance between the helicopter and obstacles in the vicinity, with the captain failed to judge the distance between the helicopter and the trees when turning the helicopter, which caused the tail cone of the helicopter to strike the trees, damaging the fuselage.
