**AIRCRAFT SERIOUS INCIDENT  
INVESTIGATION REPORT**

**ANA WINGS CO., LTD.**

**February 22, 2018**

OVERRUNNING  
ANA WINGS CO., LTD.  
BOMBARDIER DHC-8-402, JA461A  
NEAR THE END OF THE RUNWAY 01R  
AT NEW CHITOSE AIRPORT, HOKKAIDO, JAPAN  
AT ABOUT 11:58 JST, JANUARY 19, 2017

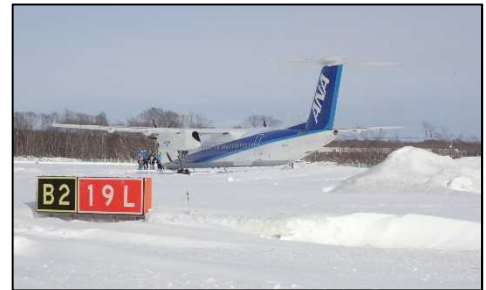
The PIC, judging that the aircraft was not decelerated enough to turn, used the pedal and steering hand-control to the left to avoid the overrun zone edge light which is not recessed type. The aircraft gradually decelerated, but passed through the end of the runway at about 20 kt GS and halted at the snow covered grassland at 11:58:07 without further deceleration. The right main landing gear was about 72 m from the runway end (about 12 m from the overrunning zone north end). There was almost no impact to stop.

**Photo 1 - the aircraft which overran  
(Provided by the Civil Aviation Bureau)**

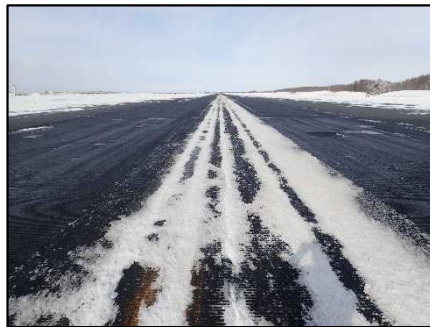
at 12:21, each of braking actions were Good, Good and Medium to good from south-side and the percentage of snow/ice coverage were less than 40%, less than 60% and 80% or more.

Photo 2 - Condition of South-side runway (Pictured at the time of assessment after the occurrence of the serious incident)

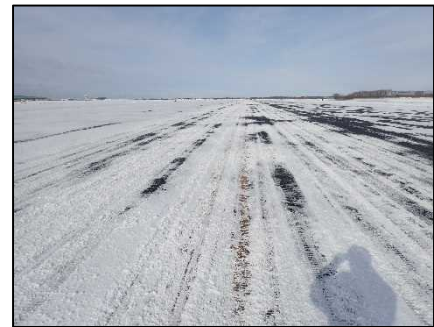
According to a staff from the Civil Aviation Bureau, the runway condition after the occurrence of the serious incident was that the north-side had more snow than south-side. There were dry part and wet part because the snow was melting. The snow quality was compacted snow of “Wet Snow” which if the snow was squeezed, water would be dripped. The overrunning zone was not snow-removed like the runway, with snow and ice remaining.

Photo 3 - Condition of North-side runway (Pictured at the time of assessment after the occurrence of the serious incident)

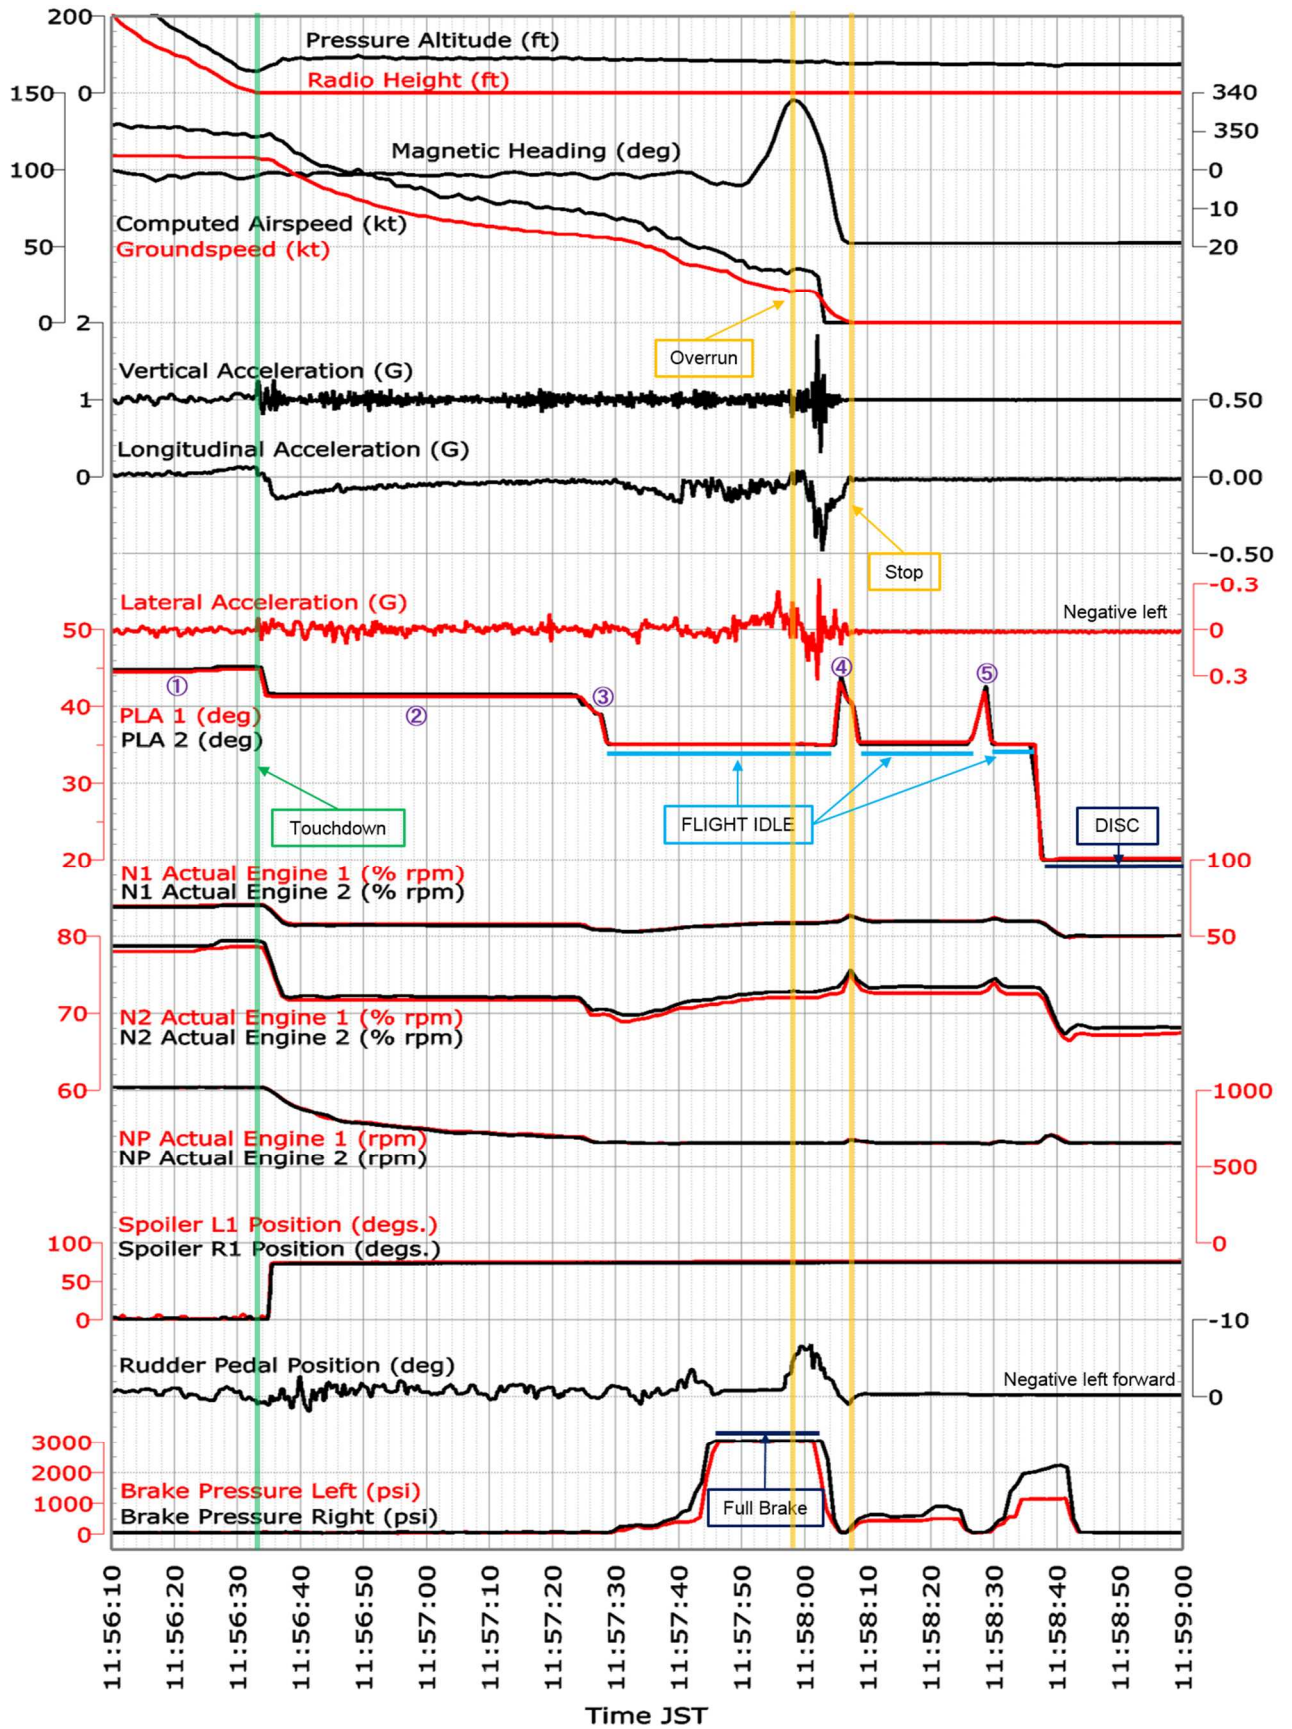
# Appendix 1: FDR Records

Right before the aircraft stopped ( ④ ), and after the conversation between the PIC and the co-pilot to check whether it could taxi or not ( ⑤ ), PL instantaneously moved more than 40°, and it moved to the Disc position at 11:58:37. The PIC reported to the ATC tower that the aircraft could not taxi, stopped the engine, instructed the status checking of the cabin and confirmed that there were no one injured.

Right before the aircraft stopped, it is somewhat likely that the spontaneous move of PL for more than 40° was connected with forward move of the PIC body by the impact caused by the stop of the aircraft. After the conversation between the PIC who saying that he would check the aircraft could taxi and the co-pilot, it is somewhat likely that the spontaneously movement of PL for more than 40° could be caused by the PIC who might move the PL to check the ability of aircraft to taxi.
