**AIRCRAFT ACCIDENT  
INVESTIGATION REPORT**

UNCONTROLLED CRASH INTO THE GROUND

EUROCOPTER AS350 B3, JA508A

APPROXIMATELY 12:17 JST, OCTOBER 3, 2011

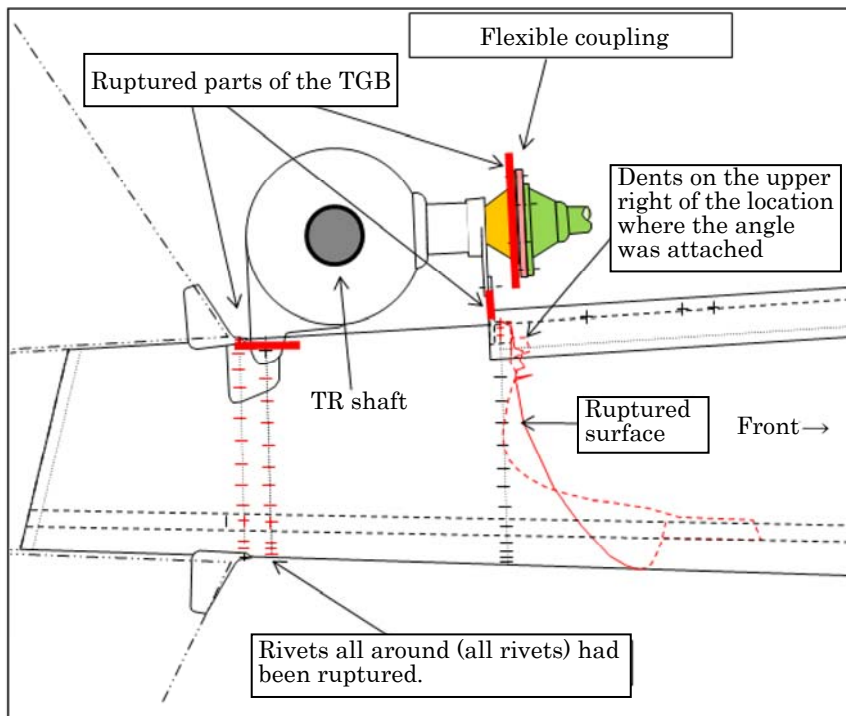
(Ruptured Tail Boom)

The tail boom was broken at an immediately fore part of the flange that was connected to the fuselage, and was damaged by fire. The tail boom was also broken at an immediately fore part of the bracket that supports the front part of the TGB (near the flexible coupling) and had separated from the back part of the tail.

On the upper side of the ruptured surface that had detached from the tail, continuous dents were seen from the upper left to the upper right of the area where the angle was attached, which resulted from being hit by the protruding portion of the flexible coupling while it was rotating. In addition, there were ruptures beginning from the left and right ends of the cutting section where the dents described above were found, as though the surface had been torn apart. The rupture on the right developed diagonally to the front, and continued up to near the section where the outer shell was overlaid, about 20 cm ahead of the upper cutting surface and on the lower left. The rupture on the left initially developed diagonally downward and then in a forward direction. It continued up to about 8 cm ahead of the end of the rupture on the right, where it fell apart towards the left as though it had been torn off.

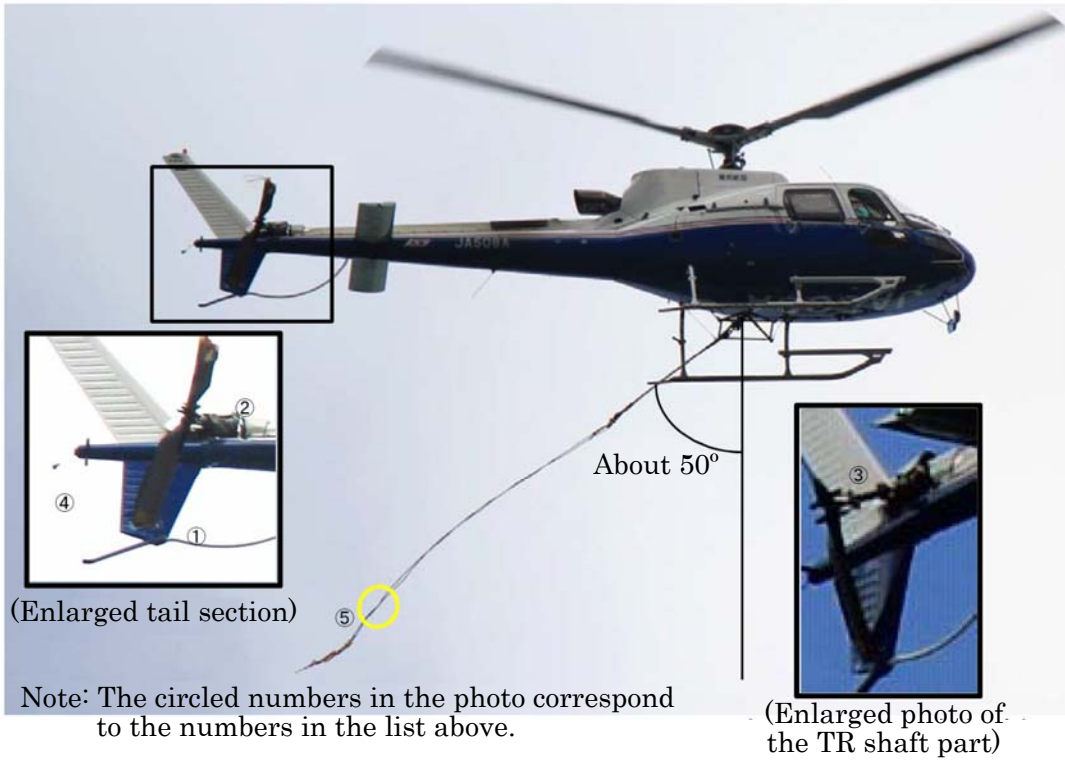
(Photos of the Helicopter taken by the Witness)

- ① The TR blades had stopped turning. The upper blade was broken at about half the length of the wing and material that appeared to be fiber was fluttering in the wind from the upper end. The lower end of the bottom blade had dug into the lower vertical stabilizer.
- ② The cover of the TGB was cut near the flexible coupling.
- ③ The TR shaft had tilted backward.
- ④ The tail lamp had come off, and was hanging from the tip of an electric wire.
- ⑤ The seven-meter sling cable that was suspended from the Helicopter was fluttering backward in the wind at an angle of about 50°. The steel wire part had been bent backward and the section near the lower end had drooped slightly downward due to the weight of the hook. A portion about one meter from the lower end had twisted abnormally. (This is where the bend and the strand that was cut off were observed in the wreckage investigation.)

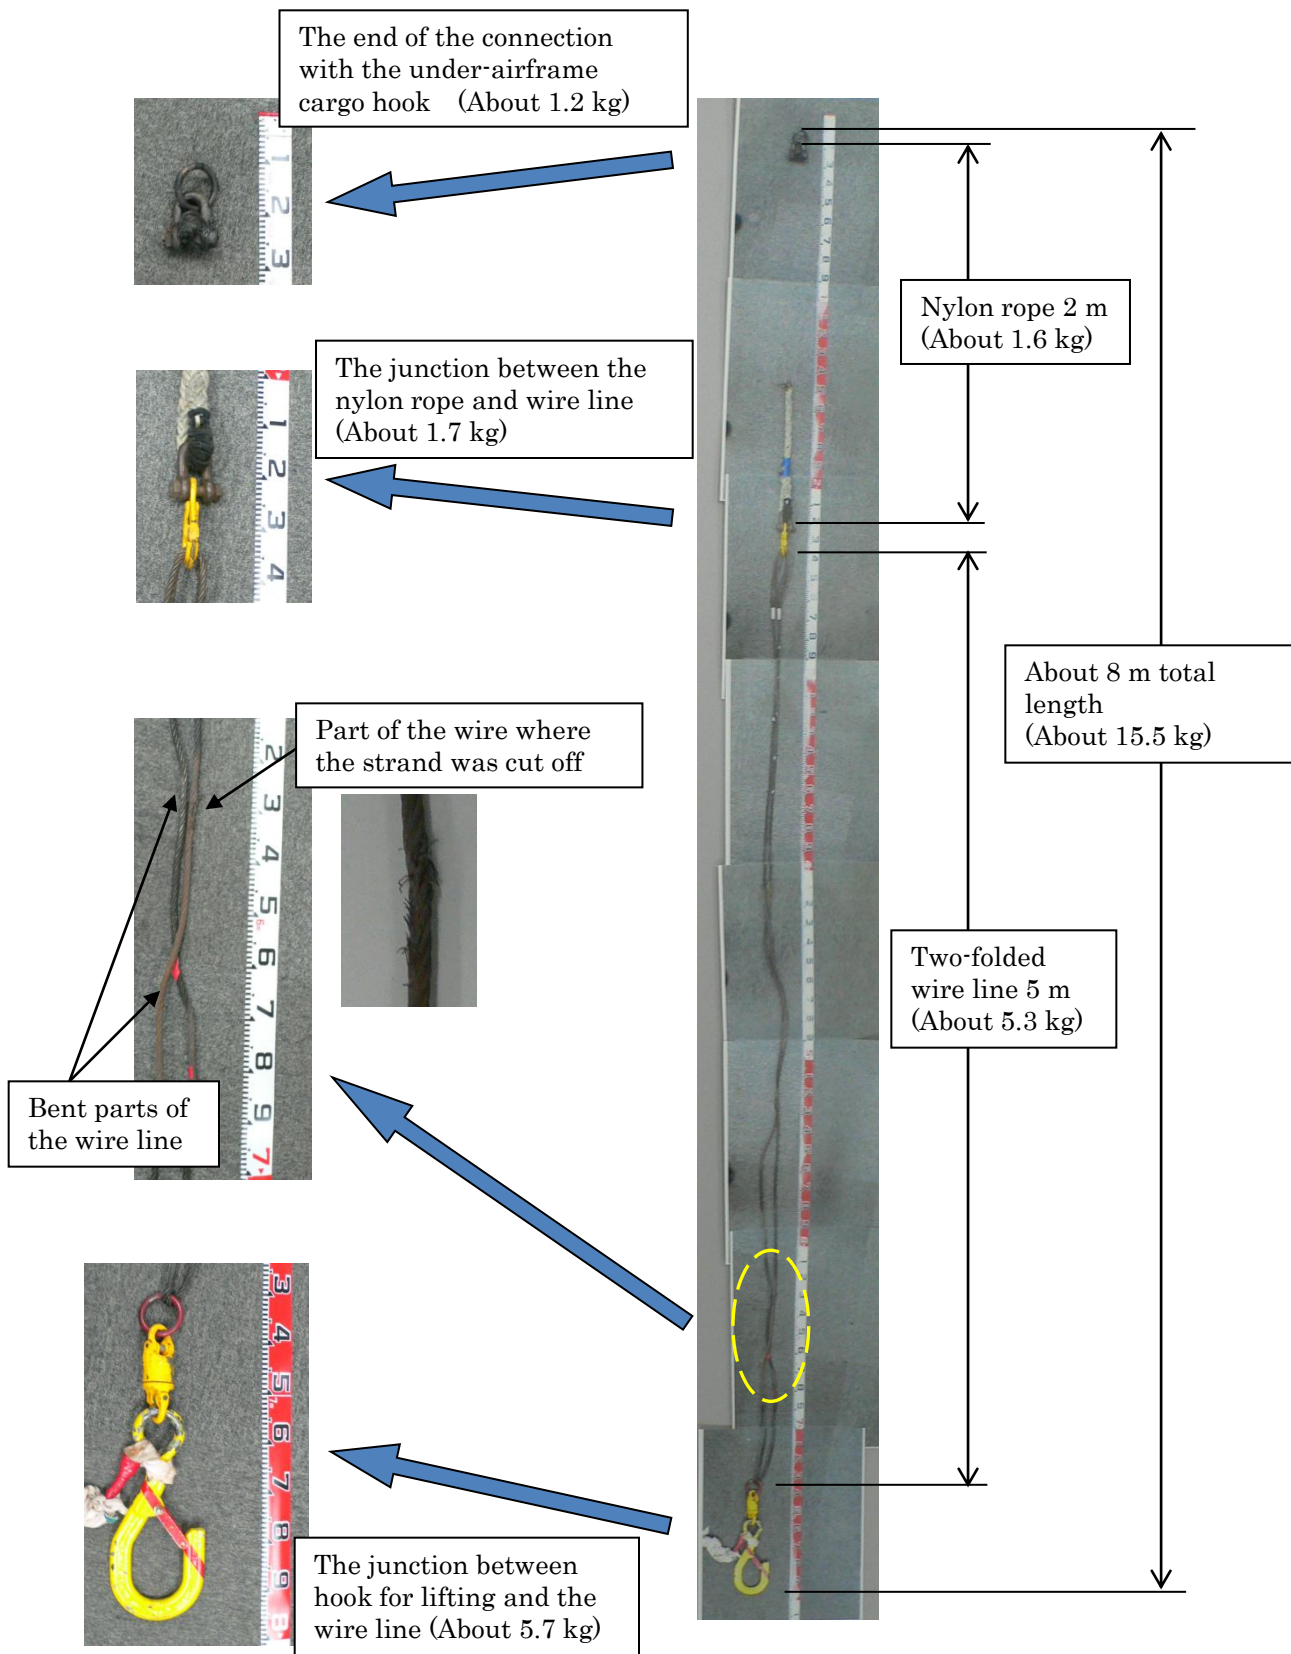
# Figure 4 Seven-meter Sling Cable

The seven-meter sling cable found at the accident site had been damaged by fire after detaching from the hook of the airframe and falling on the tail boom, with the exception of about 70 cm of the two-meter nylon rope on the upper end. The steel wire was deformed at around 90 cm and around 130 cm from the lower end, as though it had been bent, and the strand had partially been cut off.

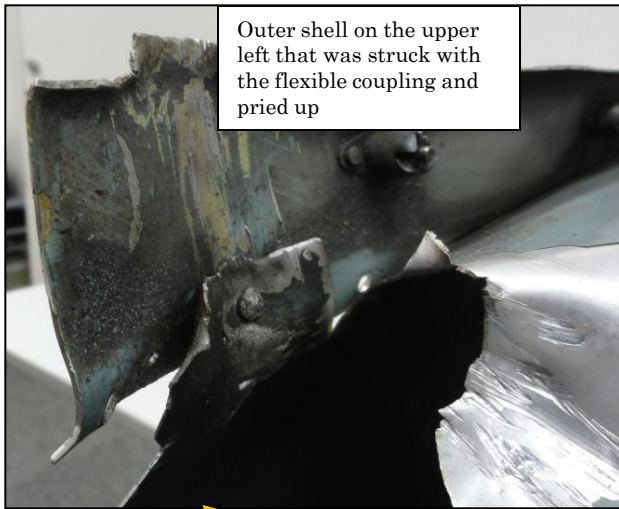
Outer shell on the upper left that was struck with the flexible coupling and pried up

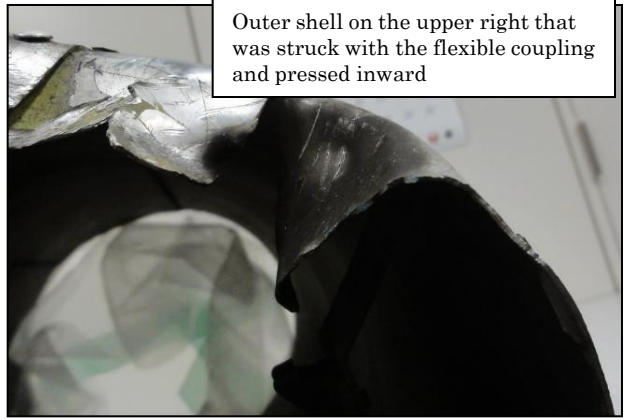
Outer shell on the upper right that was struck with the flexible coupling and pressed inward

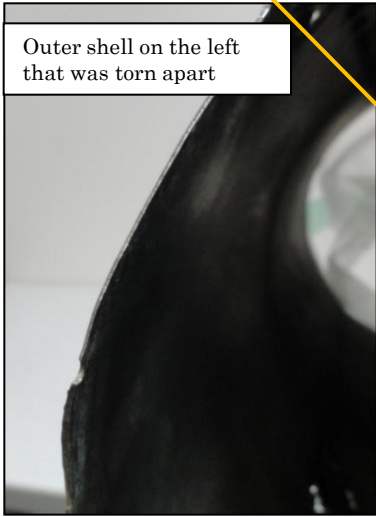
Outer shell on the left that was torn apart

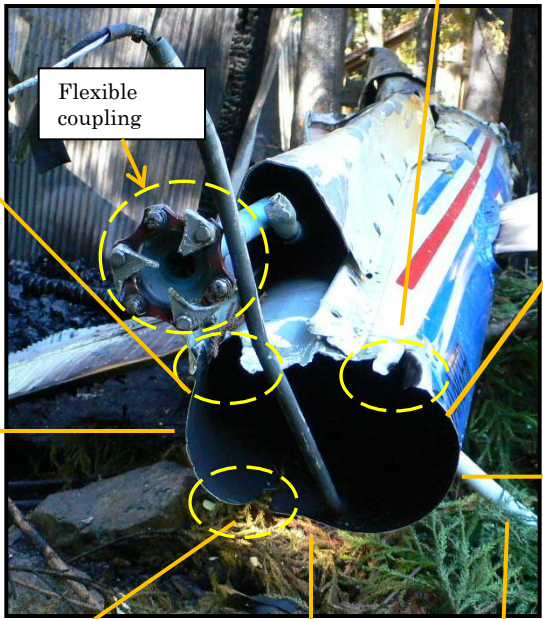
Flexible coupling

The TR drive shaft had detached at the flexible coupling section and there were many circumferential scratches on the external side of six protruding parts of the flexible coupling.

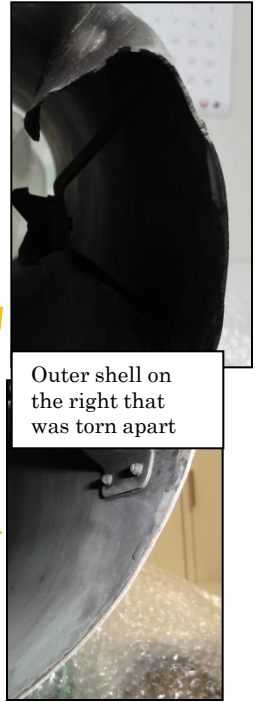
Outer shell on the right that was torn apart

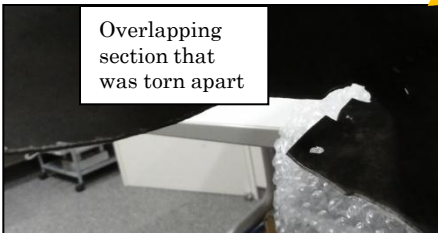
Overlapping section that was torn apart

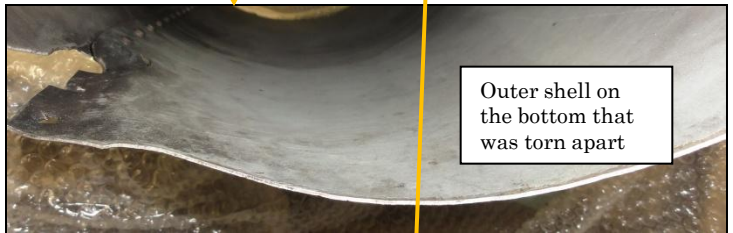
Outer shell on the bottom that was torn apart

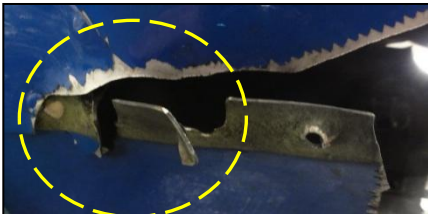
Rivets on the overlapping section that were pulled out, along with the outer shell, from the inner outer shell

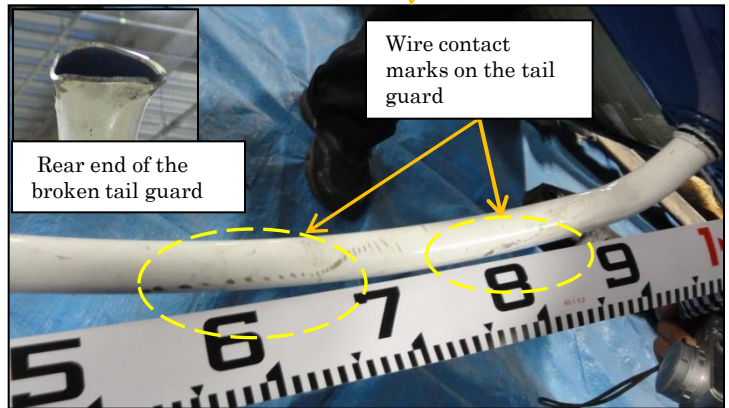
The tail guard was bent downward at an immediately fore position of the section to which the lower end of the vertical stabilizer had been attached. Its surface was crushed vertically and had ruptured. In addition, there were wire contact marks 15 to 25 cm and 30 to 45 cm from the front attaching portion.

Wire contact marks on the tail guard

Rear end of the broken tail guard
