AIRCRAFT ACCIDENT INVESTIGATION REPORT

October 11, 2024

Adopted by the Japan Transport Safety Board

Company	Privately owned
Type, Registration Mark	Cessna T303, JA5309
Accident Class	Fire
Date and Time of the Occurrence	At about 11:32 Japan Standard Time (JST: UTC+9 hours), June 16, 2023
Site of the Accident	Naha Airport

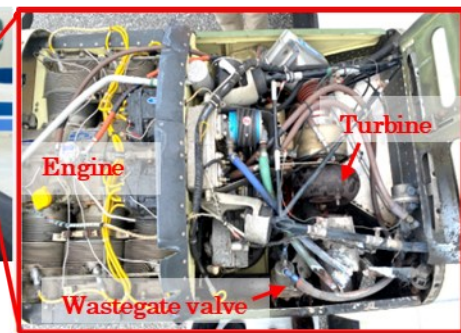
Figure 3: Inside the Left
Engine Cowl

Examination of the damage to the aircraft revealed that the left engine cowling was partially burnt (Figure 2). Inside the engine cowling, the turbine part of the exhaust turbocharger was detached from the exhaust tailpipe at their connections, and the coupling that joins the connections was damaged. In addition, the wastegate valve, which bypasses the flow of exhaust gas to the turbine part in order to control boost pressure, was detached from the exhaust tailpipe at the connections (Figure 3, 4 and 5). Besides, the heat shield in close proximity to the exhaust tailpipe on the turbine side and two vacuum system hoses were burnt out (Figure 6).

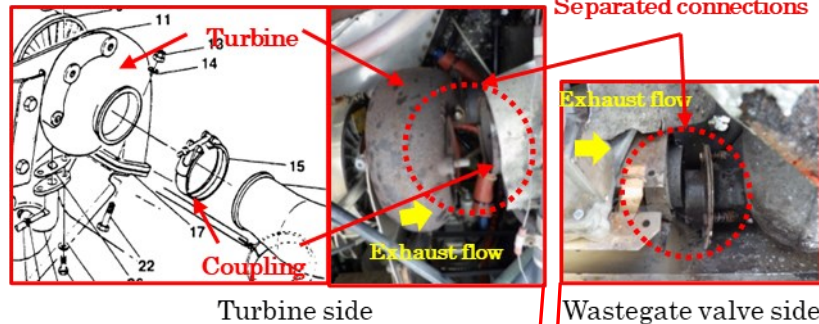
Figure 4: Exhaust Pipe Joint and
Engine Exhaust Flow

The JTTSB concludes that, based on the damage to the aircraft and the coupling, the fire on the aircraft was most likely caused by the damage to the coupling that connects the turbine part in the left engine cowling to the exhaust tailpipe, which caused first the turbine side connection and then the exhaust tailpipe connection on the wastegate valve side, connected by insertion into the wastegate valve, to separate, allowing the hot exhaust gases to escape from the connections, resulting in a fire on the heat shield installed around the connections and hoses and part of the engine cowling.

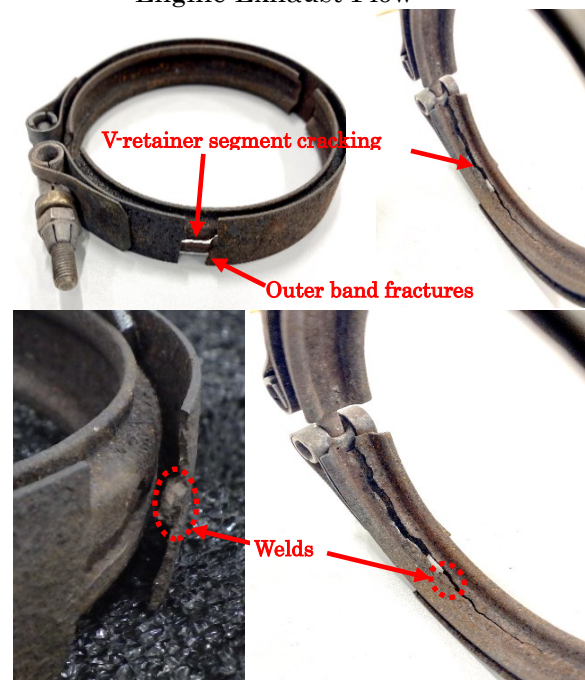
Figure 5: Damaged to the Coupling

The coupling is a single integrated structure consisting of the outer band and v-retainer segments that are attached via spot welds.

By tightening the outer band, the inner v-retainer segment is joined in contact with the connection of the exhaust tailpipe. After removing the coupling and checking, it was found that there was corrosion found throughout the coupling. In addition, fractures in the outer band and cracking in the v-retainer segment were found around the spot weld areas (Figure 5).

According to the aircraft manufacturer, the part number and/or maximum tightening torque value is marked on an approved coupling. However, only the number that differed from the part number in the aircraft manufacturer's parts list was marked on the coupling.

The JTTSB concludes that because cracking was found at or near a spot weld for the outer band and the v-retainer segment, cracking that originated at the spot weld were more likely to

have progressed, resulting in the fracture of the outer band and cracking of the v-retainer segment. In addition, during the exterior inspection on June 13, 2023, as the captain noticed that the surface of the access door at the rear of the left engine cowling had a black discoloration, possibly indicating that the coupling had already been damaged at that time and that exhaust gases had been emitted from the tailpipe connection.

The JTTSB concludes that the number marked on the coupling was different from the part numbers approved by the aircraft's manufacturer. In addition, the part number or maximum tightening torque value that should have been marked on the coupling approved by the aircraft's manufacturer was not found, thus it is certain that the damaged coupling was a non-specified part, not approved by the aircraft's manufacturer. Non-specified parts have not been certified to meet airworthiness standards when used, and proper maintenance procedures have not been established. The use of the coupling, which was a non-specified part, was likely to have contributed to the cause of the coupling damage.

It is possible that the use of the coupling, which was a non-specified part, was likely to have contributed to the cause of the coupling damage.

establishment of a 500-hour time-in-service (TIS) replacement interval for spot-welded couplings (It became into effect on July 17, 2023). The Civil Aviation Bureau, Ministry of Land, Infrastructure, Transport and Tourism issued a Technical Circular Directive (TCD-10180-2023) on September 4, 2023, directing the same actions.

Furthermore, in order to prevent the recurrence of similar accidents, it is essential to carry out regular replacement and others of the coupling in accordance with the Technical Circular Directive (TCD-10180-2023) issued by the Civil Aviation Bureau, Ministry of Land, Infrastructure, Transport and Tourism on September 4, 2023.

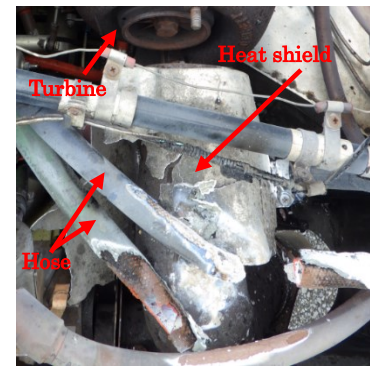
Figure 6: Heat shield and Hoses

The JTTSB concludes that the probable cause of this accident was that the fire on the aircraft was most likely caused by damage to the coupling that connects the turbine part in the left engine cowling to the exhaust tailpipe, which caused the exhaust tailpipe to detach, allowing the hot exhaust gases to be ejected, resulting in a fire from the burning of the heat shield installed at the vicinity of the connections, and hoses and part of the engine cowling.
