AIRCRAFT SERIOUS INCIDENT INVESTIGATION REPORT

DRAGGING DURING LANDING OF ANY OTHER PART OF THE

ASAHI AIRLINES CO.,LTD.

TEXTRON AVIATION G58, JA58GC

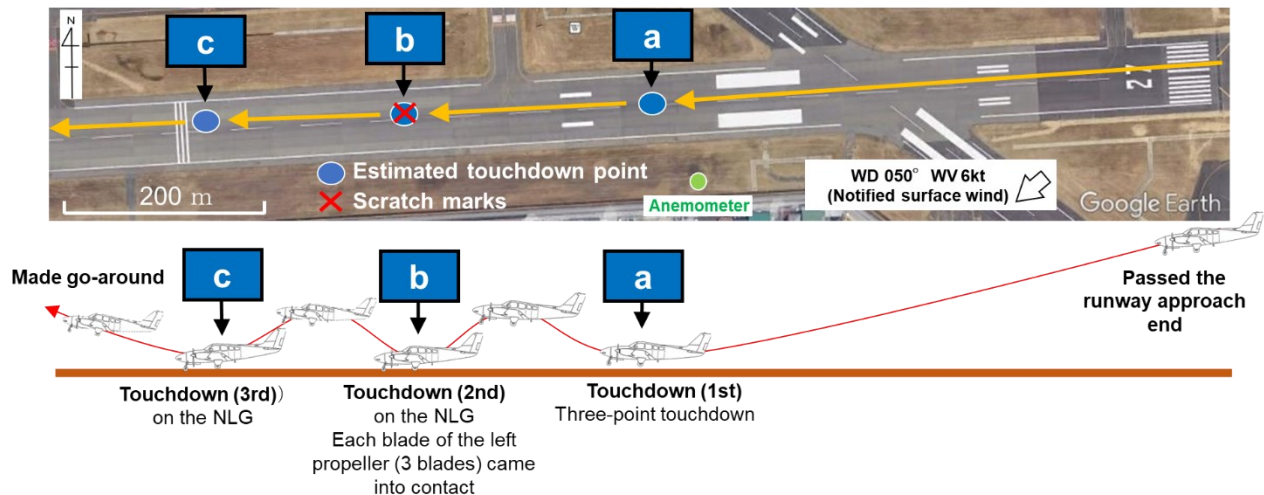
Figure 1: Estimated Flight Route

- d) After the aircraft passed the runway approach end, the trainee reduced the power to Idle.
- e) At the time of the first touchdown, the aircraft touched down with the pitch attitude lower than the original one, almost made the touchdown of three-points (nose landing gear and both main landing gears) (see Figure 1 a). The descent rate at touchdown was 600 ft/min.

- i) The second touchdown was made on the nose landing gear while the aircraft was being tilted to the left (see Figure 1 b).
- j) After touchdown, the aircraft bounced again. After the bounce, the instructor muttered, "This is not good."

- k) The third touchdown was also made on the nose landing gear (see Figure 1 c). After the touchdown, the aircraft bounced again.
- l) While the aircraft bounced repeatedly, the power of the aircraft was idle.

An Air Traffic Services Flight Information Officer conducted a runway check and confirmed four scratch marks approximately 580 m west of the Runway 27 threshold, which is located near the second touchdown point, and approximately 10 cm north of the runway centerline (see Figure 1). The scratch marks were found at intervals of approximately 1.2 m with approximately 20 cm long and approximately 1 mm deep. There were no scratch marks near the first and third touchdown point.

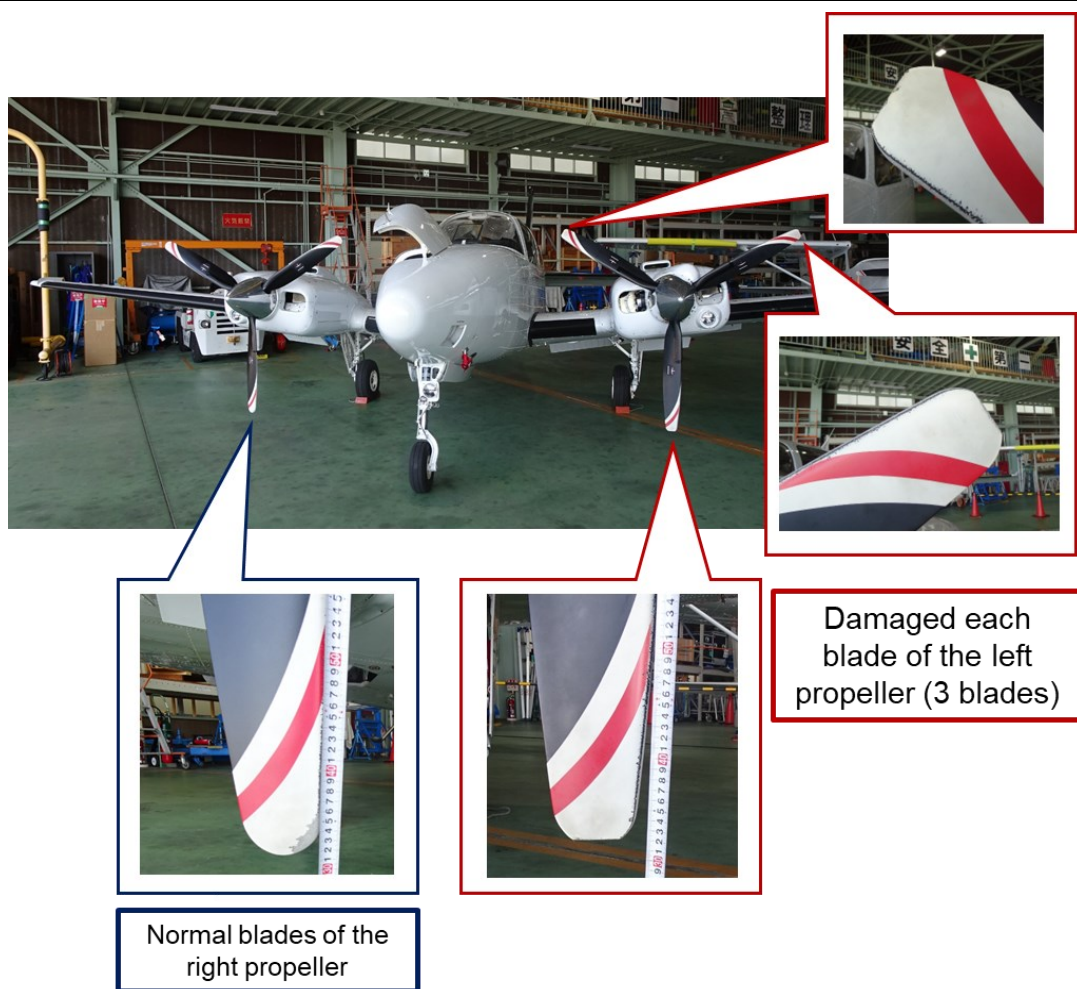
Figure 2: Status of the Propellers

Damage to each blade (3 blades) of the left propeller (approximately 7 mm)

The JTTSB concludes that from the fact that scratch marks were confirmed near the second touchdown point, the aircraft made a hard touchdown on the nose landing gear while being tilted to the left at the time of the second touchdown after the first bounce, which more likely caused each blade tip of left side propeller to come to contact with the runway.

The JTTSB concludes that the probable cause of this serious incident was that during the continuous touch-and-go training, the aircraft bounced at the time of the first touchdown and made a hard touchdown on the nose landing gear while being tilted to the left at the time of the second touchdown, which more likely caused each blade tip of left side propeller to come to contact with the runway.

The company should manage that the company's pilots thorough to comply with the go around policy and to conduct in ensuring exterior inspections during pre- and post-flight checks.
