**AIRCRAFT ACCIDENT
INVESTIGATION REPORT**

**PRIVATELY OWNED
J A 5 9 F B**

DAMAGE FROM BELLY LANDING
A PRIVATELY OWNED
PIPER PA-28R-201T, JA59FB
CHOFU AIRFIELD
AROUND 16:41 JST, OCTOBER 12, 2014

March 25, 2016

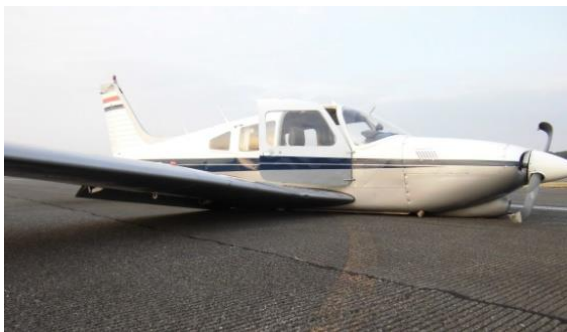
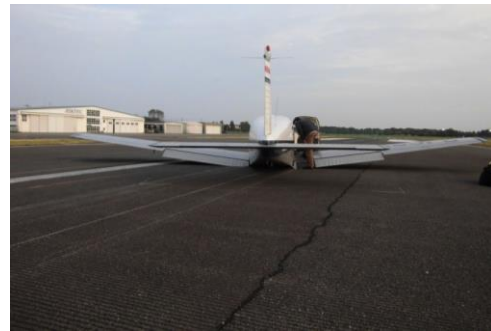
Photo 1. Accident Aircraft (Provided : Chofu Airfield Management Office, Tokyo Metropolitan Government)

- (1) Fuselage Damage to the lower section
- (2) Propeller Damage to both blades
- (3) Flaps Damage to the lower surfaces

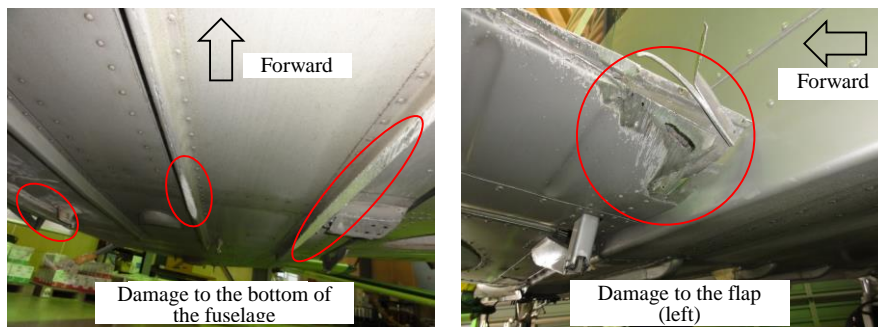
Photo 2: Situation of damage

Damage to the primary structure members (keels) in the bottom of the fuselage

Partial wear to the various antennas and boarding step equipped at the lower of the fuselage

Both blades damaged with the tips bent backward

Damaged to the inside portions of flaps (right and left) on the trailing edges of the main wings

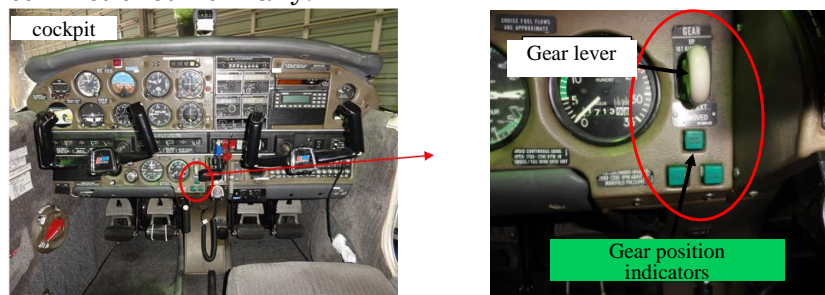
Photo 3: Gear lever and Gear position indicators

After charging the battery, normal gear operational test by operating the landing gear lever showed the gear-up and gear-down operated normally and also the landing gear position indicators normally operated: lighting on and off.

In addition to that the gear warning horn and light in the landing warning device also functioned normally.

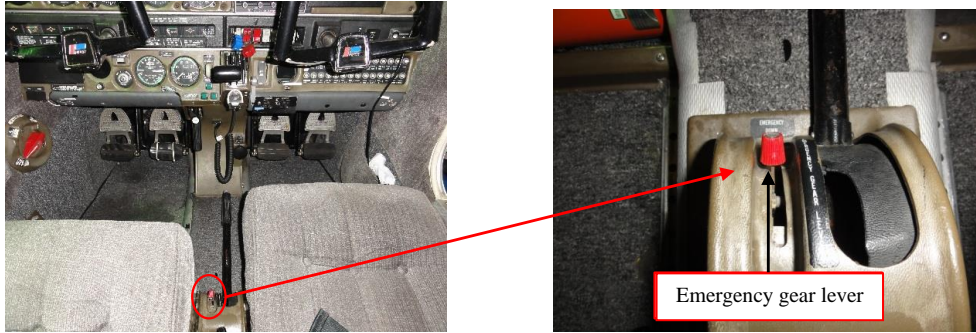
Photo 4: Emergency gear lever

Emergency gear extension test with the aircraft power supply turned off showed that the normal gear extension status was accomplished in about three seconds on operation of the emergency gear lever and the gears locked to the down position.

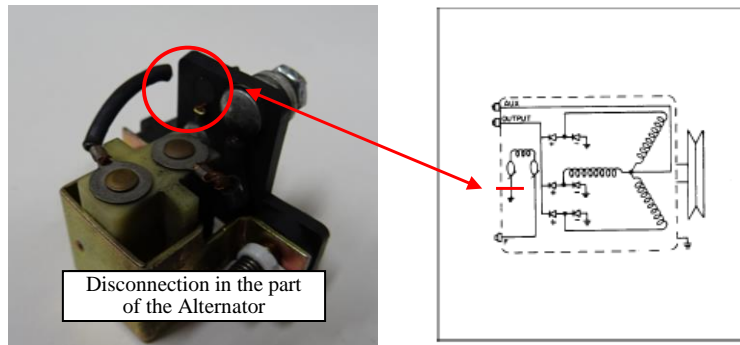
Photo 5: Disconnection in the part of the Alternator (Figure)

The disassembly inspection of the alternator revealed the wiring to the negative terminal of the field coil was disconnected showing the alternator of the aircraft did not have a normal function.

There was no anomaly in the alternator related circuit breaker and there was no evidence of overcurrent in the circuit.

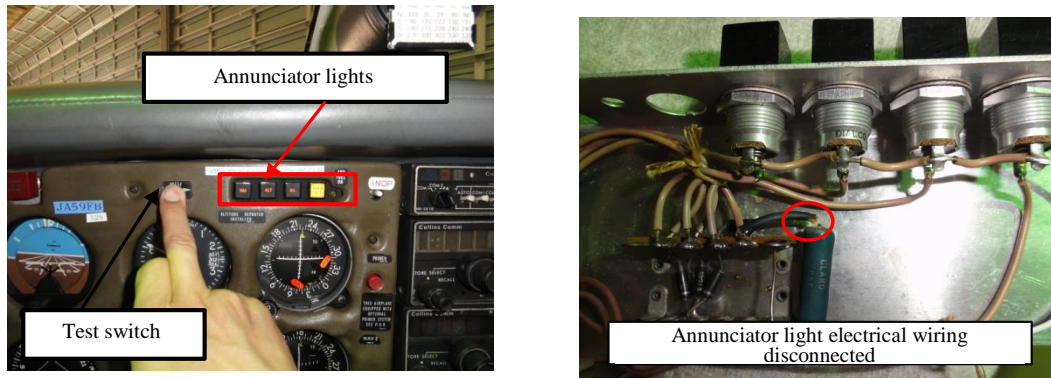
Photo 6: Annunciator Lights (Warning Lights)

The survey revealed that an electrical wiring in the annunciator light of the alternator was disconnected; even when its output decreased below the specified value, it was not illuminated. With the lamp lighting test; however, where the annunciator lighting lamp status (lamp enabled/disabled status) is checked with the test switch, it turned on normally because the current does not pass through the point where the electrical wiring was disconnected.

In the Airplane Flight Manual of the aircraft, there was a check item for the annunciator light by pressing the test switch after starting the engine.

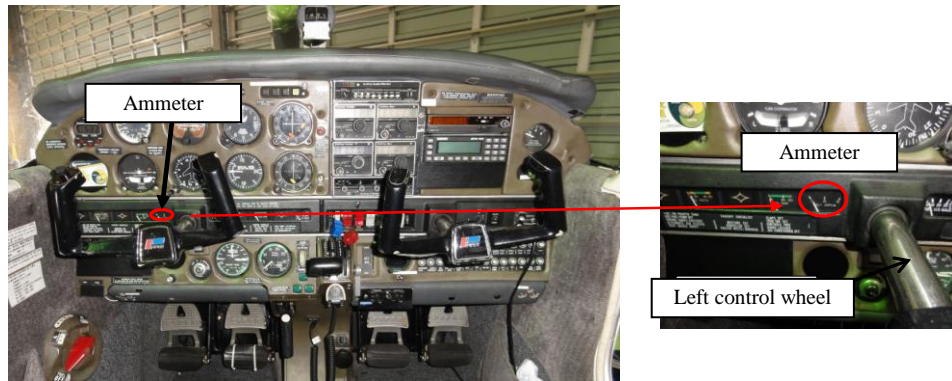
Photo 7. Ammeter

When the alternator is not driven (engine stopped) or when the alternator is driven but in failure, the ammeter indicates zero.

As described in 2.9.4, the alternator failure of the aircraft can be checked with the lowered ammeter indication (zero). However, it is somewhat likely that finding the alternator failure was delayed due to poor line of sight to the ammeter on the instrument panel overshadowed by the left front seat control wheel leave while the pilot was seated on the right front seat.

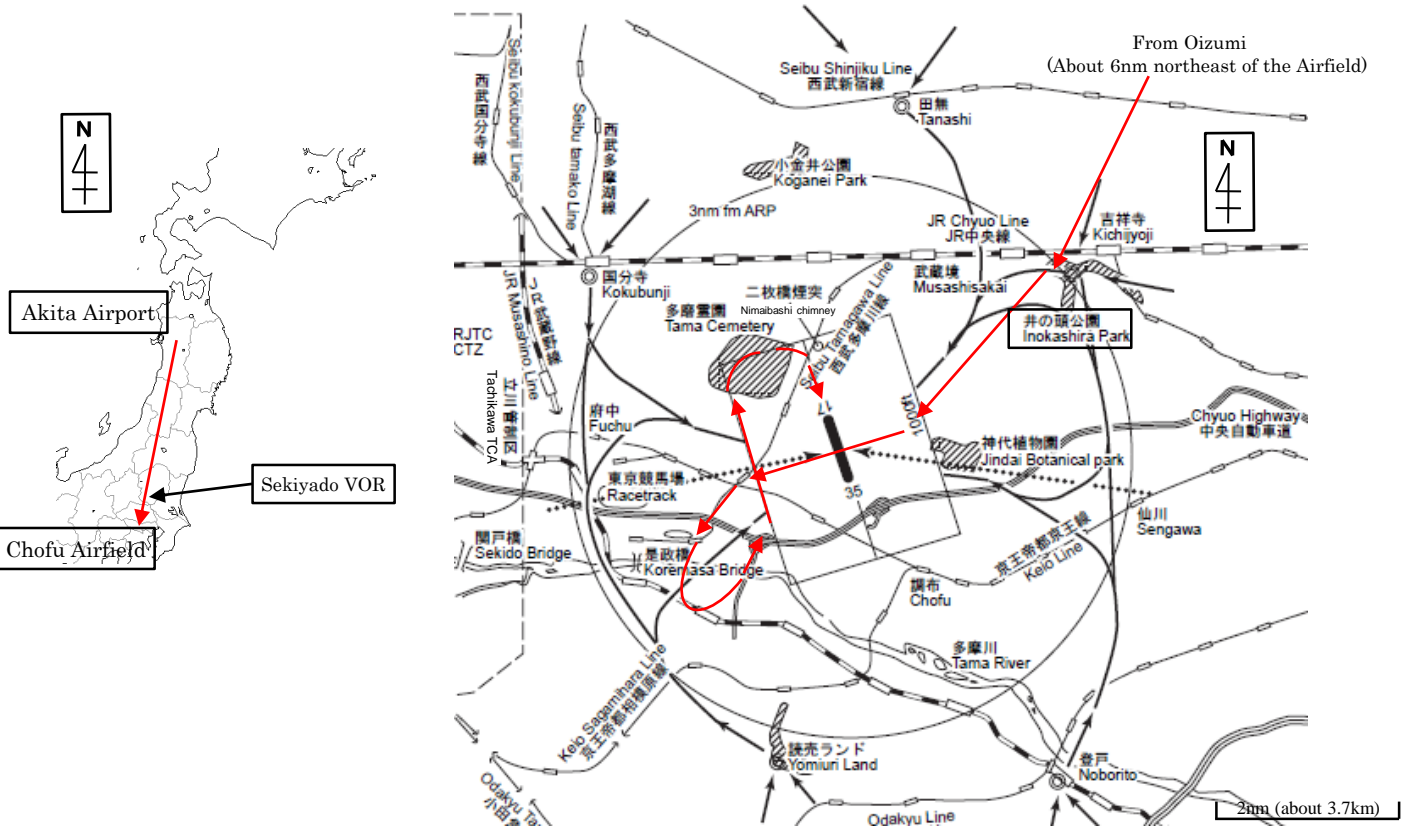
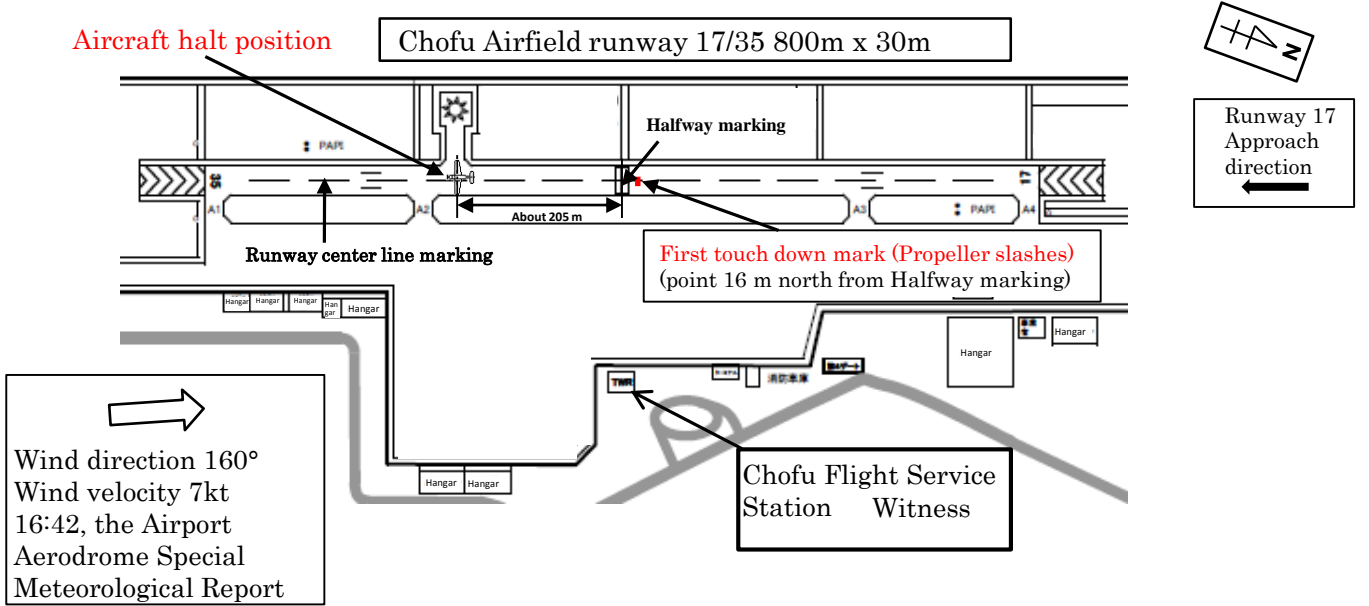
Figure 1: Estimated Flight Route and Accident Site Layout

The accident location is on the runway of the Airfield and there was a first touch down mark: the propeller slashes almost on the centerline marking about 16 m north of the halfway marking of the runway. Besides, the aircraft came to halt at about 205 m south of the halfway marking, about 3 m west of the centerline marking, with the nose to the south-southeast. On the runway are some scratch marks left caused by the airframe between the first touch down mark and the stop position.
