**AIRCRAFT ACCIDENT
INVESTIGATION REPORT**

SHIN NIHON HELICOPTER CO., LTD.

J A 6 0 5 5

SHIN NIHON HELICOPTER CO., LTD.
BELL 206L-3 (ROTORCRAFT), JA6055
MINAKAMI-MACHI, TONE-GUN, GUNMA PREFECTURE,
AROUND 9:53 JST, FEBRUARY 10, 2009

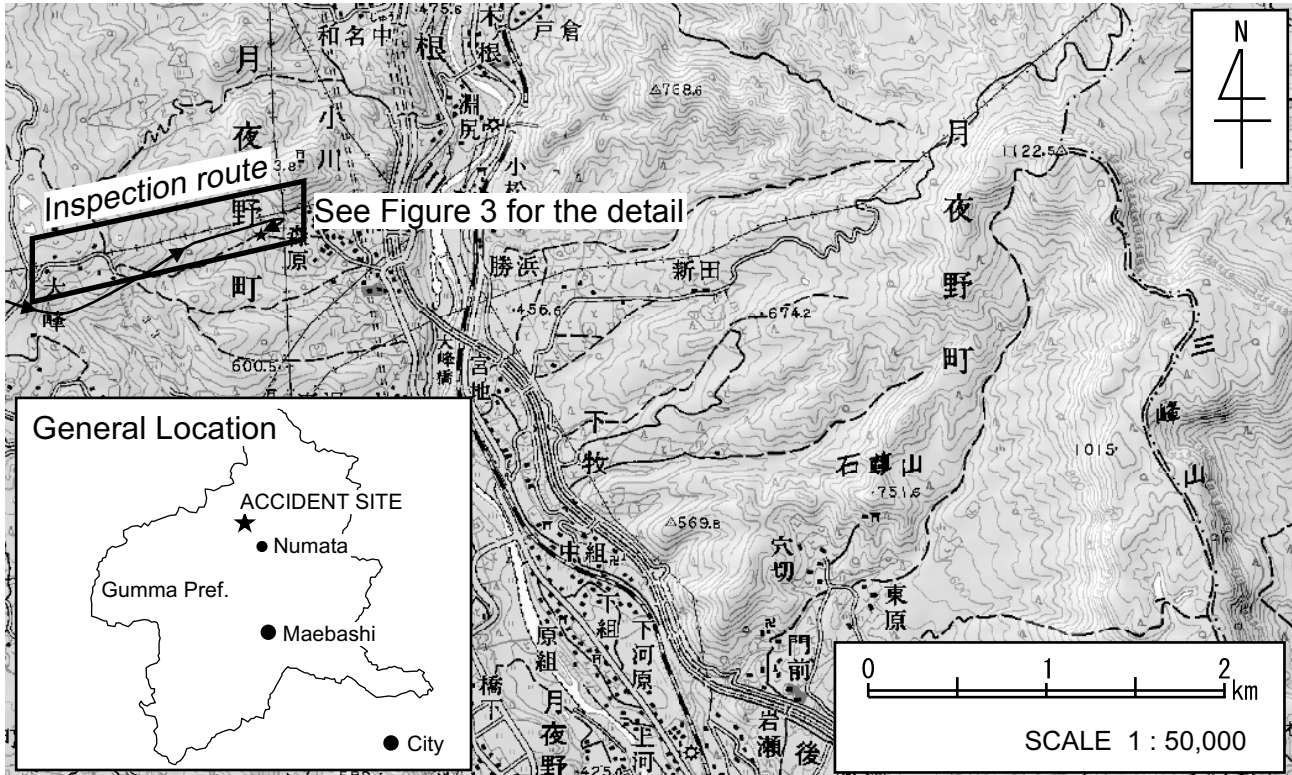
Figure 1 Estimated Flight Route

As shown on Figure 3, the slope east of tower 42 descends to the east and the Overhead Intersection is located in lower part of the slope. As shown on Figure 1, from tower 36 one can see the west slope of Mitsumine mountain range. The upper part of the west slope is higher than tower 36 by 200 – 400 m.

Additionally, this accident occurred as a result of flight over the mid spun of transmission lines. It is strongly recommended that an aircraft should, as stipulated in the company's flight operations manual and Bell's document, cross at a tower.

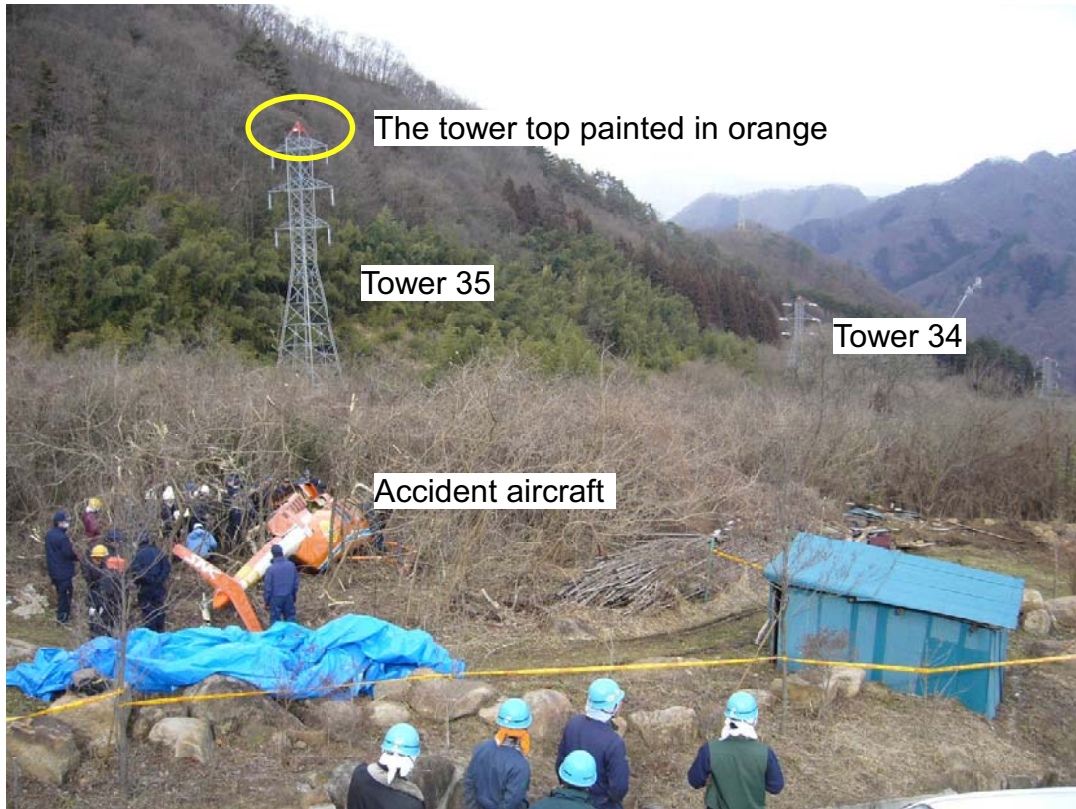
Picture 1 Accident Site

The accident site was the mulberry field on a slope in Minakami-machi, Gunma Prefecture, which faces east with broad-leaved forest to the north and terraced paddy fields to the south. Grid B intersects Grid A and runs above it about 90 m east of the accident site.

The Aircraft lied leaning about 45° to the left from the upright position facing to the east. Mulberry tree canopies near the Aircraft exhibited slashed appearances.

About 4 m east of the Aircraft there sat a main rotor component: a mast separated at the point about 1.2 m from its top and two main rotor blades. There were ground scars made by main rotor blades nearby. Main rotor blade (red³) was bent. Main rotor blade (white) was separated at the point about 1 m from its hub and the separated portion was found in a terraced paddy field about 95 m south-east from the Aircraft.

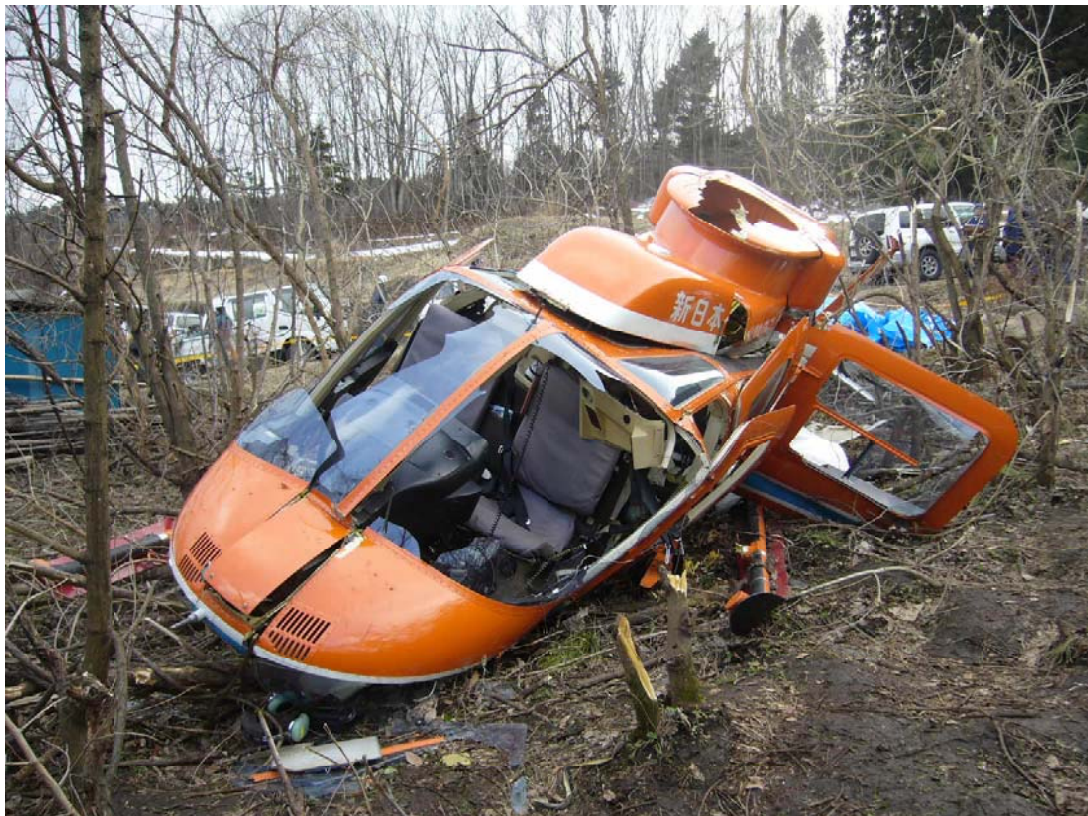
Picture 2 Accident Aircraft (forward fuselage)

The fuselage was damaged as if it were crushed from above and was inclined about 45° to the left from the upright position. The forward left part of lower fuselage, ranging from the nose section to the cabin section, was substantially damaged.

The forward part of the left elevator was damaged by tree at the accident site.

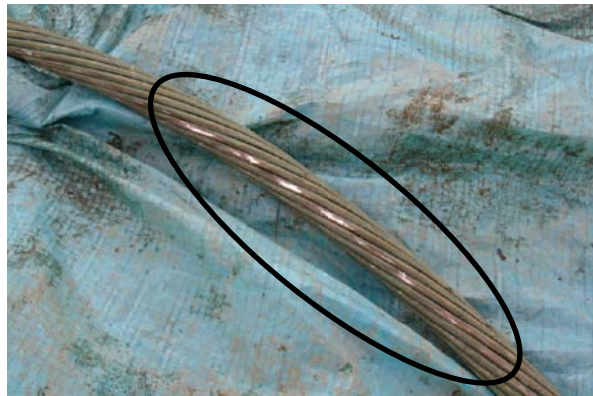
Picture 3 Contact Marks on Line C

Transmission line C was cut near the insulator installed on tower 117.

According to the railway company, the post restoration measurement revealed that Line C had contact marks with the helicopter about 85 m south from the tower 117, with the above-ground-level (AGL) altitude of 44.9 m, and that the vertical distance between Line C and the upper-most ground line measured 12.6 m.

Given the ground elevation of the contact marks to be about 565 m, contact marks' elevation is calculated to be about 610 m.

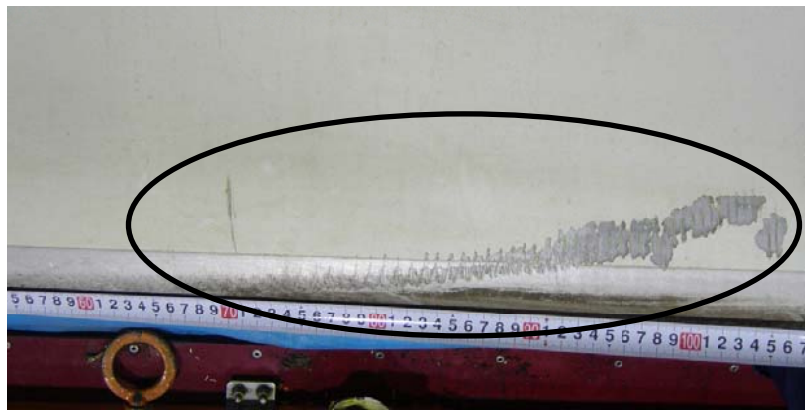
Picture 4 Contact Marks Near Leading Edge of Main Rotor Blade (white)

Major part of the white blade (length about 3.3 m) was separated at the point about 1 m from its hub. On the under surface of the separated portion, striped fine scratch marks were found near the leading edge in the area of about 1 m from the tip.

The metallic material found on striped fine scratch marks was analyzed to be copper. (See Picture 1 Accident Site, Picture 2 Accident aircraft (forward fuselage), Picture 3 Contact Marks on Transmission Line C, Picture 4 Contact Marks Near Leading Edge of Main Rotor Blade (white), Picture 5 Contact Marks on Inner Surfaces of Both Tail Rotor Blades)

It is certain that the Aircraft made a contact with Line C judging from the following facts: as described in 2.10.4(1) individual transmission line of Grid B is made up of twisted hard copper strands; as described in 2.8.2(7) the metallic material found on striped fine scratch marks on the main rotor blade and the tail rotor blades was analyzed to be copper and as described in 2.1(1) the PIC stated that he had made a contact with Grid B.

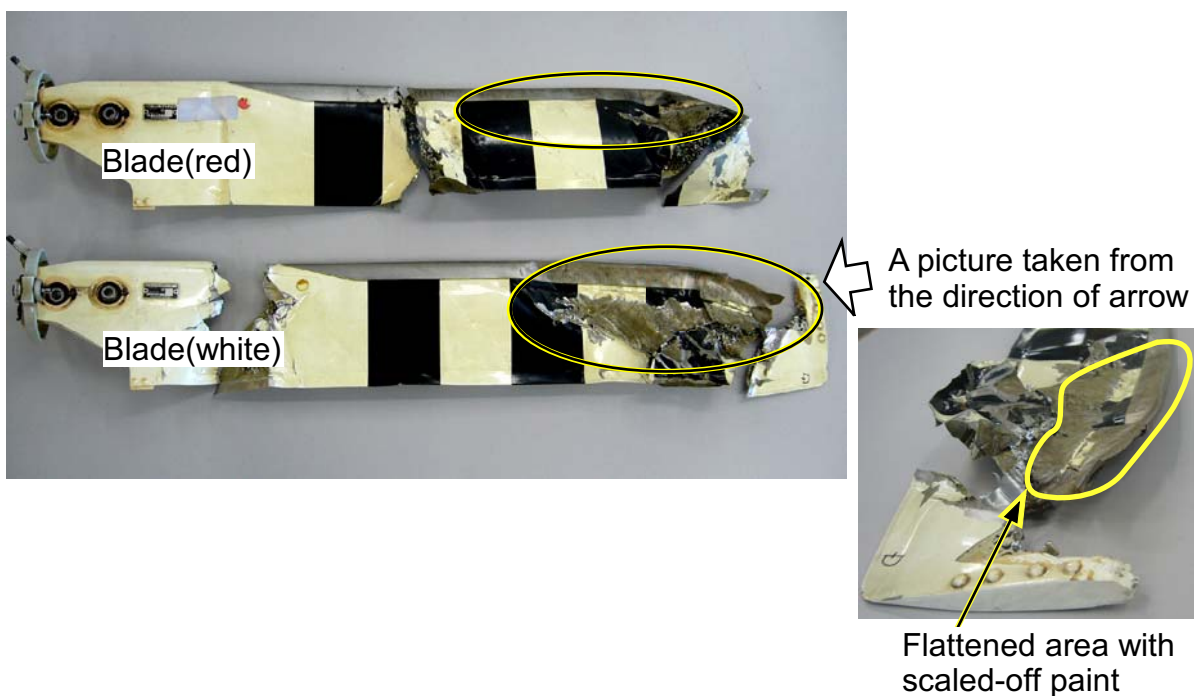
Picture 5 Contact Marks on Inner Surfaces of Both Tail Rotor Blades

The inner surface (tailboom side) of both blades exhibited striped copper-colored fine scratch marks.

The end of the red blade was separated. It was bent in the middle section. The area up to about 10 cm from the outer end on inner surface exhibited scaled paint and striped fine scratch marks.

The white blade was separated at the point about 15 cm from the hub. The area near the leading edge of inner surface, up to about 30 cm from the tip was flattened and the airfoil property was compromised.

Because above mentioned scratch marks were found on flat areas on each blade, not on the forward edge, it is considered highly probable that each blade made contacts with the Line C as a plane. It is also considered highly probable that, during the contacts the inner surface of both tail rotor blades, the area stretching as long as 30 cm from the tip, were flattened.
