AIRCRAFT ACCIDENT INVESTIGATION REPORT

CRASH

AKAGI HELICOPTER CO., LTD.

KAMAN K-1200 (ROTORCRAFT), JA6200

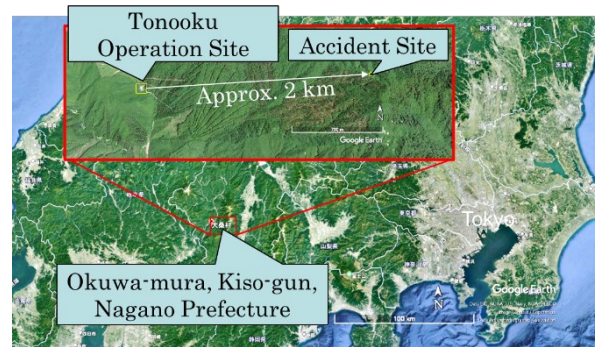
Figure 1: Accident Site

On September 20, 2021, at about 13:01 Japan Standard Time (JST: UTC+ 9hr, unless otherwise stated, all times are indicated in JST on a 24-hour clock), the helicopter took off from Tonooku Operation Site, Okuwamura, Kiso-gun, Nagano Prefecture to helicopter logging, with only the captain sitting in the pilot seat, and started helicopter logging back and forth from the loading site in the mountain forest located east side of the Operation Site to the unloading site adjacent to the Operation Site. On the 6th transport run, the helicopter flew to the loading site located about 2 km east of the Operation Site and made a transition to an eastward hovering at a ground altitude of about 40 m over the loading site (See Figure 1).

With its heading facing the valley side while contacting with the trees (southwest), the helicopter crashed into the mountains about 20 m south side from the hovering position with its nose facing downward. The helicopter's attitude after the crash was about 70° in the nose-down direction with the roll angle of about 80° to the left. Broken pieces of the helicopter were scattered over a radius of approximately 20 m from the crash site (See Figure2).

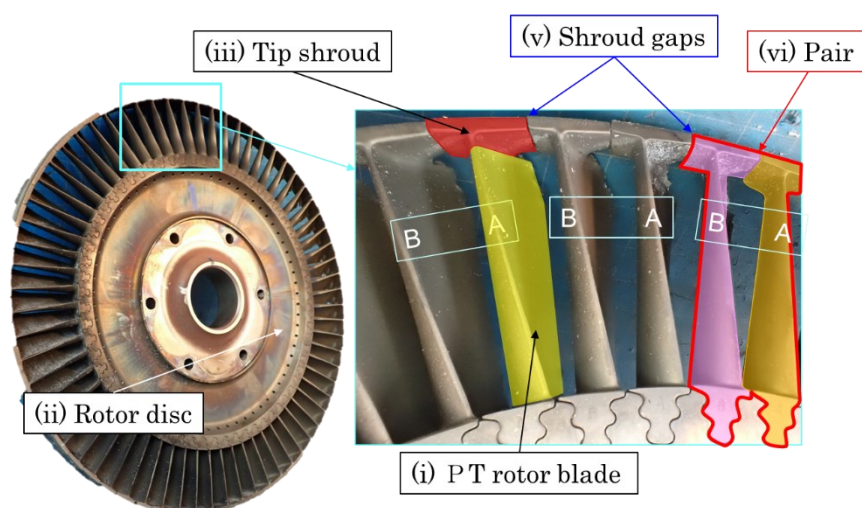
Figure 6: PT1 Rotor

As for the PT1 Rotor, damage was observed to the trailing edge of about half the blades and the Shroud.

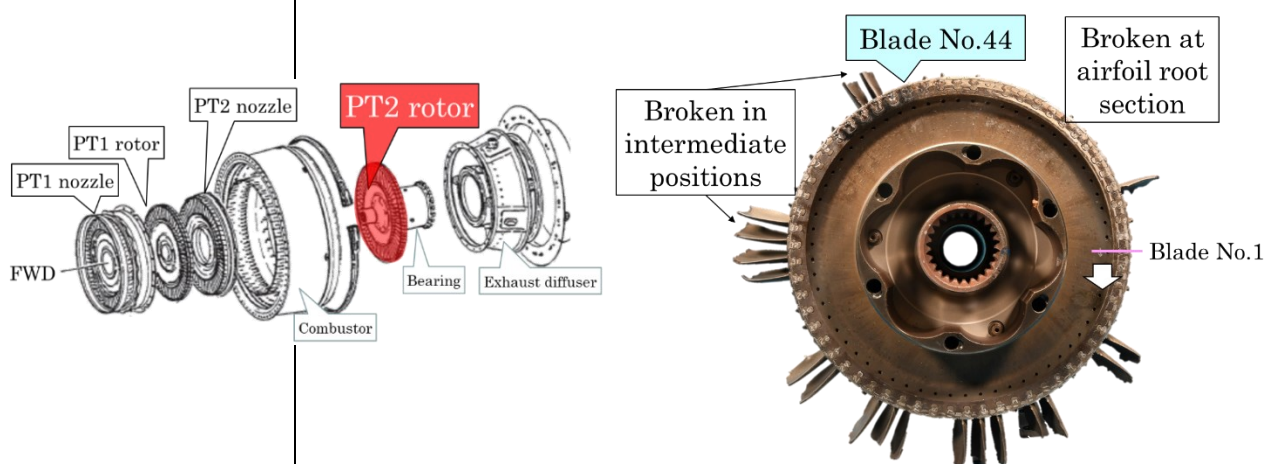
Figure 7: Damage to PT2 Rotor Blades

The PT2 rotor blades (62 blades) were all broken, of which 43 PT rotor blades were broken at the airfoil root section, and other remaining 19 blades approximately in the intermediate positions (see Figure 7).

The visual check of the fracture surface of the PT2 rotor blades revealed that only for the blade number 44 (hereinafter referred to as “Blade 44”), approximately 1/3 of the fracture surface on the leading edge side was smooth and that on the trailing edge side was rough. Other than Blade 44, all PT rotor blades had rough fracture surfaces on all sides.

The engine was damaged because the Blade 44 was broken initially and broken pieces of the Blade 44 damaged other PT2 rotor blades, at this time, the engine probably shut down. Besides, it is highly probable that broken pieces of the damaged PT2 rotor blades were scattered forward and backward, causing secondary damage to the upstream PT2 nozzle and the downstream exhaust diffuser. Furthermore, it is probable that the engine rotating shaft went out of balance due to the damage to PT2 rotor, the compressor and PT1 rotor rubbed against the engine case, leading to scratch marks on the compressor and damage to the PT1 rotor.

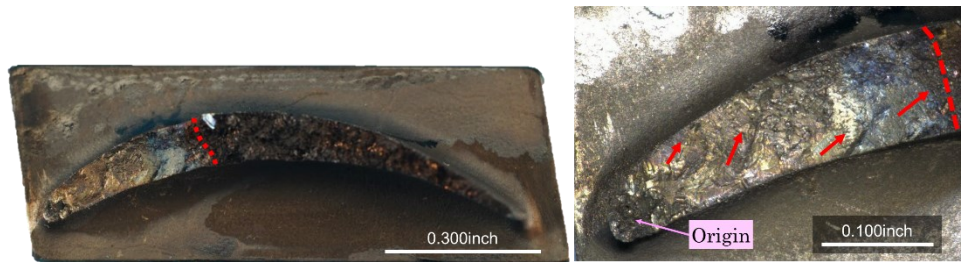
Figure 8: Enlarged View of the fractured surface of Blade 44

The result of the detailed examination revealed that Blade 44 base material was IN713C material specified in design, the smooth fracture surface on about 1/3 of the leading edge side indicated the fatigue region emanating from its origin of a sub-surface faceted region near the leading edge of the blade, in addition, a rough fracture surface on its trailing edge side was caused by the overload.

In Figure 8 and 9, the red arrows identify the direction of fatigue propagation, and the red dashed lines indicate the extent of fatigue propagation.

The JTSCB concludes that the Blade 44 was highly probable fractured because the region of the fatigue due to the HCF initiating from near the leading edge propagated to the trailing edge side, and when the fatigue region reached approximately 1/3 from its leading edge, the Blade 44 became no longer able to withstand the load and was fractured, from the features of the fractured surface.

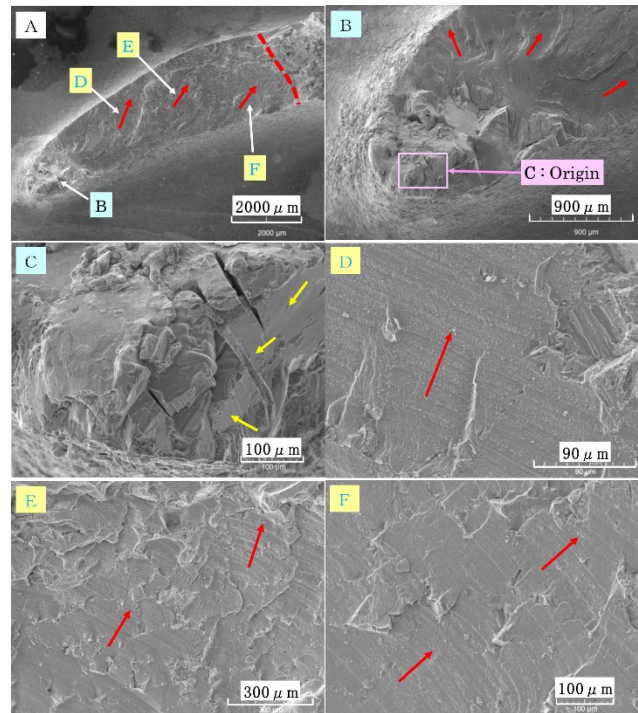
Figure 9: SEM Images of Blade 44

Figure 9A is an SEM image of the entire fatigue surface seen on approximately 1/3 of fracture region on the Blade 44 leading edge side. Among those SEM images, B shows the fatigue origin (pink arrow), C indicates the faceted region (yellow arrow) that is a fatigue origin, and D to F identify the fatigue propagation section. In the fatigue region, shell-like patterns (beach marks) suggestive of the High Cycle Fatigue (hereinafter referred to as “HCF”) propagation were observed.

According to the Design and Manufacturing Company of the engine (Company B), the HCF of the same type of engines was caused by the high frequency vibration load generated by the flutter*¹ that would occur in the PT rotor blades, which has come to be easily moved due to excessive shroud gap.

The HCF on the Blade 44 was probably caused by the high frequency vibration that occurred due to the flutter of the Blade 44 generated as the excessive PT2 shroud gap had influenced the individual gaps of the Blade 44, which became easier to move.
