AIRCRAFT SERIOUS INCIDENT INVESTIGATION REPORT

August 8, 2025

Adopted by the Japan Transport Safety Board

Company	Shin Nihon Helicopter Co., Ltd.
Type, Registration Mark	Bell 412EP (Rotorcraft), JA6412
Incident Class	Case where a slung load, any other load carried external to the aircraft, was released unintentionally. Item (xvi), Article 166-4 of the Regulation for Enforcement of the Civil Aeronautics Act of Japan.
Date and Time of the Occurrence	At about 15:15 Japan Standard Time (JST: UTC+9 hours), Oct 10, 2024
Site of the Serious Incident	Joetsu City, Niigata Prefecture

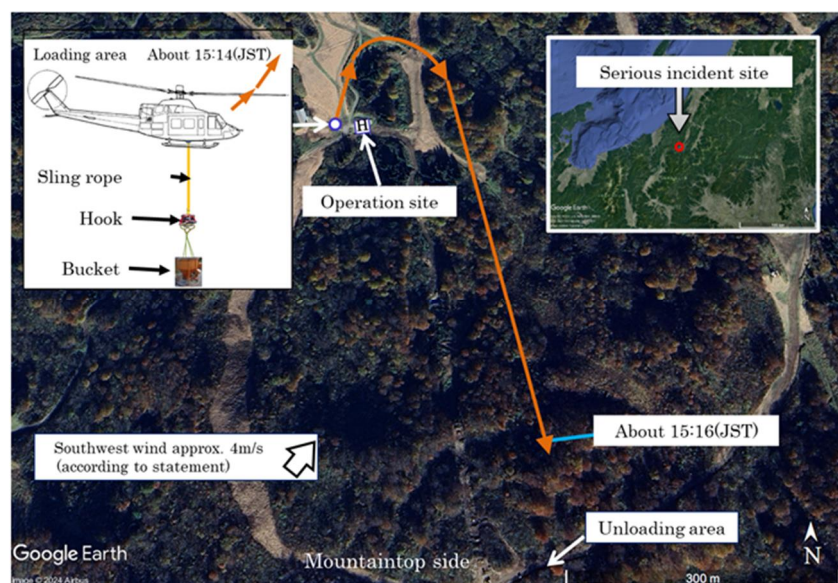
Figure 1: Estimated Flight Route

At around 15:14, the helicopter lifted the bucket containing ready-mixed concrete at the loading area for its 29th cargo transport, then made a right turn while climbing northeast, and headed for the unloading area at the top of the mountain on the southern side.

At around 15:16, as the helicopter approached the unloading area, the onboard mechanic opened the left rear door to check the condition of the load, noticed that the ready-mixed concrete in the bucket had been gone, and reported it to the captain and the pilot.

The captain, upon receiving the report from the on-board mechanic, confirmed through a mirror attached to the exterior of the helicopter that there was no more ready-mixed concrete in the bucket, and decided that the helicopter would not be able to continue cargo transporting and that they should return to the operation site. The helicopter retraced its flight route and searched for the location where the ready mixed concrete would have fallen but was unable to find it. The helicopter then landed at the operation site at 15:28. Also, after landing, the on-board mechanic checked the bucket and found that the bottom plate of the bucket was slightly open.

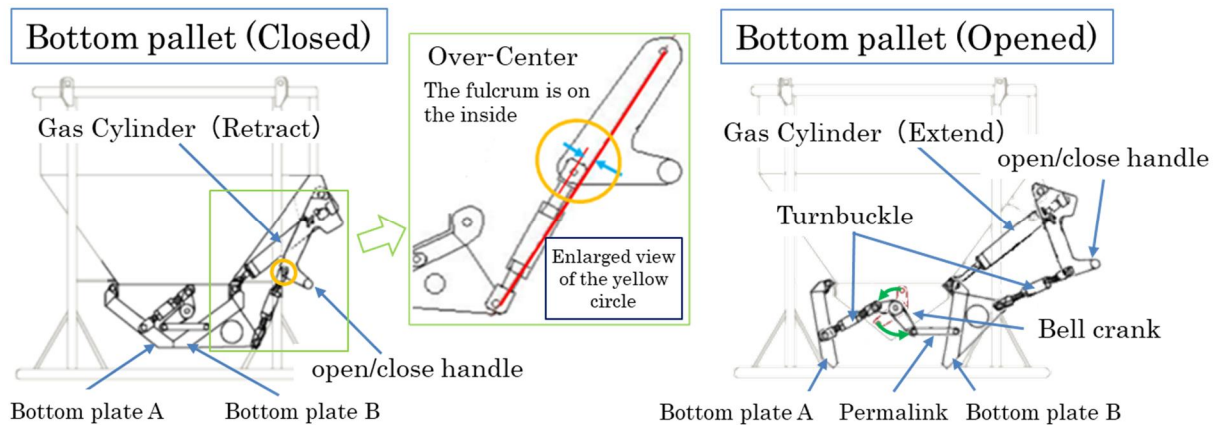
Figure 2: Link Movement when Opening and Closing the Bucket

Shin Nihon Helicopter Co., Ltd. (hereinafter referred to as "the transport company") has a contract with a bucket manufacturer (hereinafter referred to as "the manufacturer") and uses buckets whose links are adjusted by the manufacturer. The manufacturer has adjusted to the state, in which the fulcrum connecting the two struts is initially adjusted to be 10 to 15 mm inward from the position where the struts are connected in a straight line (hereinafter referred to as "over-centering"), and the links are then adjusted so that there are no gaps when the bottom plate is closed.

In normal operation, when the on-board operation switch is set to ON (OPEN), an electrical signal is sent to supply carbon dioxide to the gas cylinder connected to the opening/closing handle, which extends the gas cylinder and moves the link to open the bottom plate. In addition, the bucket used by this helicopter has a small internal volume and places less load on the bottom plate, therefore the bottom plate is supported only by the links. In addition, there is no locking mechanism to prevent the bottom plate from opening unintentionally, but when the bottom plate

is closed, the bottom plate is designed not to open easily due to the over-centering locking mechanism.

According to the manual, the longer the time of service of the bucket, the more the play in the links is generated because the soft rubber attached to the bottom plate wears and deteriorates, so the links need to be adjusted according to the condition of the bucket. Also, if the bucket bottom plate opens during transportation, it is likely that the over-centering lock is not working effectively or the force holding the over-center is weak, so the transport company would adjust the links at the site of use as necessary.

After this serious incident, the bucket was moved to the transport company's hangar and examined in detail. No abnormalities were found in the opening and closing operation, but the fulcrum had recessed inward by approximately 9 mm, which was shallower than that at the initial adjustment.

The JTSB concludes that it is most likely that while the helicopter was flying with a bucket of ready-mixed concrete slung over, the bottom plate of the bucket opened unintentionally, causing the ready-mixed concrete to fall. Regarding the unintentional opening of the bottom plate of the bucket, it is more likely that as the service time of the bucket increased, the soft rubber attached to the bottom plate began to wear and deteriorate, generating play in the links, causing the fulcrum to be recessed and shallower, and preventing the lock from working properly. As a result, it is more likely that the load on the bottom plate increased due to centrifugal force as the helicopter turned right, and the bottom plate was no longer able to withstand the load, causing the bottom plate to temporarily open.

Regarding the unintentional opening of the bottom plate of the bucket, it is more likely that as the service time of the bucket increased, the fulcrum of the link became shallower, preventing the lock from working properly, in addition, as the load on the bottom plate increased due to centrifugal force as the helicopter turned right, the bottom plate was no longer able to withstand the load.

As shown in 3 Analysis, on buckets with bottom plate supported only by links, the condition of the links must be checked regularly and adjusted as necessary. In addition, it is advisable to install a locking mechanism to prevent the bottom plate of the bucket from opening

unintentionally, in case of unforeseen circumstances.

The transport company has revised its procedures to install a locking mechanism on the bucket, where a locking arm is attached to the bucket and will only lock if it is over-centered within a specified value, to prevent the bottom plate from opening unintentionally and to confirm that the locking arm is securely engaged before the ready-mixed concrete is poured.

The transport company has also revised its procedures to thoroughly inspect buckets delivered to the site to make sure they are over-centered before delivery.
