**AIRCRAFT SERIOUS INCIDENT
INVESTIGATION REPORT**

**AERO ASAHI CORPORATION
JA 6 5 1 2**

Company Name	Aero Asahi Corporation
Type, Registration Mark	Eurocopter AS350B3 (Rotorcraft) JA6512
Incident Class	Dropping of Object During External Cargo Sling Operation Close 15, Article 166-4 of the Ordinance for Enforcement of Civil Aeronautics Act of Japan
Date and Time of the Occurrence	At about 10:02 JST, August 3, 2017
Site of the Incident	Kurobe City, Toyama Prefecture (36°48' 59" N, 137°36' 12" E)

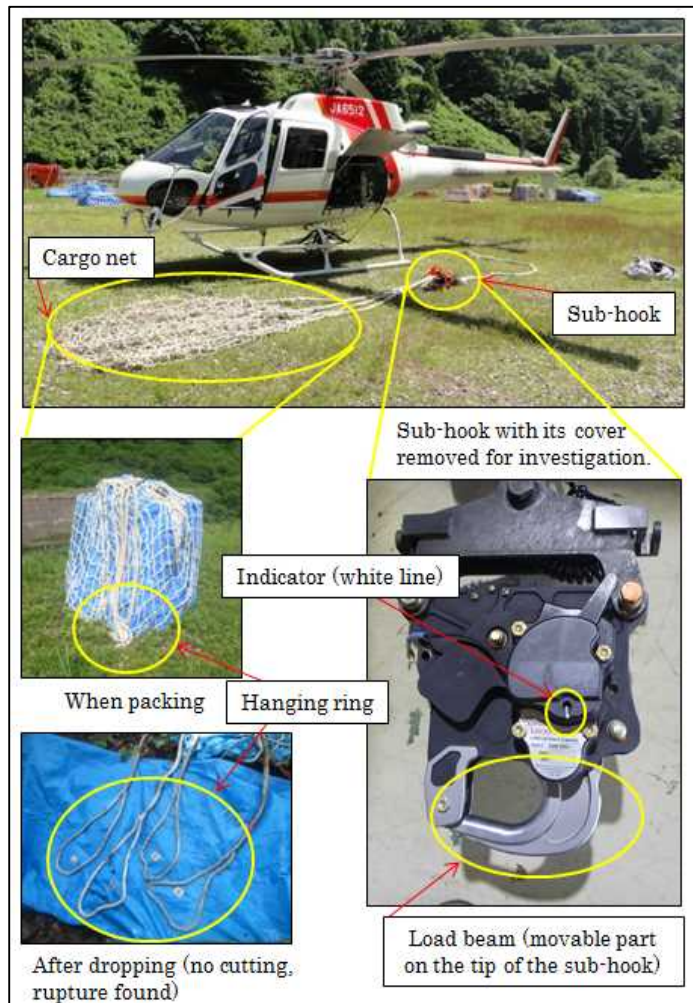
After takeoff, when the Aircraft was climbing slowly at about 70 kt at about 610 m AGL, the cargo dropped suddenly even though the unhooking switch of the slinging load had not been operated. At this time, the captain felt the Aircraft shaking up and down, and right away looked at the mirror to confirm the state of the slinging load, but could not find it in the mirror. Therefore, the captain decided to stop the cargo transportation and returned back to the departed helipad. The ground worker confirmed that at its landing approach, the Aircraft did not have the slinging load with its load beam closed. There was no damage found in the hanging ring of the cargo net that was collected.

Photo: The Aircraft (hooking the cargo net on the sub-hook)

In the teardown inspection of the sub-hook alone, it was confirmed that the lock was not unintentionally released or the structure which the hanging ring of the cargo net does not slip through. In addition, abnormal conditions could not be found though the detailed examination of the external cargo sling system was performed as follows:

It is somewhat likely that the reason why the slinging load dropped is that during the flight, the lock on the sub-hook was unintentionally released and its load beam was opened due to temporary malfunction of the electric circuit in the external cargo sling system caused by the Aircraft vibrations, temporary insulation failure of the electric circuit in the external cargo sling system, or temporary electromagnetic interference from the Aircraft equipment or external facilities. Therefore, the detailed examination of the external cargo sling system and the sub-hook was conducted, however abnormal conditions could not be found and the probable cause could not be determined.

In this serious incident, it is somewhat likely that the slinging load dropped, since the lock on the sub-hook of the external cargo sling system was unintentionally released and its load beam was opened during the external cargo sling operation. However, the probable cause of opening the load beam due to unlocking the sub-hook could not be determined.

The Company stopped using of the same type of the external cargo sling systems after the serious incident.
