**AIRCRAFT ACCIDENT  
INVESTIGATION REPORT**

**SHIKOKU AIR SERVICE CO., LTD.**

**J A 6 5 2 2**

FIRE FROM REAR HOLD  
SHIKOKU AIR SERVICE CO., LTD  
EUROCOPTER AS350B3 (ROTORCRAFT), JA6522  
HIKETA, HIGASHIKAGAWA CITY, KAGAWA PREFECTURE  
AT ABOUT 10:10 JST, SEPTEMBER 22, 2011

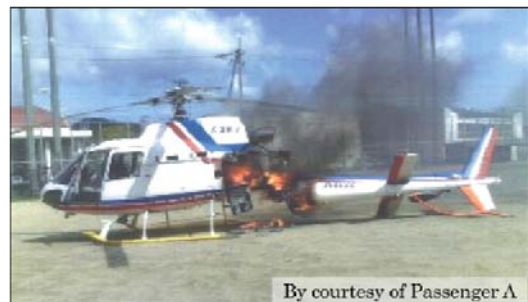
Condition of the fire on the helicopter at around 10:12

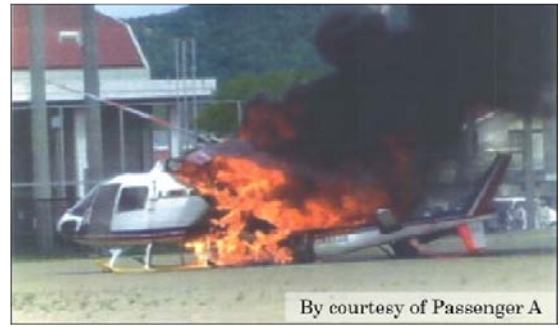
Condition of the fire on the helicopter at around 10:19

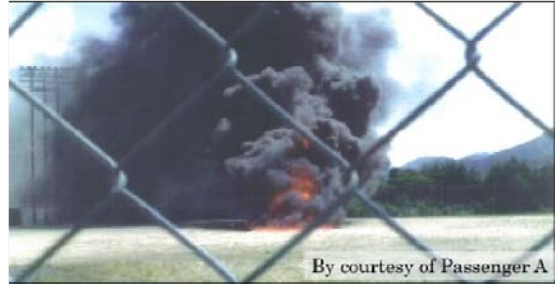
Condition of the fire on the helicopter at around 10:23

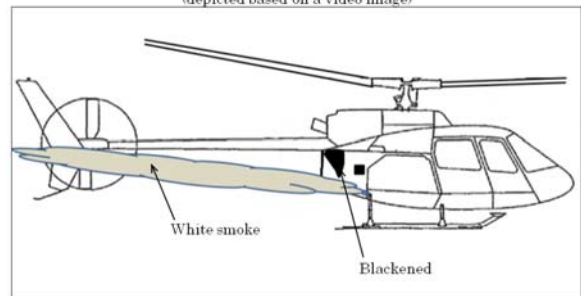
Condition of the approaching helicopter  
(depicted based on a video image)

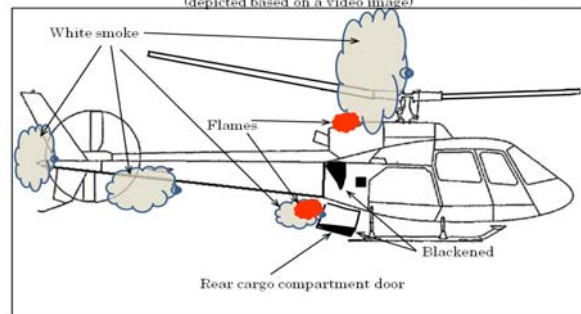
Condition of the helicopter just before landing  
(depicted based on a video image)

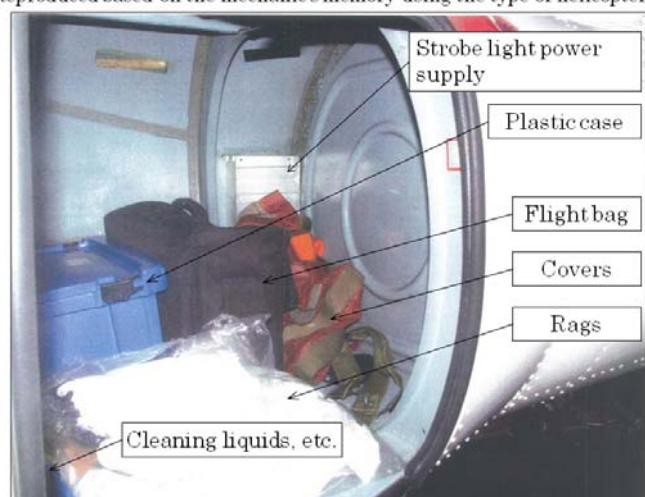
Mechanic performed a pre-flight inspection of the Helicopter. As shown by the photograph to the right, deep in the front part of the rear hold was a plastic case that contained extra oils such as engine oil. Behind the case was a flight bag that included documents, and at the rearmost part of the hold were cloth covers used during parking. Near the door were rags, cleaning agents, and so forth. All these items were not covered with a floor tie-down net to prevent them from moving, but were kept tidy and in order. The mechanic confirmed that there was nothing abnormal and closed the door.

Condition of embarkation in the rear hold  
(Reproduced based on the mechanic's memory using the type of helicopter)

In this accident, it is possible that since measures were not taken to prevent the movement of embarkation in the rear hold using a floor tie-down net, the embarkation moved during the flight, and then damaged the wiring of electrical equipment in the hold, causing a fire.

When having embarkation in the rear hold of Eurocopter AS350B3, the Company should take measures to prevent its movement using a net as provided in the Flight Manual in order to prevent an unforeseen event due to such movement. In addition, when transporting items that fall into the category of explosives and other goods, the Company should confirm the content of the pronouncement and meet the standards specified therein when transporting such items.

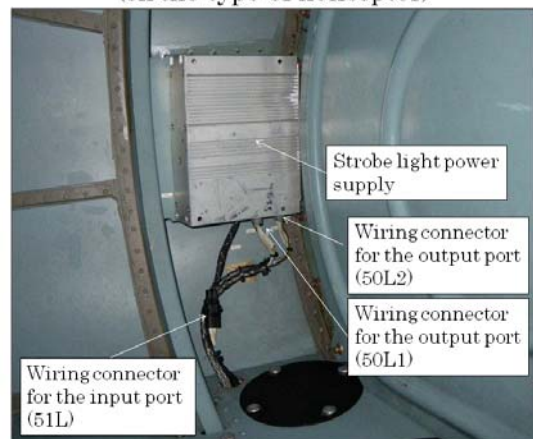
Installation of the strobe light power supply (on the type of helicopter)

In addition, as described in 2.9.8(1), FAR Section 27.855(b) requires wiring in the baggage compartment to "*be protected so that it cannot be damaged by the movement of cargo in the compartment, and that its breakage or failure will not create a fire hazard.*" Moreover, FAA's AC recommends specific protection methods, saying that "*wiring should be protected by a cage or rigid housing adequate to protect the items.*" The wiring of the Helicopter's strobe light power supply, however, was not protected in a "*a cage or rigid housing*" as recommended by the AC.

The wiring of the Helicopter's strobe light power supply clearly did not conform to the method recommended by the AC, and there is also a possibility of the wiring failing to meet FAR's airworthiness standards. For this reason, the designer and manufacturer of the Helicopter should modify the design of the strobe light power supply in line with the method recommended by FAA's AC so that the modified one meets FAR's standards.

The EASA should make it mandatory to modify the rear hold of the Eurocopter AS 350 series so that electrical equipment and its wiring are fully protected.

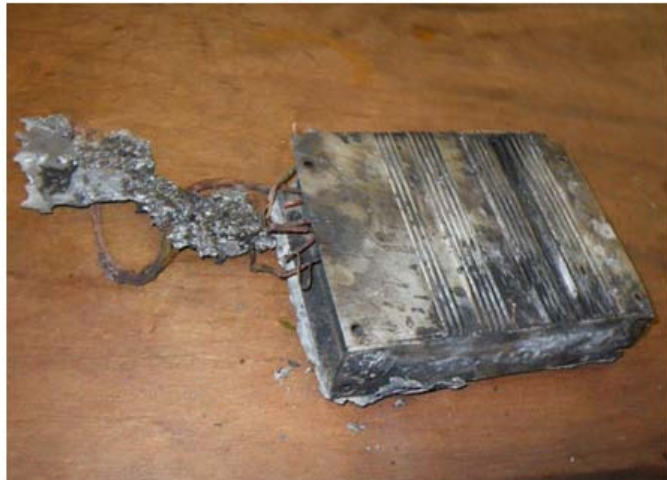
Strobe light power supply and its wires investigated by NTSB

- a. The power supply did not experience an internal failure that led to the fire. It was a victim of the fire.
- b. No evidence of major arcing to the external wire was found. Some very localized

melting of strands were found, which may have been from strobe operation as the wire was externally damaged. The localized melting may also have been created by localized oxygen depletion during the post-landing fire.

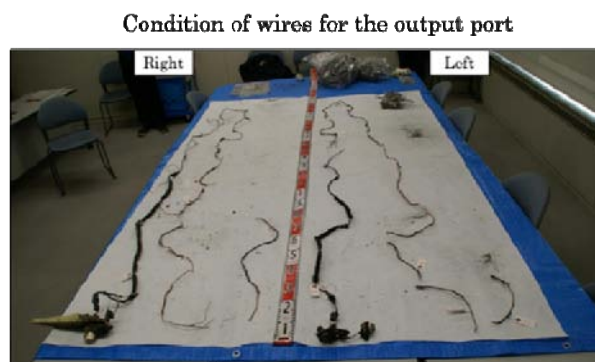
The wiring for the output ports of the right and left strobe lights were retrieved from the wrecked Helicopter, and the portion of the wiring that was close to the power supply was damaged by heat and fragile.

As a result of detailed observation of the retrieved wiring, no event that could be used to identify the cause of the fire such as melting points was detected.
