**AIRCRAFT ACCIDENT
INVESTIGATION REPORT**

**JAPAN AIRLINES CO., LTD.
J A 6 5 4 J**

CABIN ATTENDANTS INJURIES
BY THE SHAKING OF THE AIRCRAFT
JAPAN AIRLINES CO., LTD., BOEING 767-300, JA654J
AT AN ALTITUDE OF APPROXIMATELY 16,000 FT
ABOUT 95 KM SOUTHEAST OF
GIMPO INTERNATIONAL AIRPORT (KOREA)
AT 17:33 JST, SEPTEMBER 12, 2014

April 24, 2015

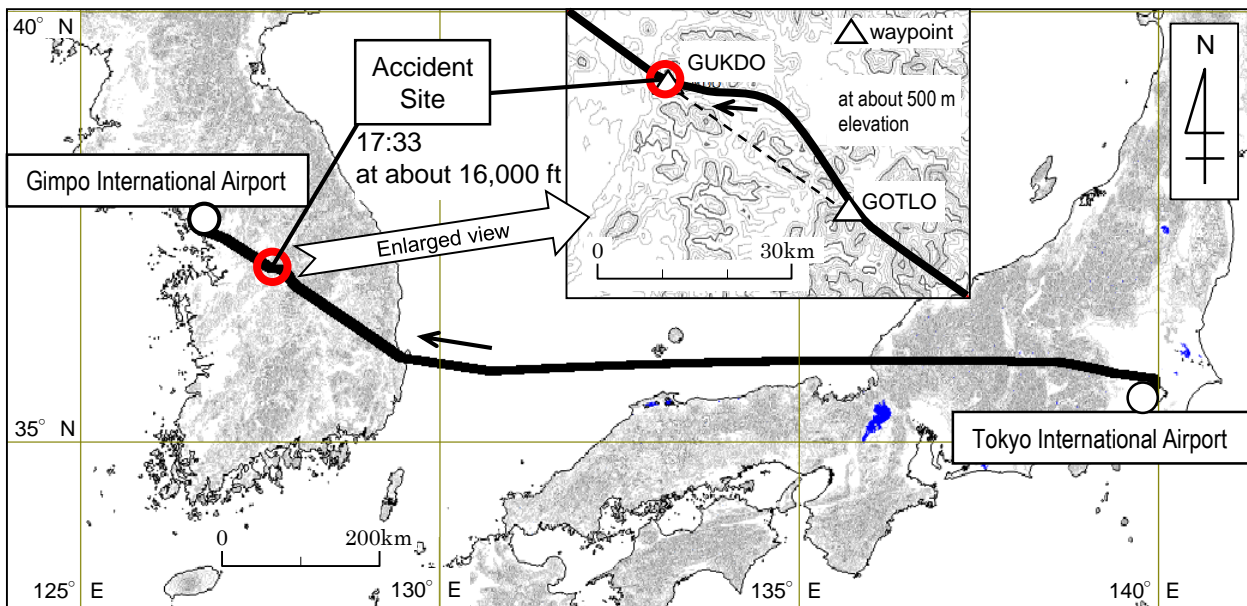
Figure 1 Estimated Flight Route

Although no weather echo was observed around GUKDO, at 17:33, a clear visible cloud came into sight nearby with no sufficient time to avoid, and the aircraft entered it. At that moment, shaking of large amplitude considered nearly TB4 *1 continued for around three seconds. The PIC was informed that no passengers sustained injuries, while several cabin crewmembers and interpreters did.

<p>preparing for landing. Since shaking of the aircraft gained its momentum from around 17:28, CAs and interpreters in the aft galley took their seats temporarily although the seatbelt sign was not lit on. When they resumed their work after the shaking subsided, they suddenly encountered a violent vertical shaking, by which cabin crewmembers were thrown into the air to hit the ceiling and one of them fell onto the floor on her back. As a result, she was seriously injured.</p> <p>The atmosphere being stabilized after clearing clouds, the PIC turned on the seatbelt sign at 10,000 ft as usual and continued descent. The aircraft landed at Gimpo International Airport at 17:51.</p> <p>The accident occurred at 17:33 on September 12, 2014, near GUKDO, about 95 km southeast of Gimpo International Airport (37°01'43" N, 127°38'05" E), at an altitude of approximately 16,000 ft.</p> <p>(See figure 1 and 2)</p>

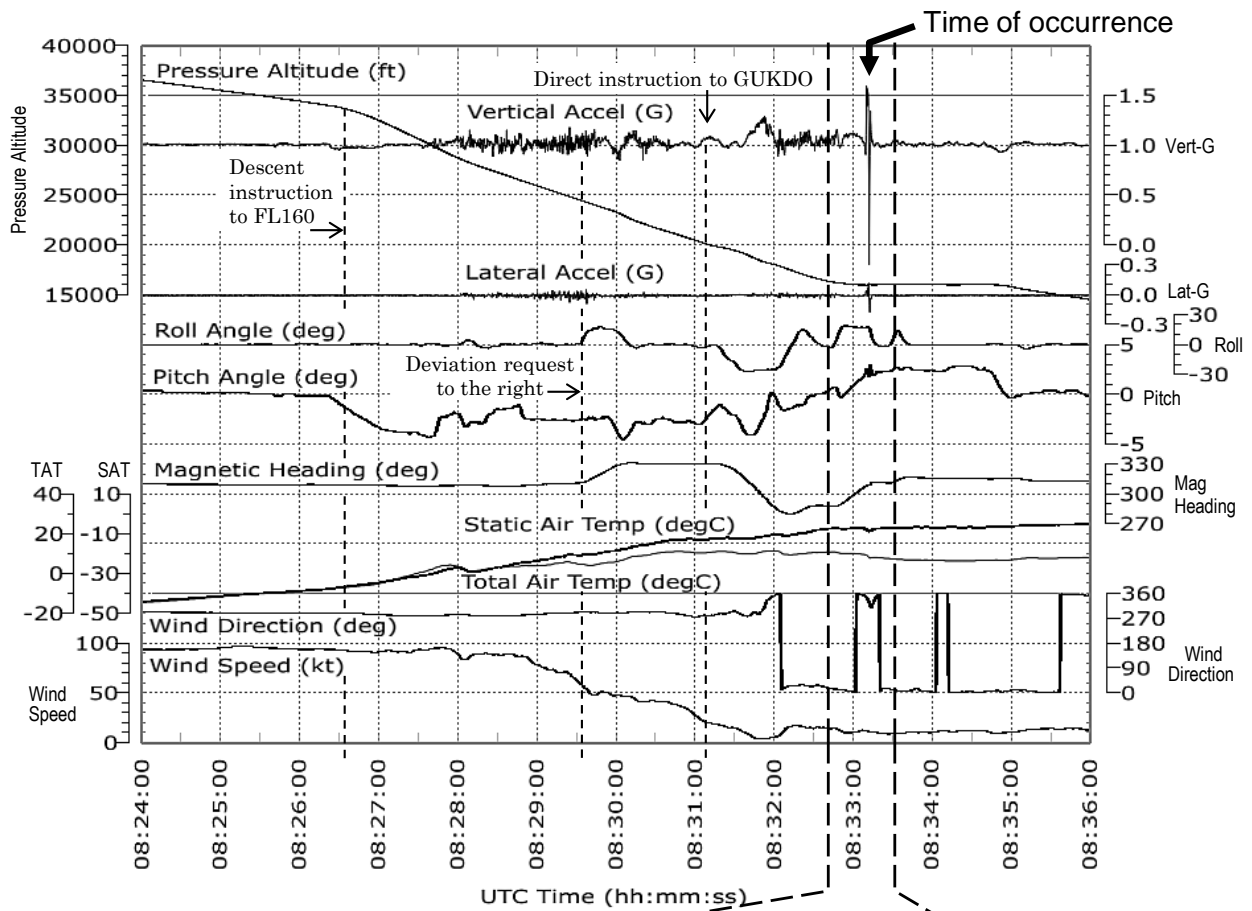
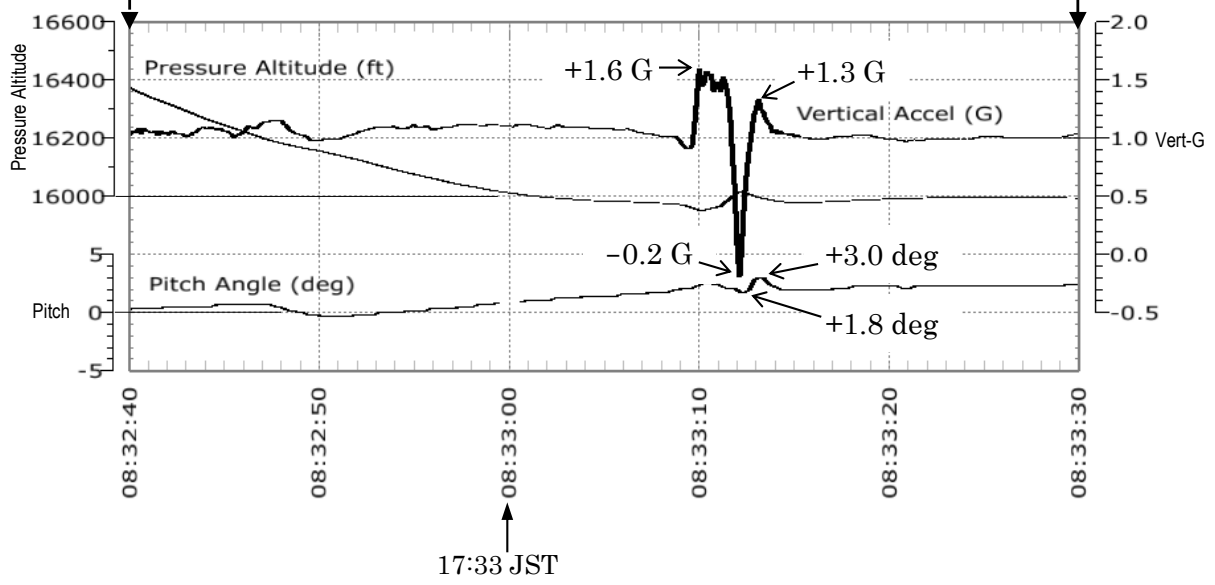
Figure 2 Records of the FDR

A vertical acceleration of approximately +1.5 G continued for around two seconds, and momentarily it changed to -0.2 G, then +1.3 G (+: moving upward) when the aircraft encountered strong shaking. There was a little change of pitch angle. The autopilot and autothrottle remained engaged during the shaking.

(2) Judging from the fact that significant change of vertical acceleration was observed at 17:33 when the aircraft was about to level off at FL160 around GUKDO after its descent, it is highly probable that the aircraft was strongly shaken as it encountered turbulence by the convective clouds, causing cabin crewmembers thrown into the air to hit the ceiling, and one of them fell onto the floor on her back to sustain a severe injury.

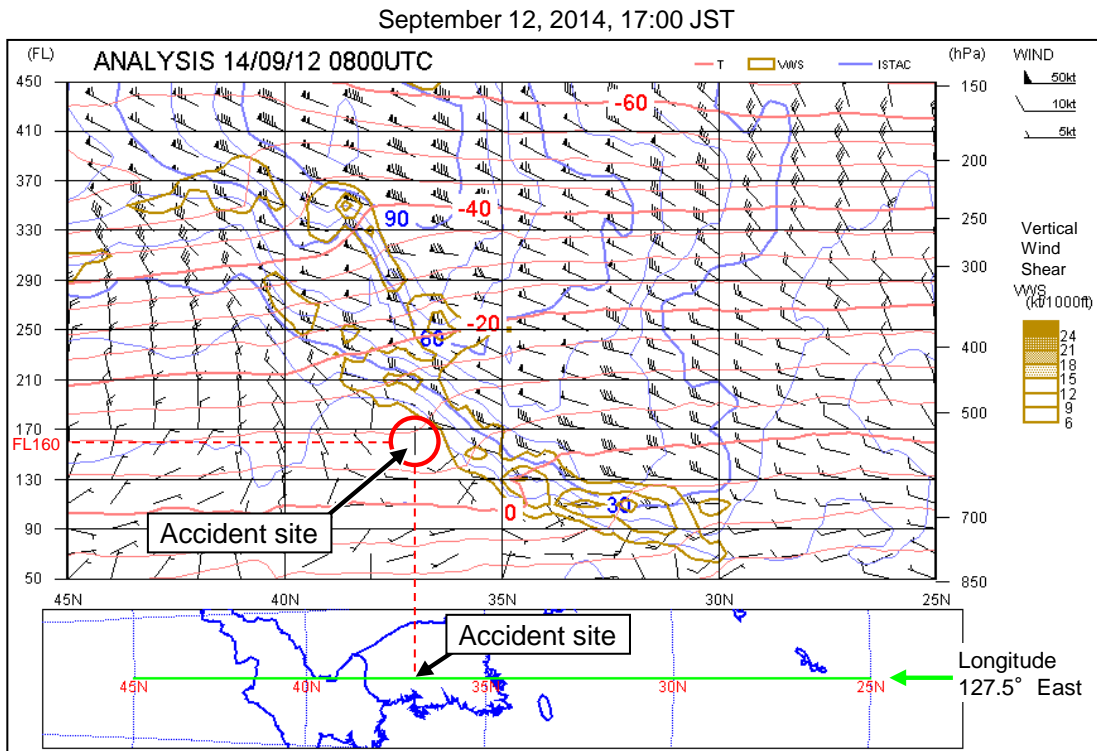
Figure 3 Hourly Analysis Chart (vertical cross section)

2.6 Meteorological Information	<p>(1) Weather conditions confirmed before the flight</p> <p>The Korean Peninsula area was covered by high pressure system from the north, and there were no low pressure system or fronts which might imply bad weather. Although jet stream of about 100 kt in FL390 was expected from the Korean Peninsula to the Kinki district of Japan, bad weather such as clear air turbulence or convective clouds were not expected around Seoul.</p> <p>According to the Pilot Report (PIREP) of the company's preceding flight, weak turbulences (TB2 *1) were reported at 13:25 in clouds the altitude of which were from 24,000 to 23,000 ft and from 7,000 to 5,000 ft during the descent towards Gimpo International Airport.</p> <p>(2) Weather information provided during the flight</p> <p>At 16:43, during cruising flight, cloud condition provided from the operation support staff at Gimpo International Airport was as below.</p> <p><i>Some isolated CB has been developed around west of GUKDO, over Seoul and over Gimpo Airport. But now it tends to go weak. No significant CB observed on your approach course and no need to deviate.</i></p> <p>(3) Weather conditions at the time of the accident</p> <p>According to the hourly analysis chart (127.5° East vertical cross section) of 17:00 and 18:00 of the Japan Meteorological Agency, weak Vertical Wind Shear (VWS) existed in the upper layer, however, it was not at the altitude of the accident.</p> <p>According to the upper-laid observation weather chart (500 hPa, 700 hPa and 850 hPa) of 09:00 and 21:00 of the Japan Meteorological Agency, the Korean Peninsula area had been covered with the rear surface of the cold air trough. Although the center of the cold air had moved to the east, it was under the condition that cold air stayed as about -10 °C at around 500 hPa.</p> <p>According to the images of the Terminal Doppler Weather Radar (TDWR) installed in Incheon International Airport (Korea), small echoes had been scattered to the west of GUKDO (123 km southeast of Incheon TDWR), these echoes attenuated once. However, they began to grow up near GUKDO from past 17:00.</p> <p>(See Figure 3 and 4)</p>

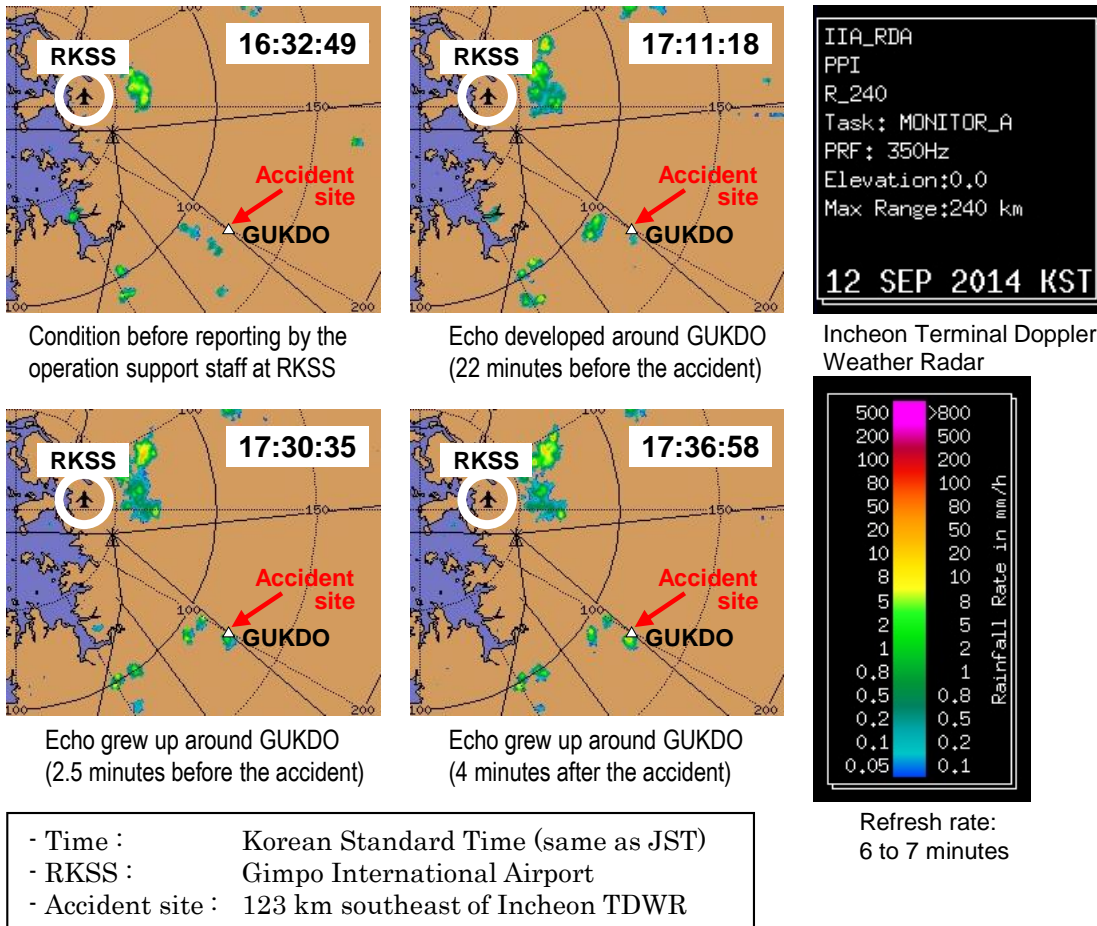
Figure 4 Radar Observation Data

(1) It is probable that the operation support staff of the company at Gimpo International Airport, based on the images of Inchon TDWR that scattered echoes of clouds shown in the east of GUKDO were attenuating, judged the aircraft would not need to deviate because no convective clouds which might give significant impact on the flight were observed along the approach course before 16:43 when the staff sent the information to the aircraft. However, convective clouds were redeveloping near GUKDO after 17:00.

It is highly probable that the turbulence the aircraft encountered was caused by the redeveloped convective clouds after once shrinking. It is probable that the pilots were unable to capture the echoes of the convective clouds in their early developing stages which existed in its flight direction (forward and downward of the aircraft) due to having set the antenna tilt angle of the airborne weather radar to auto mode.
