# AIRCRAFT ACCIDENT INVESTIGATION REPORT

## INJURY TO GROUND WORKER DURING

#### SHIN NIHON HELICOPTER CO., LTD.

#### AEROSPATIALE AS332L1(ROTOR CRAFT), JA6686

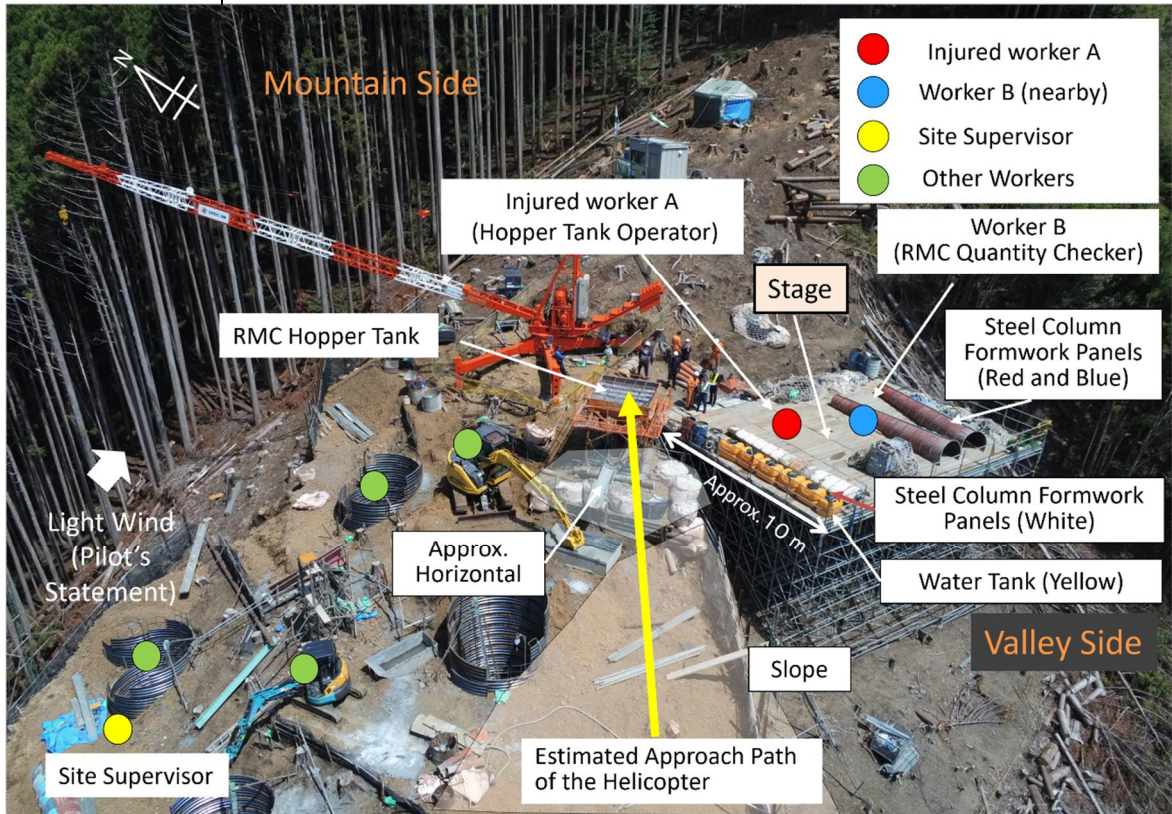
Figure 1: Positions at the Time of the Accident and Estimated Flight Path of the Helicopter

The stage next to the hopper tank, as shown in Figure 1, was located on a mountain slope. It was constructed from steel pipes and had an open structure that allowed air to flow underneath. According to Figure 9, the distance from the point at which the tip of the main rotor blade reached directly above the stage to the point where the helicopter hovered above the hopper tank was approximately 11 m. During the approach, excluding the effect of wind, most of the downwash would flow toward the valley side of the slope until the main rotor disk overlapped the stage. Therefore, it is more likely that the formwork panels were not affected by the downwash until that point. Additionally, according to the pilot's statement, the helicopter approached from approximately 20 m in front of the hopper tank at a ground speed of less than 15 kt. Assuming the helicopter hovered directly over the hopper tank, a deceleration rate of approximately 3 kt per second would have been required. Based on this deceleration rate, it is estimated that it took approximately 3.5 seconds to travel the 11m during which the main rotor disk overlapped the stage. During this period, it is probable that strong downwash flowed over the surface of the stage.

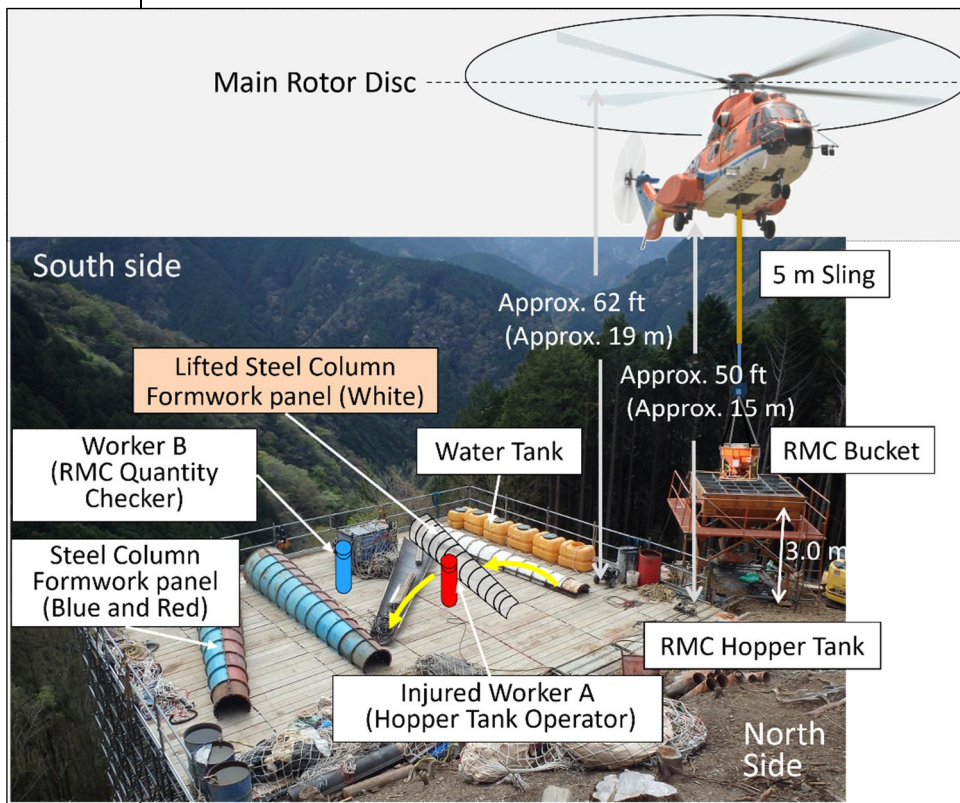
**Figure 2: Stage Area Conditions During the Helicopter Approach (Composite Image)**

When the helicopter resumed operations after refueling and began its approach over the hopper tank with the RMC bucket suspended, both workers felt a stronger downwash than during the previous transport. The four stacked white formwork panels (see 2.7(1)) began to vibrate with a rattling sound. Immediately thereafter, the topmost panel lifted off toward Worker A, who was operating the hopper tank handle and had taken cover next to the panels. The formwork panel flipped over its wider southern edge as a pivot point, causing the northern tip to move. Worker A attempted to hold back the approaching formwork panel by hand but was unable to do so. The panel flipped over and came into contact with the upper right knee and lower left knee, resulting in injury. Worker B, who was nearby, heard a sound as if something had been struck when the formwork panel lifted off and flipped over. After the helicopter began to ascend, Worker B asked Worker A if everything was all right. Although there was pain in the knees, Worker A believed there was no bleeding and responded, "I'm okay."

Subsequently, to prevent the flipped-over formwork panel from being displaced by the downwash, Worker B placed weights, such as wires, on it. The remaining three white panels were secured by threading iron wires through bolt holes. In addition, the site supervisor was at the site the foundation work area where RMC was being continuously delivered and therefore did not notice the formwork panel lifted off.

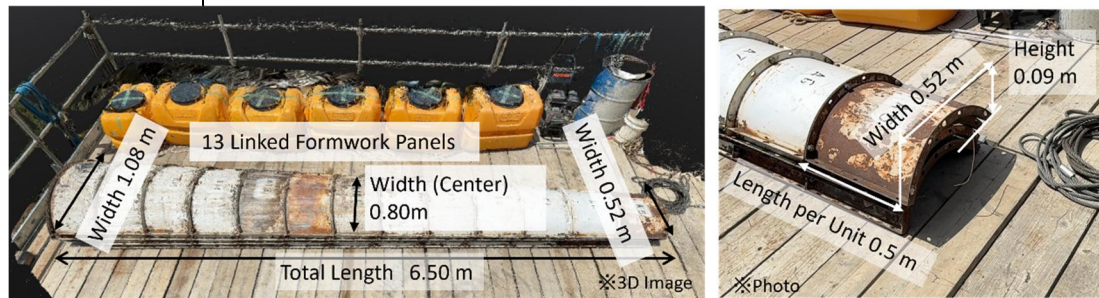
**Figure 3: Steel Column Formwork Panels**

| <b>2.7 Additional Information</b> | <p>(1) Overview of Steel Column Formwork Panels</p> <p>The steel formwork panels used to construct the foundations of transmission towers consist of cylindrical column segments divided into three 120° arc sections and color-coded white, red, and blue. Panels of each color, each 0.5 meters in length, are bolted together to form the required total length, and the three colors are then combined for use. The white formwork panel that lifted off at the time of the accident was 6.50 meters long (comprising 13 connected panels), had a tapered shape—1.08 meters wide at the bottom and 0.52 meters at the top—and weighed 139.77 kg per panel. (See Figure 3.)</p> <p>As shown in Figure 2, at the time of the accident, the red and blue formwork panels had been assembled and placed with their arc sections</p> |

facing upward. The white formwork panels were stacked in four layers. These panels were intended to be assembled at the foundation of the transmission tower at the appropriate time as molds for pouring the transported RMC.

| <b>5.2 Safety Actions<br/>Taken after the<br/>Accident</b> | <p>The operator and the consortium responsible for the construction project implemented the following recurrence prevention measures:</p> <p>(1) When placing steel column formwork panels within the construction site during helicopter transport operations, measures to prevent scattering—such as securing with wire ropes, iron wire, or covering with nets—must be implemented.</p> <p>(2) During pre-deployment training, the site manager shall instruct workers that if there are signs of flying debris or cargo collapsing during helicopter transport, they must immediately evacuate to avoid being caught.</p> <p>(3) During pre-deployment training, the site manager shall instruct workers that if they are injured during the work, regardless of the severity, they must immediately report it to the site supervisor.</p> |

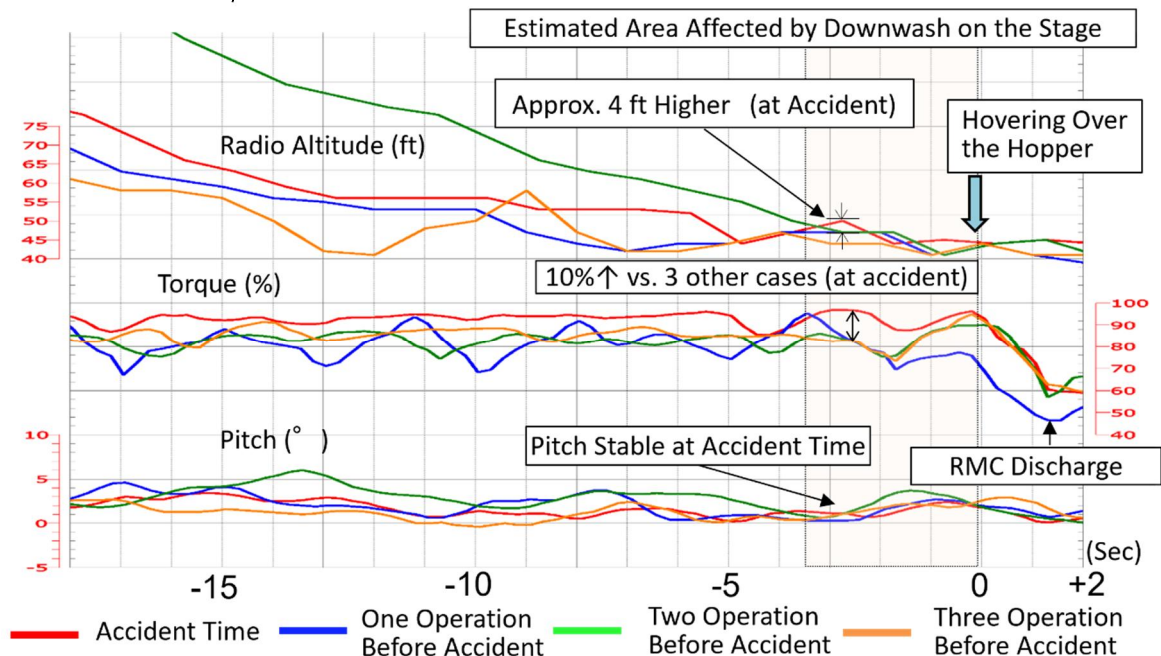
**Figure 4: Comparison of Engine Torque, Pitch Attitude, and Radio Altitude During Approach**

Although GPS-based speed and position data were not properly recorded in the helicopter's flight recorder, a comparison was made, as shown in Figure 4, for the approximately 3.5 seconds immediately before hovering over the hopper tank during four approach runs, including the accident flight. The comparison was based on engine torque, pitch attitude, and radio altitude—factors related to differences in downwash strength.

Comparing the four approaches, during the approach at the time of the accident, the radio altimeter indicated approximately 4 feet higher than in the other three approaches at about 3 seconds before hovering over the hopper tank, and the helicopter approached while descending. In addition, a

comparison of engine torque changes immediately before releasing the RMC showed that the engine torque at the time of the accident remained approximately 10% higher than in the other three approaches for about 1.5 seconds. Furthermore, the pitch attitude was shallower and showed less variation.

Regarding the approach immediately preceding the accident, although the change in pitch attitude was small and the change in radio altitude was similar to that during the accident, the engine torque was significantly lower overall compared to the other three approaches including the accident. It is possible that, in addition to a reduction in aircraft weight due to fuel consumption, the helicopter was temporarily affected by wind, resulting in a lower engine torque requirement for flight.

In contrast, during the approach at the time of the accident, it is probable that a stronger downwash continuously flowed onto the stage compared to the other three approaches. This is due to the combination of higher engine torque, faster downwash wind speed, a descending approach, and a shallow and stable pitch attitude, all of which would have caused the downwash to be more concentrated downward. This assessment is consistent with the statement made by two workers who noted, “The downwash felt stronger than during the previous transport.”

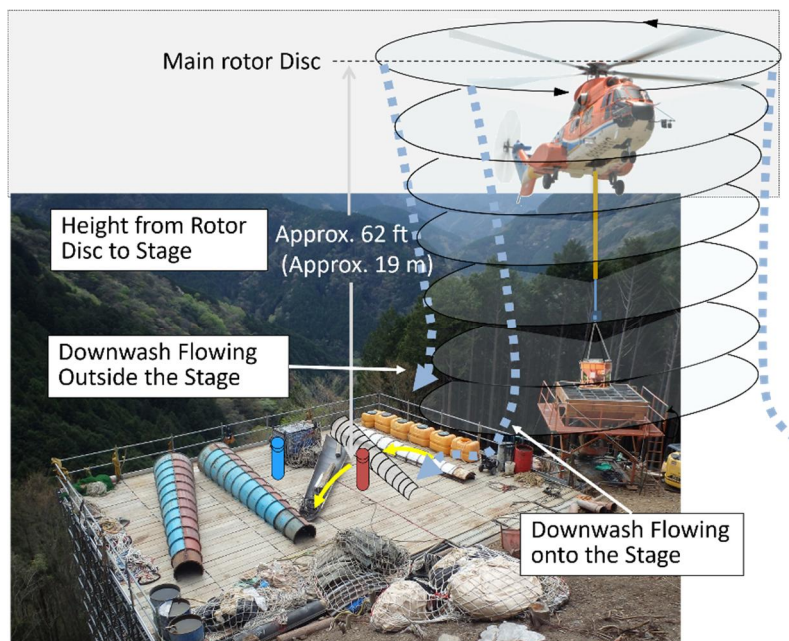
**Figure 10: Downwash Flow on the Stage**

As shown in Figure 10, the height from the rotor disk to the top surface of the stage was approximately 19 meters when the bucket was in contact with the hopper tank. During the approach prior to contact, the height from the rotor to the stage exceeded the rotor diameter of 15.6 meters. At this height—where downwash wind speed is known to double—it is estimated, based on the environmental conditions at the time of the accident and as shown in Figure 11, that the helicopter’s induced velocity was approximately 26 kt, and that the average estimated downwash wind speed, accelerated by this height, reached approximately 53 kt (27 m/s). Furthermore, under the aircraft weight during RMC transport before refueling (with approximately 454 kg of fuel onboard), the average estimated downwash wind speed was about 51 kt. Additionally, as shown in Figure 9, the location where the formwork panel lifted off was near the tip of the main rotor disc. As described in section 2.7(3)c, it is

probable that the downwash in this area exceeded the estimated average wind speed and reaches its maximum velocity. Moreover, a water tank was positioned in front of the white formwork panels, and the downwash passed through the space between them. It is possible that this caused additional acceleration of the wind due to the Venturi effect\*8.

The behavior of downwash flow is difficult to simulate accurately, as it is influenced not only by the complex airflow patterns around the fuselage but also by the structures present on the stage. However, during the helicopter's approach at the time of the accident, the formwork panels on the stage were observed to vibrate with a rattling sound and then lifted off and flipped over. It is most likely that temporarily accelerated downwash generated sufficient force to lift off the panels, flipped over them, and subsequently move them to the point of impact by means of the outwash.

Downwash generated by a helicopter can become highly complex and may increase rapidly, even during repeated operations, due to slight variations in rotor thrust and aircraft attitude, as well as the influence of surrounding winds and nearby ground structures. Therefore, in areas where a helicopter passes at low speed, measures must be reliably implemented to prevent objects—even heavy ones—from being blown away by the downwash. In addition, personnel involved in the operation should take cover as far as possible from directly beneath the main rotor and from the vicinity of potentially displaced objects.
