# AIRCRAFT SERIOUS INCIDENT INVESTIGATION REPORT

October 09, 2025

Adopted by the Japan Transport Safety Board

<b>Company</b>	Shin Nihon Helicopter Co., Ltd.
<b>Type, Registration Mark</b>	Aerospatiale AS332L1 (Rotorcraft), JA6686
<b>Incident Class</b>	Case where a slung load carried external to the aircraft was released unintentionally Item (xvi), Article 166-4 of the Regulation for Enforcement of the Civil Aeronautics Act of Japan.
<b>Date and Time of the Occurrence</b>	At about 12:21 Japan Standard Time (JST: UTC+9 hours), July 2, 2025
<b>Site of the Incident</b>	At about 150mt above the ground over Hamamatsu City, Shizuoka Prefecture (35° 02' 32" N, 137° 55' 45" E).

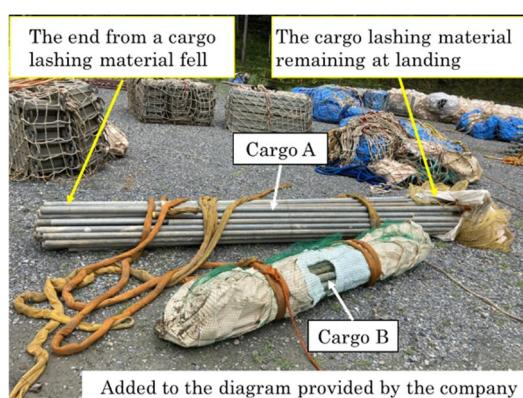
Figure 2: The Status of Underslung Cargo  
(This photograph was taken after landing at the operation site)

Upon hearing from the captain that the ton pack had fallen, the mechanic (instructor) opened the left cabin door and checked the underslung cargo, confirming that one end of the two cargo lashing materials covering both ends of Cargo A was missing. In addition, the mechanic (instructor) reported to the captain that the other end of the cargo lashing material remaining on Cargo A, was flapping in the wind and on the verge of falling off.

At about 12:23, the helicopter landed at the operation site, and the captain reported to the company that the subsequent transport operations would be cancelled. After the flight, upon inspecting the slung cargo, it was confirmed that approximately 4 kg of lashing materials attached to Cargo A (a ton bag, a net covering the ton bag, and a binding wire) was missing.

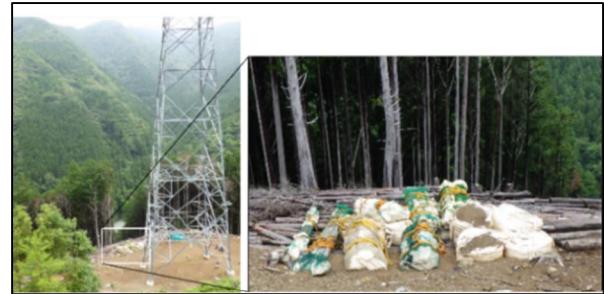
Figure 3: Packing Condition of Cargos at the Loading Site

Company A conducted cargo packing with eight workers on June 16, 2025, and with four workers on June 17, 2025. A total of 25 cargoes were packed over the two days, each weighing between around 50 and 800 kg (see Figure 3).

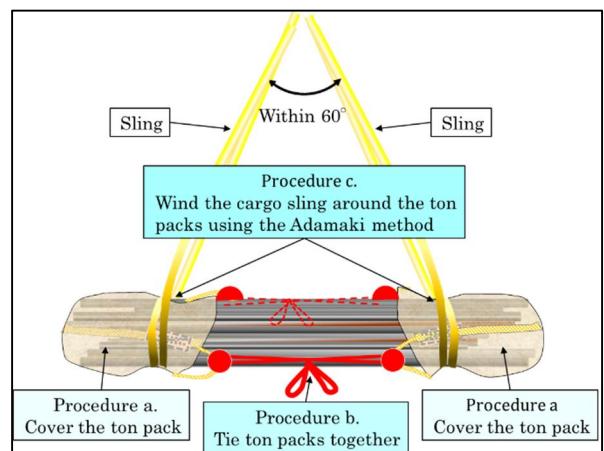
Figure 4: Packing Procedures for Using ton Packs at Both Ends of the Cargo

The Safety Text lists five examples of packaging methods for long items similar to those involved in this serious incident. Regarding the procedure for packaging when using ton packs at both ends, the following (summary) is provided. For reference, a schematic diagram is shown in Figure 4

- a. Cover both ends of the long cargo with a ton pack (hereinafter referred to as "Procedure a.")
- b. Ensure to tie the ton packs at both ends together to prevent them from flying away due to wind pressure during flight (hereinafter referred to as "Procedure b.").
- c. Further wind the cargo sling around the ton packs using the Adamaki<sup>\*2</sup> slinging method to prevent them from flying off (hereinafter referred to as "Procedure c.").

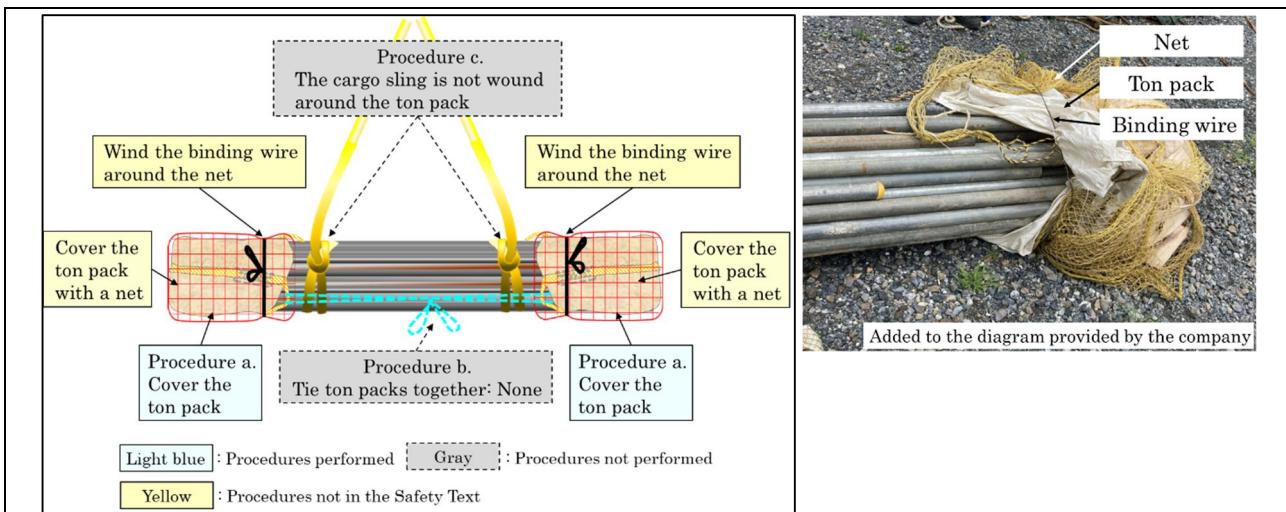
Figure 5: Packing Condition of Cargos at the Time of the Serious Incident

According to the site supervisor of Company A who checked Cargo A following the serious incident, the condition of the cargo lashing material remained at one end of Cargo A, rather than flying away, led the site supervisor to conclude that Procedure b. and Procedure c. as shown in the Safety Text, had not been performed at the time of the serious incident. Besides, as there were not enough ropes available to tie the ton packs together when the cargo was packed, it was decided that Procedure b. was scheduled for completion at a later stage. However, the site supervisor of Company A did not perform Procedure b. Furthermore, Procedure c. was not performed, instead the sling wire was wound directly around Cargo A and the ton packs were covered with nets around which binding wire was wound to tie them together (see Figure 5).

The JTSB concludes that it is highly probable that based on the statement of Company A's site supervisor, Procedure b. and Procedure c. of those procedures shown in the Safety Text, had not been performed. Therefore, it was most likely unable to prevent Cargo A's ton pack from falling off due to wind pressure during the flight.

Procedure b. was not performed when the cargo was packed because it was decided that Procedure b. would be performed on a later day, as there were not enough ropes available at the time to tie the ton packs together. However, it is most likely that Company A's site supervisor forgot about it. In addition, Procedure c. was not performed probably because, to securely fasten the cargo A with

varying lengths using a sling, priority was given to ensuring the sling was securely attached to the shorter steel pipe rather than placing it over the ton pack.

- a. To ensure that the cargo is packed appropriately.
- b. To confirm that all workers involved in cargo sling operations have received the Safety Education.

- (c) The flight mechanics were reminded again that they should confirm that the cargo is packed in accordance with the rules set out in the Safety Text before lifting it, and if they find that the cargo is not packed in accordance with these rules, they must not lift it.

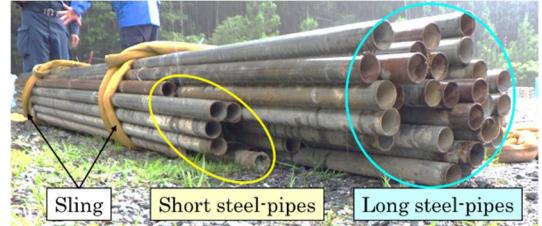
Figure 6: Condition of cargo A

The following conditions of Cargo A were confirmed in this investigation (see Figure 6).

- Cargo A consists of approximately 50 steel pipes of various lengths, ranging from about 2.5 to 4.2 m, which were bundled together with their centers aligned.
- The sling attached to Cargo A was placed in a position well inside both ends of the shortest steel pipe so that all steel pipes could be wrapped and secured.
