AA2016-3

**AIRCRAFT ACCIDENT
INVESTIGATION REPORT**

**SHIN NIHON HELICOPTER CO., LTD.
J A 6 7 4 1**

CRASH AFTER COLLISION WITH POWER TRANSMISSION LINES
DURING LEAVING FROM HOVERING
SHIN NIHON HELICOPTER CO., LTD.
AEROSPATIALE AS332L1 (ROTORCRAFT), JA6741
KIHOKU TOWN, KITAMURO GUN, MIE PREFECTURE, JAPAN
AT AROUND 10:51 JST, MARCH 6, 2015

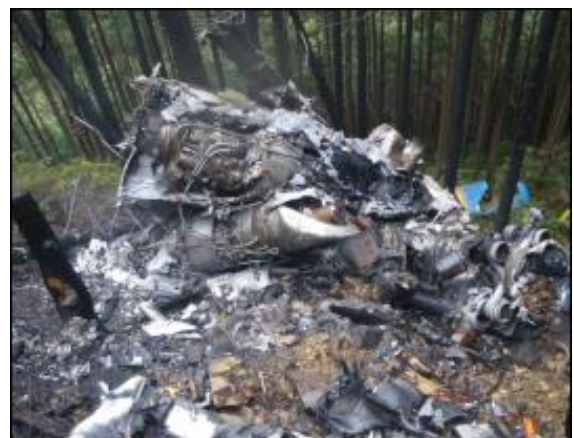
(Photo 2: Condition of main components)

The accident site is an inclined surface with gradient of about 45° in the north, which is located southeast of the forward base. The burnt wreckage of main components such as the body, engine, main gear box, main rotor hub, landing gears, and so on remained together, and parts were scattered within the range of about 10 m in width and about 20 m in length along the inclined surface. MRB Yellow (four MRBs are distinguished by colors, such as yellow, red, black, and blue) hung on the tree in the position of main components and was affected by fire. TB completely fell off from the connection part with the body and was supported upside down by trees about 50 m south of the main components. MRB Black was in its immediate southeast, MRB Blue was in a position about 50 m southwest of the main components, and MRB Red was in an opposite shore of a river about 100 m northwest of the main components, all of which fell off from the basis. The instrument panel, canopy, engine cowling, TRBs, and so on were scattered around the main

components and were not affected by fire.

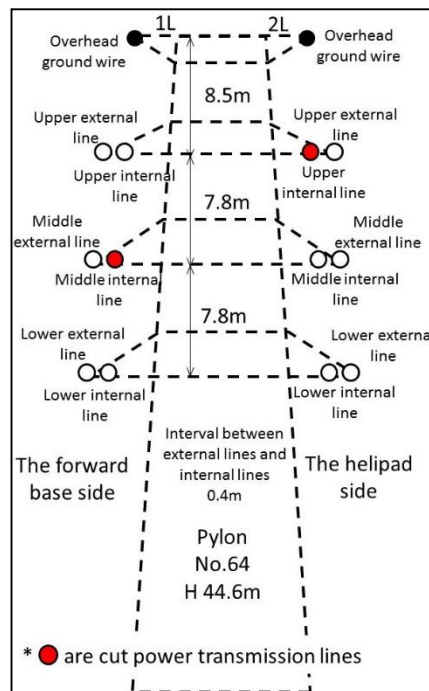
(Figure 4: Situation of power transmission lines)

The power transmission lines stretched between Pylon No.64 and Pylon No.65 in Chubu Electric 275 KV Owase-Ise Line consists of 14 wires which are 12 electric wires and two overhead ground wires*3. The height of Pylon No.64 is 44.6 m from the ground and 263.6 m above sea level. The power transmission line group in the forward base side is referred to as 1L, and the power transmission line group in the Helipad side is referred to as 2L. The overhead ground wire, upper lines, middle lines, and lower lines of electric wires are arranged from the top, and the interval between the external lines and the internal lines is 0.4 m. Regarding the interval between top and bottom of power transmission lines in the pylon, the interval is 8.5 m between the overhead ground wires and between the electric wires on the top, and 7.8 m between other electric wires.

1L middle internal line and 2L upper internal line in power transmission lines broken at the point located about 185 m from Pylon No.64 in the direction towards Pylon No.65 at the height of about 140 m from the forward base (about 240 m above sea level), and other nearby power transmission lines were also damaged.

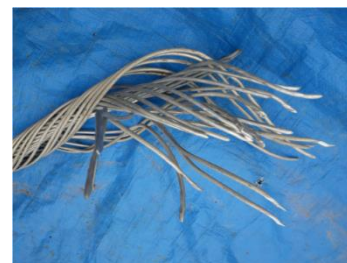
(Photo 3: Fracture surface of an electric wire)

The specification of the electric wire is shown in Figure 5. The fracture surface of ruptured electric wire is as Photo 3. The lay was untwisted in the fracture surface of the electric wire and wires were tangled. The fracture surface of external layer became thinner in the end and sharp like the edge of a chisel, and the fracture surface of steel core became slightly thinner in the end, both of which show the sign of ductile tensile fracture.

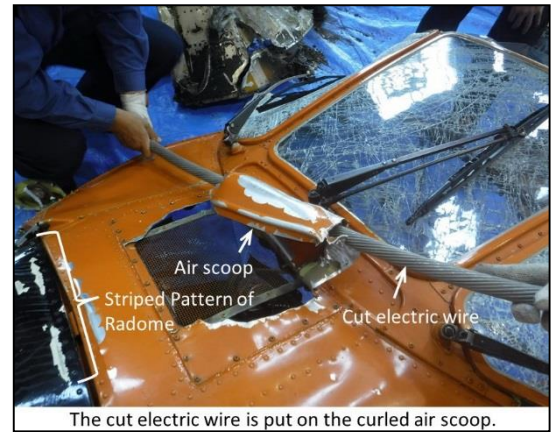
(Photo 4: Upper part of canopy)

The upper surface of a radome in the nose had striped scratch marks, an air scoop in the forward upper side of the canopy (a structure covering around the cockpit) curled to the basis of the central wiper, the upper part of the canopy from there was almost undamaged, and the whole wind shield was cracked. The canopy fell off from the body in the rear of the pilot seat. The cargo mirror, receiver of meteorological radar, battery, instrumental panel, and other parts, which were equipped in the nose, fell off but were not affected by fire. The cowlings in the upper part of the body fell off, had scratch marks in the upper surface, and was not affected by fire, though aluminum wires were stuck in its part. The left sponson (the cover of main landing gear) and tail hatch (a door in the rear of the body) fell off and were not affected by fire.

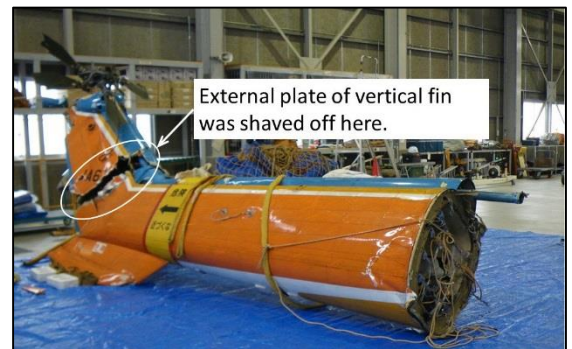
(Photo 5: TB)

TB fell off from the connection part with the body. Regarding the ruptured part of TB, the right rivets were all ruptured from the basis and the left was ruptured so as to be compressed. Tail rotor drive shaft consisting of seven stages was ruptured in the flexible coupling of connection part between the third stage and the fourth stage. In the right lower part of the vertical fin, an external plate of 14 to 40 cm in width was shaved off from the lower rear to the upper front. The tail rotor of the Helicopter is pusher type which rotates anticlockwise when viewed from the right. The five TRBs were all ruptured in the almost middle.

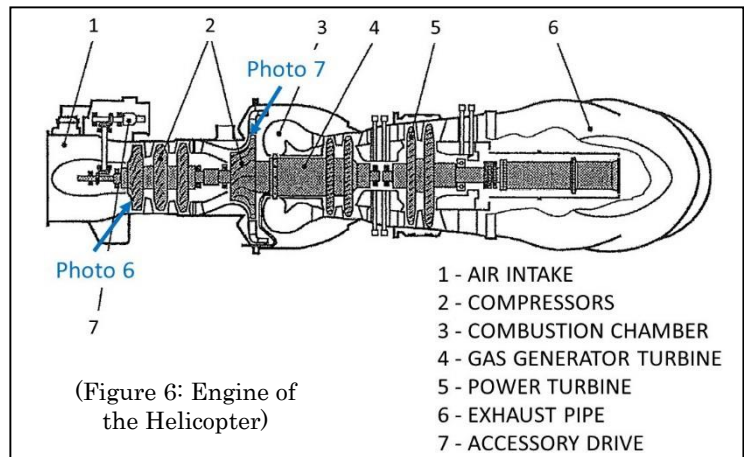
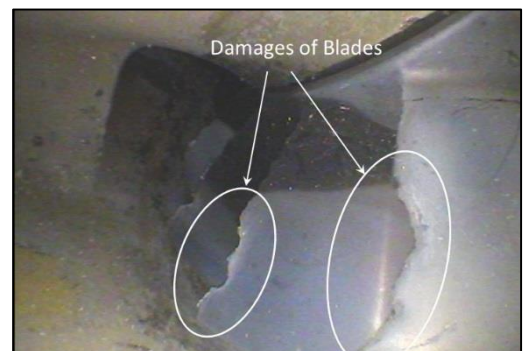
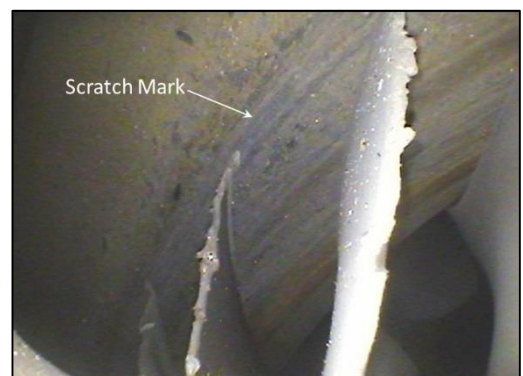
Although it was inspected from the compressor side whether or not the engines can be rotated by hand, both of the engines could not be rotated by hand. When the inside of the engine was observed with borescope, the leading edge of blades in the first stage of the axial compressor were damaged and the inner surface of casing of the centrifugal compressor had scratch marks by impellers in both engines.

Based on the internal damages of both engines described in 2.12.1, it is highly probable that the compressor had been rotating when the Helicopter crashed and external forces were exerted on the engines. Besides, the indication of the pitch indicator described in 2.12.2 corresponds to the value of collective pitch for the climbing Helicopter.

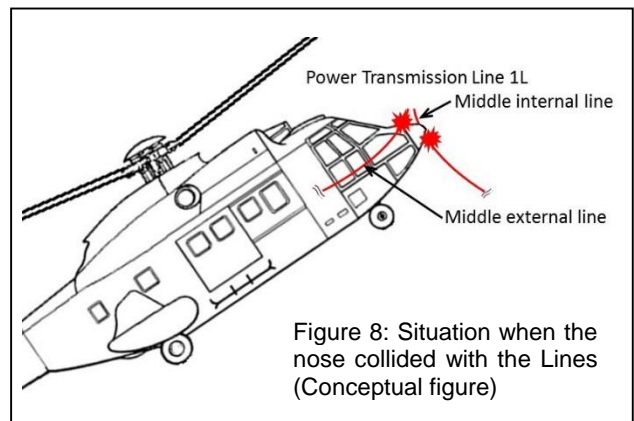
Based on the damages of the power transmission lines and the Helicopter's body described in 2.9.2 and 2.9.3(2), it is somewhat likely that the nose was put between 1L middle external line and middle internal line in the attitude where the Helicopter was nosed up higher than the ordinary climbing attitude with little tilting to the right or left. That time, the Helicopter had sufficient speed for moving forward and climbing; therefore, it is highly probable that it flew to 2L upper internal lines with inertia while canopy, equipment parts of the nose, the cowling in the upper part of the fuselage and so on fell off, during which the whole of the Helicopter collided with the power transmission lines.

Based on the wreckage scattering of the Helicopter, the damages of the power transmission line, and the damages and discoloration part of MRB described in 2.9.1, 2.9.2, 2.9.3(1), and 2.12.3, it is highly probable that each MRB of the Helicopter mainly hit the power transmission lines several times to cut or damage them, while each MRB itself was ruptured and scattered from the basis. Based on the description of 2.9.3(3), it is highly probable that the strength limit of TB was exceeded

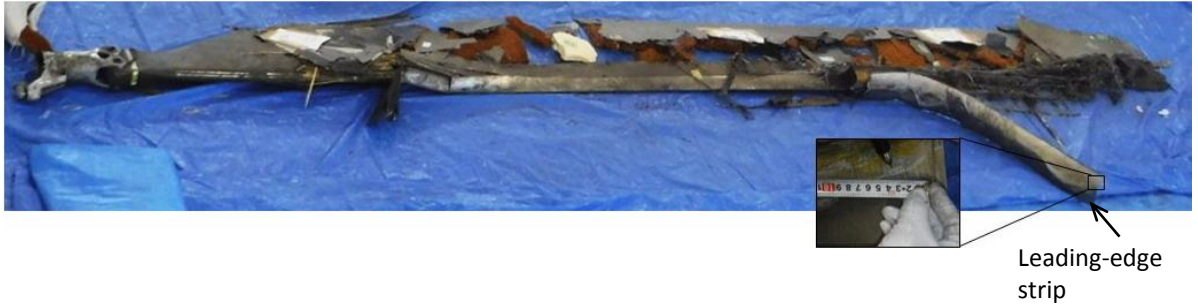
MRB Yellow

All MRBs fell off from the basis and were damaged. The parts of a blade tip fairing and a leading-edge strip fell off. The leading-edge strip, and so on had dents, deformation, scratched marks, cracks, discoloration part of black, white and orange, and a small quantity of the fouling like rust. The traces of perforation, dissolution, or arc discharge of black discoloration were found in the joint, and so on of the part of the leading-edge strip.

The discoloration part of white, black and orange, and the fouling like rust, which were attached in the leading-edge strip of MRB Yellow, were observed by energy dispersive X-ray spectrometry. Aluminum was mainly detected from the discoloration part of white. Aluminum and oxygen were detected from the discoloration part of black. Lead, silicon, carbon, and chromium were detected from the discoloration part of orange. Iron, oxygen, and carbon were mainly detected from the fouling like rust.
