**AIRCRAFT SERIOUS INCIDENT
INVESTIGATION REPORT**

**Shin Nihon Helicopter Co., Ltd.
J A 6 7 4 1**

DROPPING OF OBJECT

DURING EXTERNAL CARGO SLING OPERATION

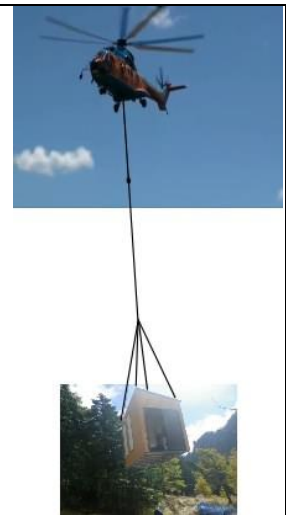
Photo 2.1 Sling Transport Operation (composite image)

In this sling transport operation of the hut, the company staff members connected the 16 m long sling-rope fixed to the Rotorcraft with four ropes extended from the clasps mounted on the four corners of the hut's roof (see Photo 2.1).

Although there were no securing ropes and protective nets around the outer package of the hut, the company judged that it was sufficient enough for safety to be secured to lock all the doors and windows by the Captain, the mechanic and other ground staff.

In this case, if the company secured the hut using securing ropes and protective nets and others, it is highly probable that it could have prevented the door from dropping.

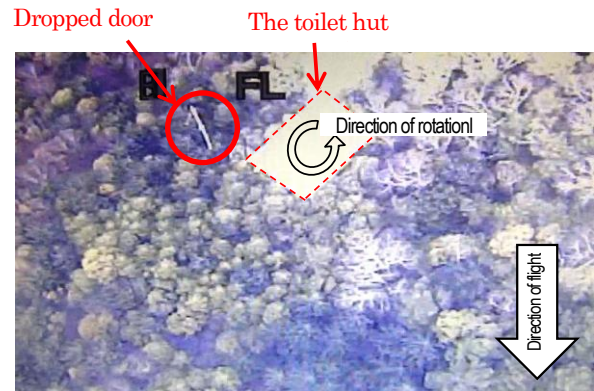
Photo 2.8 (2) Scene where the door fell

The video footage of the surveillance camera revealed dropping of a

piece of the door (see Photo 2.8 (2)). Since the hut was slung and transported in the air, it was rotating in a counterclockwise direction viewed from above when the Rotorcraft flew over the forest. At a point, the door was forced open when it rotated and the door faced to the opposite side of the direction of flight. After a while, it was once made closed though, when it rotated and the door faced to the perpendicular side of the direction of flight, the door was forced sharply reopen. As the result of this, it violently struck the sidewall of the hut and got separately broken and dropped on the ground.

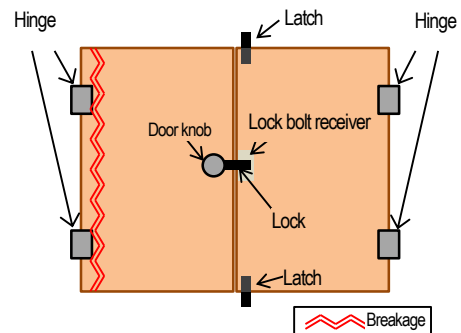
Fig. 2.8 (3) Fixed Condition and Damage of the Door

Air pressure durability of the double swing doors was based on JIS standards and was not designed to be destructive against wind of around 36 m/s (approximately 70 kt).

The left-side door of the double swing doors, which had the door-knob, was fixed at three points: two hinges and a lock bolt, while the right-side one was fixed at four points: two hinges and two latches at the top and bottom of it.

Regarding the right hut, the mounting portion of the left-side one of the double swing doors got separately broken. The lock bolt receiver on the right-side door got deformed by the stress of the lock bolt.

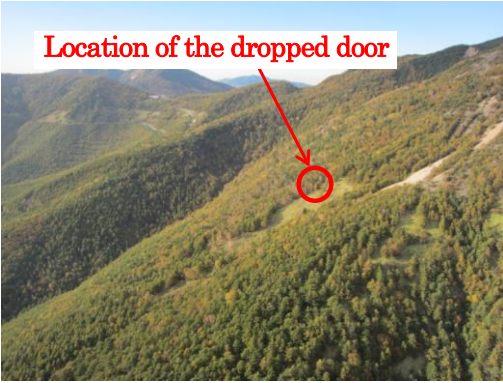
Photo 2.8 (5) Location of the dropped door

<p>After reviewing the footage of the surveillance camera, the company could identify the estimated location of the dropped door. Then, they successfully found some parts of the broken door in the trees. In the surrounding area of that location, no specific damage was observed, caused by dropping of these parts, . The location where some parts of the door had dropped was the spot of N 36 °23 "40 ', E 138 °28 "47 '.</p> <p>(6) Flight route of the sling transport operation</p> <p>In normal cases, operators engage in sling transport operation make a point of arranging flight routes which do not cause safety issues to persons and objects on the ground.</p> <p>The Rotorcraft flew following the company’s operational standards, along the line with a company’s predetermined flight route which was arranged in the light of safety issues to persons and objects on the ground the sling operation might cause.</p>

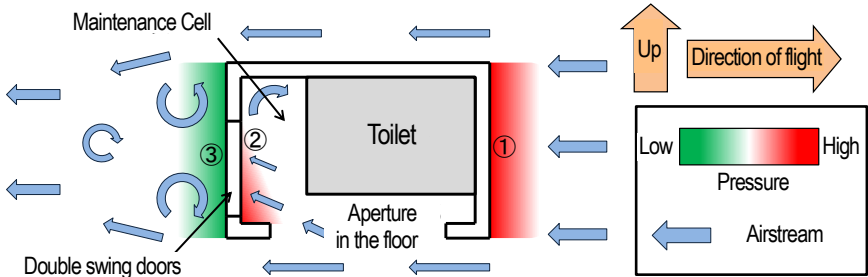
Fig. 3.5 (2) Flow of airstream and distribution of pressure (image view of cross section by A-A in Fig. 2.8 (1))

faced to the opposite side of the direction of flight was as shown in Fig. 3.5(2).

It is probable that since the lower parts of surface ① and surface ② were subject to air pressure in parallel with airspeed. Regarding surface ③, since it was faced to the opposite side of the direction of the flight and corresponded to separation region accompanied by slipstream vortex, it is probable that surface ③ was in negative pressure region. It is probable that, under these circumstances, the air pressure applied to the door exceeded the design strength (air pressure durability) and caused the lock bolt receiver to get deformed and then the door was forced open.

It is highly probable that, since the door was remained open while the hut rotatng, when the door turned to face toward airstream, it violently struck the sidewall and the door's mounting portion got separately broken and it dropped.

Since the effect of airstream and air pressure associated with the flight could be alleviated by reducing airspeed, it is highly probable that the flying at lower airspeed could decrease the possibility of dropping of the door.
