**AIRCRAFT ACCIDENT
INVESTIGATION REPORT**

**CHUBU REGIONAL BUREAU, MINISTRY OF LAND,
INFRASTRUCTURE, TRANSPORT AND TOURISM
(OPERATED BY CONTRACTED NAKANIHON AIR SERVICE)**

J A 6 8 1 7

HARD LANDING
CHUBU REGIONAL BUREAU, MINISTRY OF LAND,
INFRASTRUCTURE, TRANSPORT AND TOURISM
(OPERATED BY CONTRACTED NAKANIHON AIR SERVICE)
BELL 412EP (ROTORCRAFT), JA6817
UPSTREAM OF NAGASHIMA DAM TEMPORARY HELIPAD
KAWANEHON-CHO, HAIBARA-GUN, SHIZUOKA PREFECTURE,
JAPAN
12:54 JST, JUNE 29, 2012

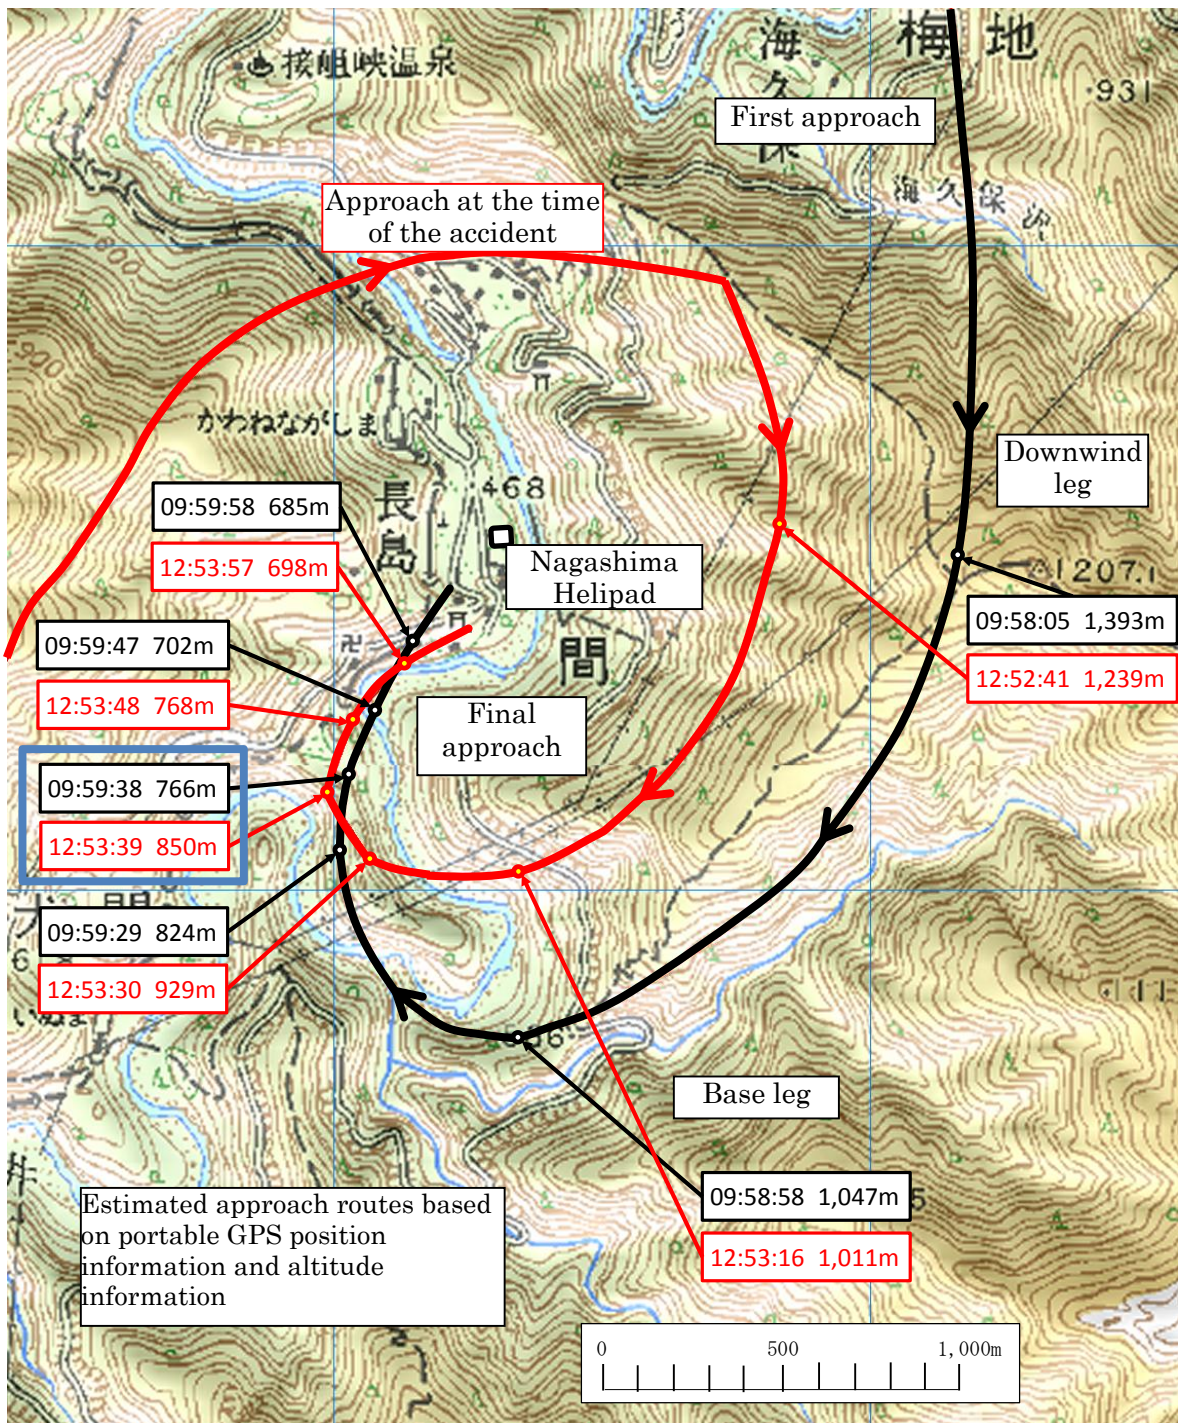
Diagram 1: Comparison with the Approach Route of the first Landing and the Approach Route at the Time of the Accident

According to these pieces of information, the Pilot took a relatively wide traffic pattern traveling along the river in the valley for the first approach, which was his first time to land there, descending in stages during the base leg. In comparison, at the time of the accident, he flew along a ridge where high-voltage lines were located, using a narrower traffic pattern and descending during the base leg in a shallower manner than in the first approach. Therefore, at 12:53:39, near the area where the Pilot transitioned to his final approach, the Helicopter was at about the same position as during the first landing but 84 meters (about 275 ft) higher in altitude.

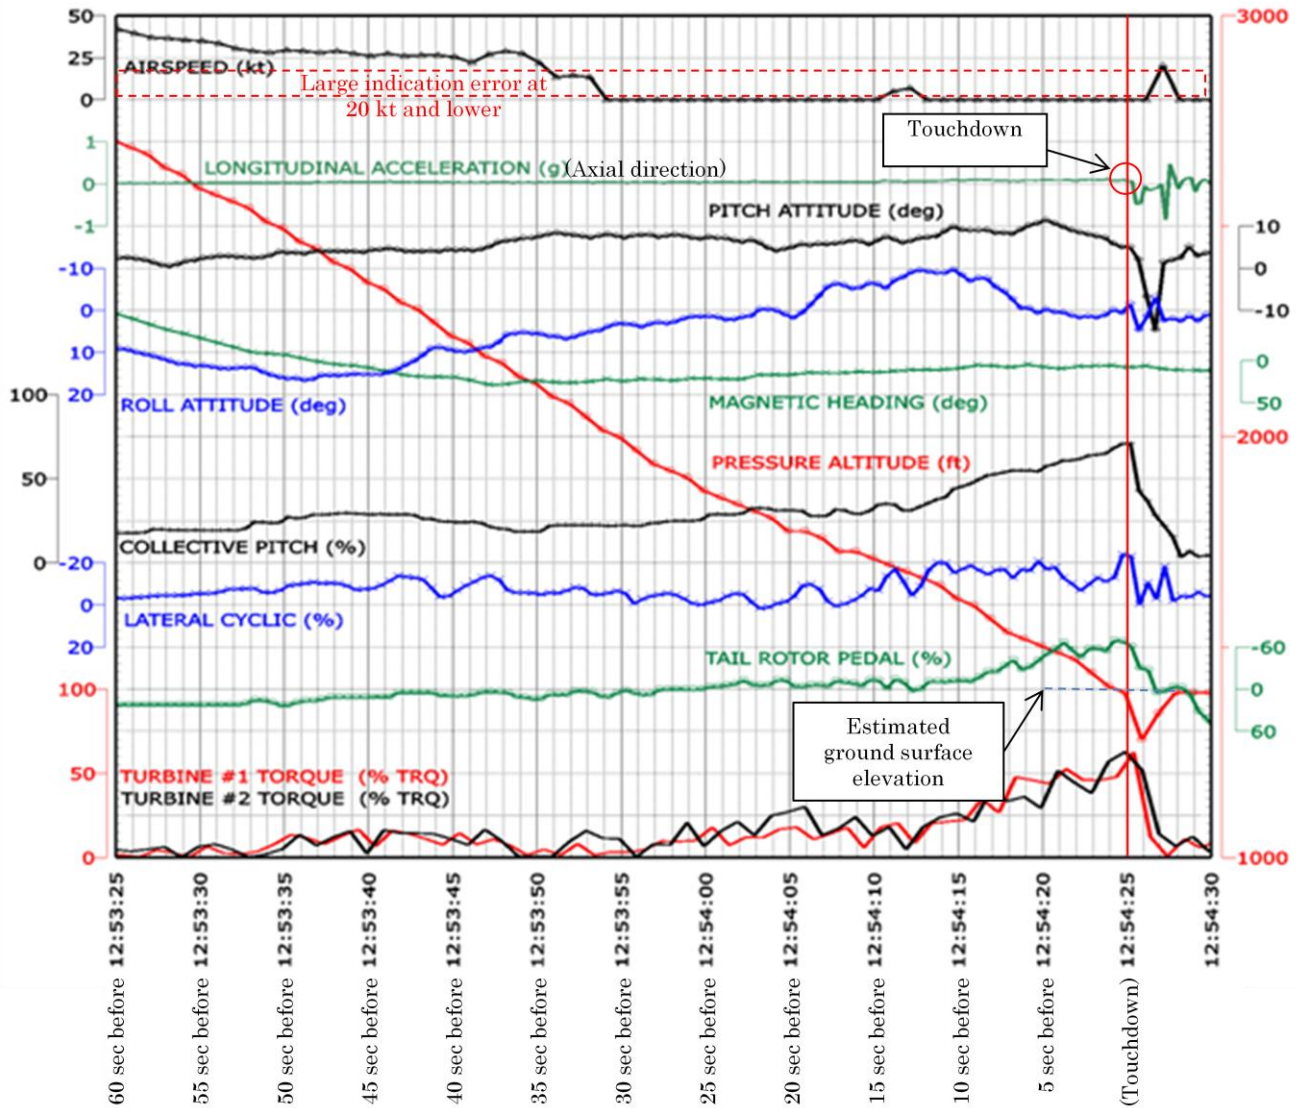
Diagram 2: DFDR Data at the Time of Accident

At the time of the accident, in the latter half of the base leg 50 seconds before touchdown (The touchdown on Diagram 2 where sudden change in longitudinal acceleration is observed.), the Helicopter was in a low-power output state, with a CP position of about 26%, TQ1 of 11%, and TQ2 of 6%. From 15 seconds before touchdown, when the Helicopter was on a nearly straight-line route in its final approach, the CP position was 34% and had started to increase to 45% at 10 seconds before touchdown and to 56% at five seconds before touchdown, nearly reaching the maximum position it had attained during the first landing, with an accompanying increase in engine torque. Moreover, after this, two seconds before touchdown (the point at which the Pilot exclaimed “Ah...”), the CP position was 64%, and at the time of touchdown it was 71% and was still increasing when the Helicopter made contact with the ground.

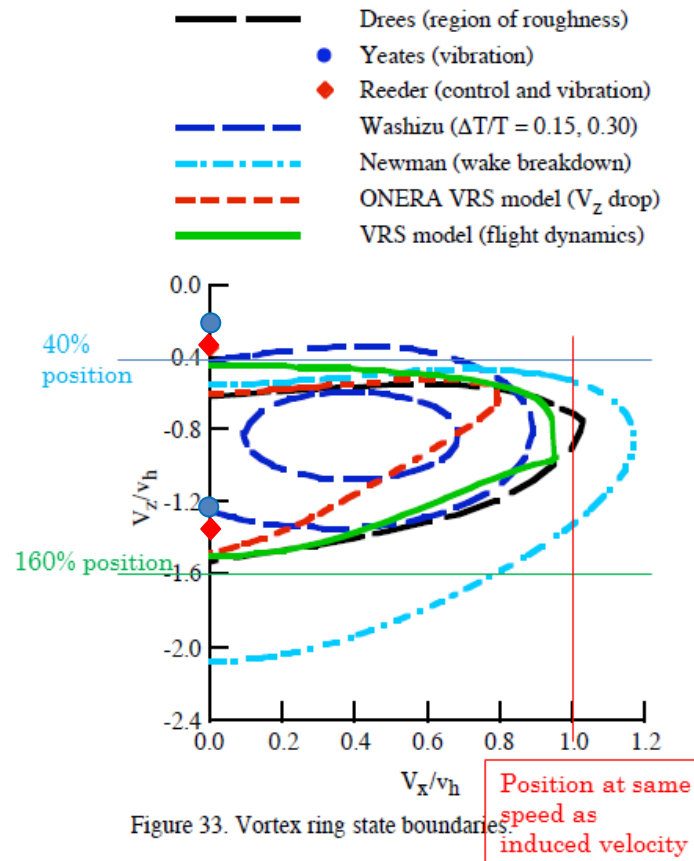
Summarizing the individual models shown in the VRS Boundaries diagram of 2.9.3 b., as shown in Diagram 5, roughly speaking, when the forward airspeed is the same as or lower than the induced velocity, a helicopter will enter the VRS boundaries when the descent rate approaches 40% of the induced velocity. The center of the VRS boundaries will be located on the area from 60% to around 100%. Also, it is probable that a helicopter will exit the VRS boundaries when the descent rate reaches or exceeds roughly 160% of the induced velocity.

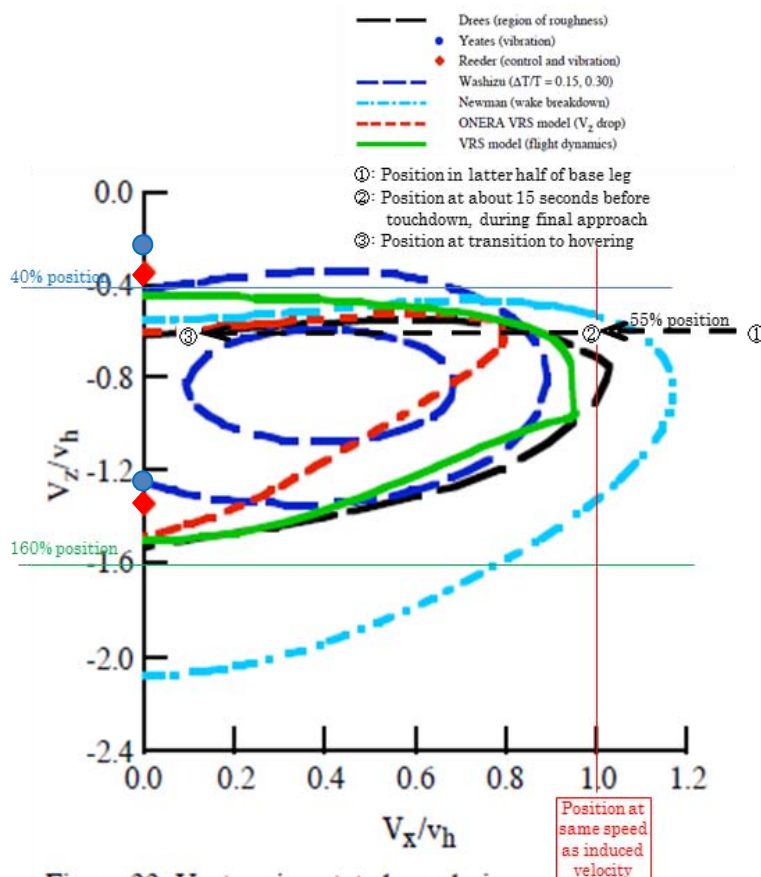
their ratios with the induced velocities become about -0.55 and about 0.96 respectively, which are near the entry point of the VRS boundaries as indicated by ② in Diagram 6.

Also, as described in 2.9.2 b., at five seconds before touchdown when the Pilot had raised the engine power output to hovering output, the descent rate was about 1,320 ft/min and the forward airspeed was about 2 kt. Therefore, the ratios of these with the induced velocity become about -0.56 and about 0.09 respectively, which are indicated by the position ③ in Diagram 6.

After the Helicopter's flight at conditions outside of the VRS boundaries during the latter half of its base leg as indicated by ① in Diagram 6, it is probable that along with the decrease in speed it experienced when entering its final approach, the descent rate indicated by ② began to approach 55% of the induced velocity, entering into the VRS boundaries.

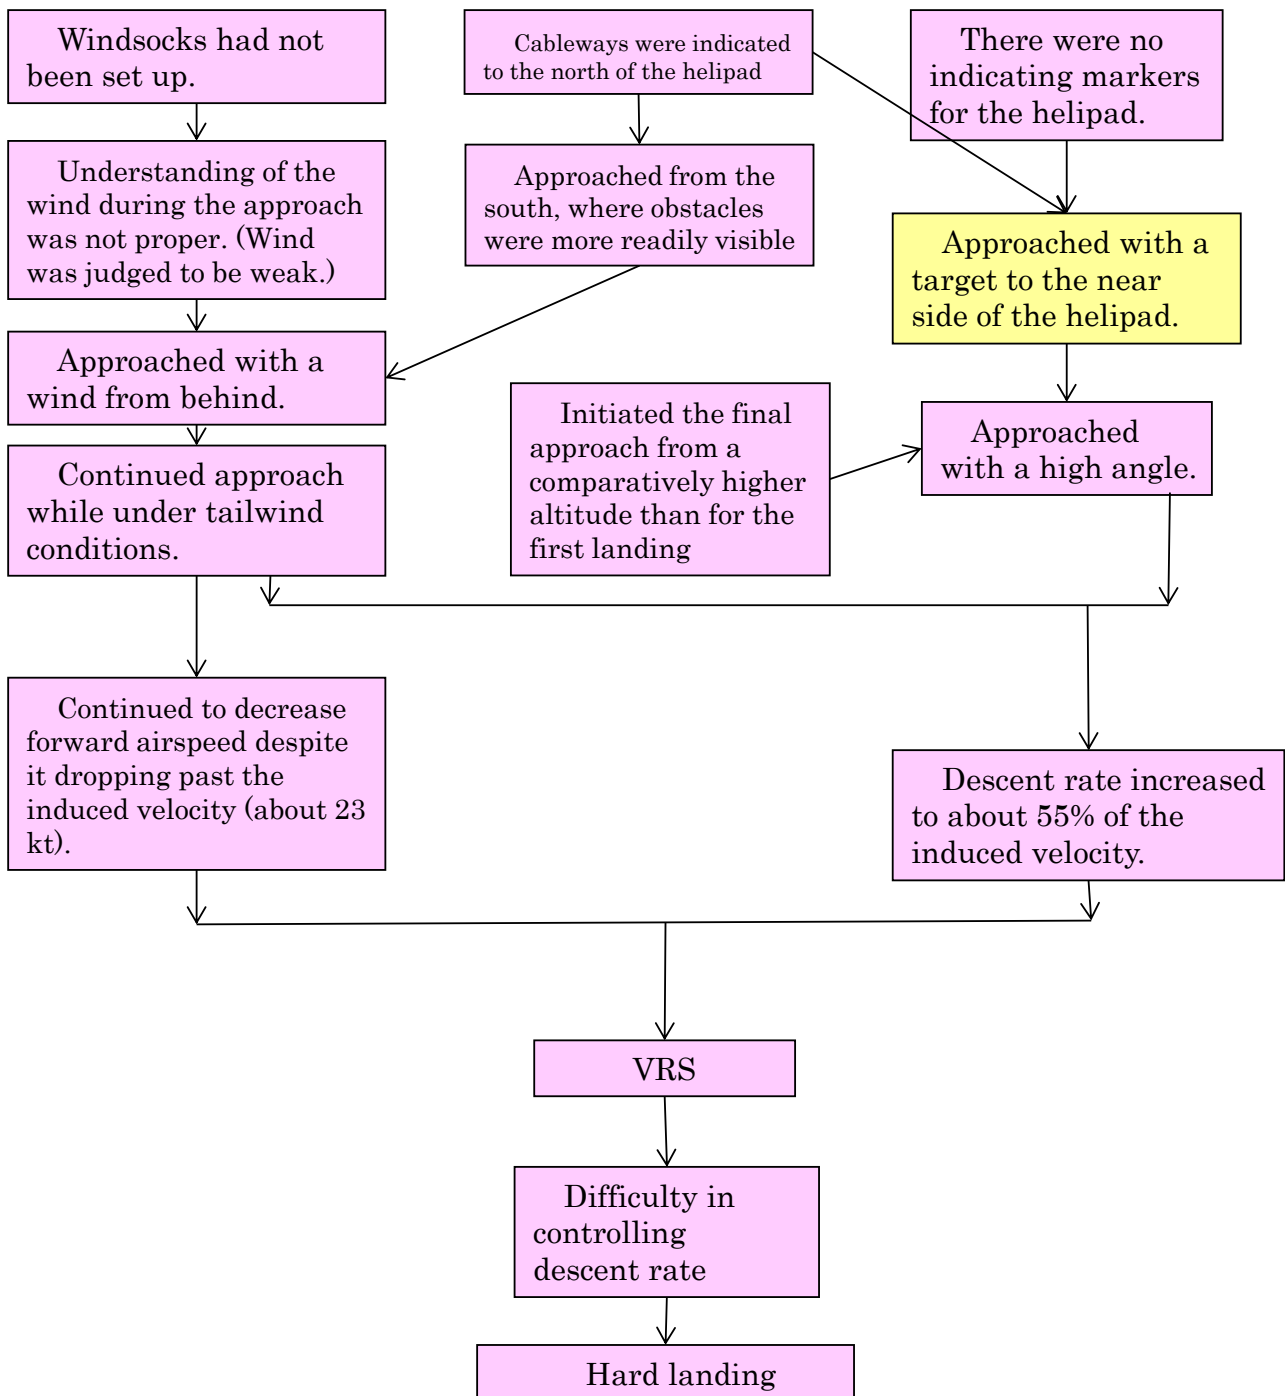
Figure 4: Chain of Probable Causes of the Accident

When there is a wind from behind, the ground speed increases due to the tailwind conditions, and it becomes necessary to reduce forward airspeed in order to maintain the approach angle. As described in 3.5.3 b., it is probable that when transitioning to a hovering state, the Helicopter's forward airspeed, which was about 30 kt in the latter half of the base leg, dropped to about 2 kt, a state with almost no forward airspeed at all. It is probable that this was because the Helicopter was attempting to land on steep approach path under tailwind conditions. As a result, it is probable that while experiencing a high descent rate of about 55% of the induced velocity, the Helicopter's forward airspeed continued to decrease even further despite dropping past the induced velocity, causing the occurrence of VRS.

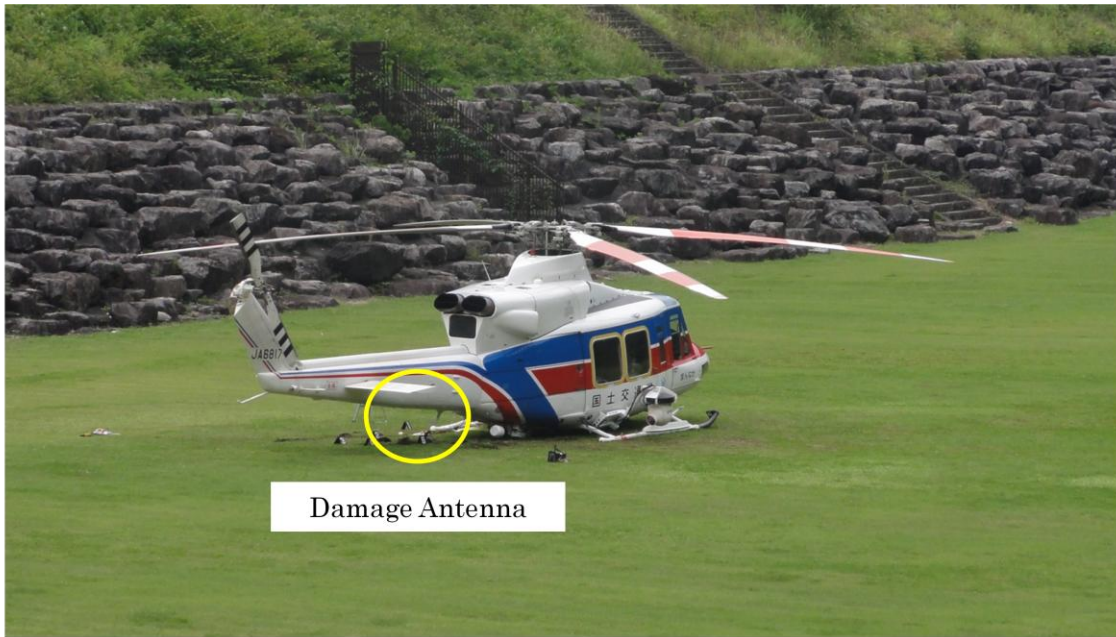
- a. Fuselage: The cockpit floor and the floor under the fuel tank were partially damaged. The antenna mounting surface of the underside of the fuselage was deformed and damaged. The infrared camera mount was damaged.
- b. Landing Gear: The cross tube was deformed outward, and the width of the left and right skids was enlarged by about 40 centimeters.
- c. Equipment: The infrared camera was dropped, the external speaker was damaged, and the antenna equipment was damaged.

Damage Antenna

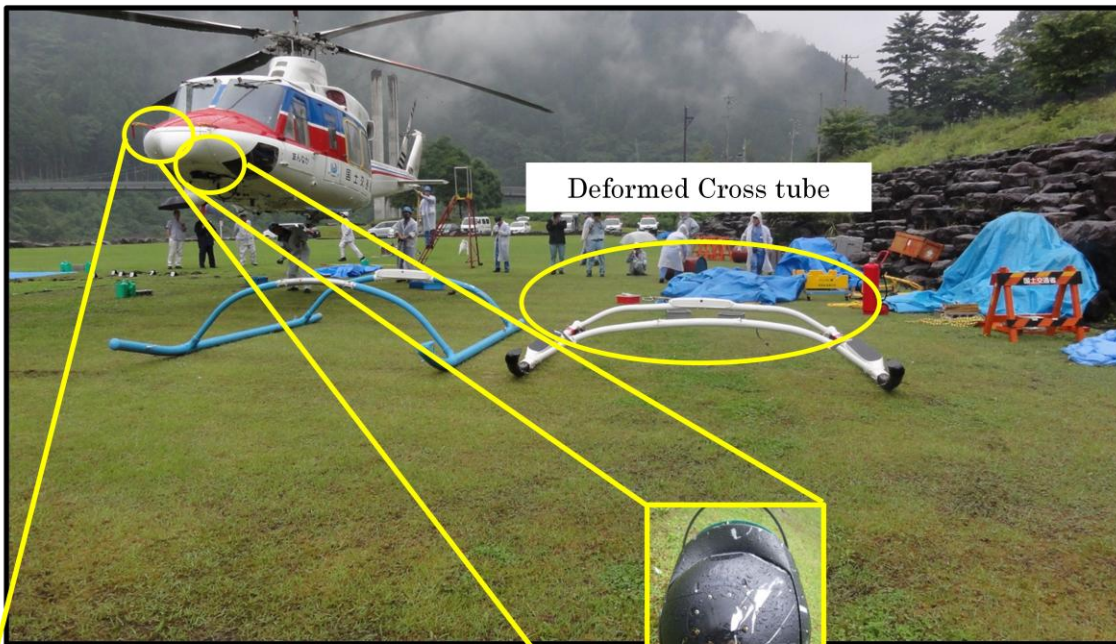
Deformed Cross tube

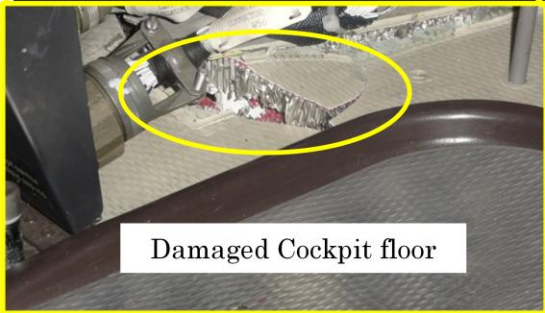
Damaged Cockpit floor
