**AIRCRAFT ACCIDENT  
INVESTIGATION REPORT**

**JAPAN COAST GUARD**

**J A 6 9 0 3**

**SIKORSKY S-76C (rotorcraft), JA6903**

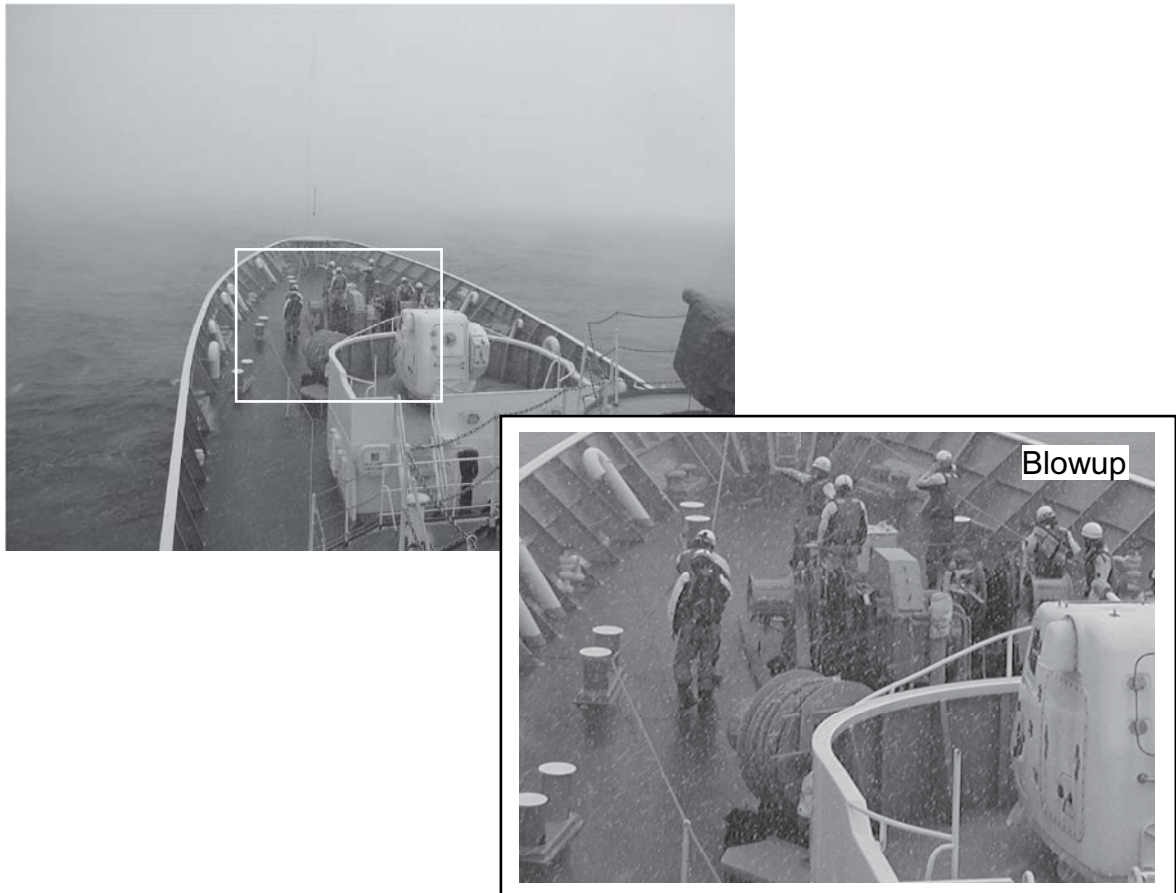
Picture 2 Snowfall

Wind about 250°15kt, snow with rain, OAT 0° to 1°C

At the time of the accident it was snowing with rain and the temperature was 1°C and humidity was 86% (equivalent to dew point -1°C). It was 1° away from freezing point, and as the picture 2 shows moisture existed in the air. Given the trigger of reduced temperature it is considered that the icing might occurred.

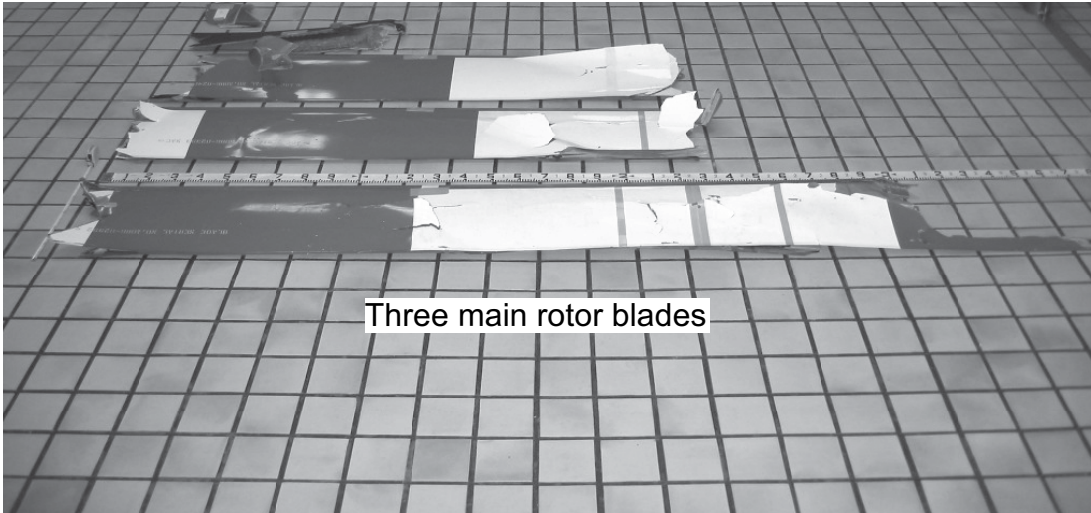
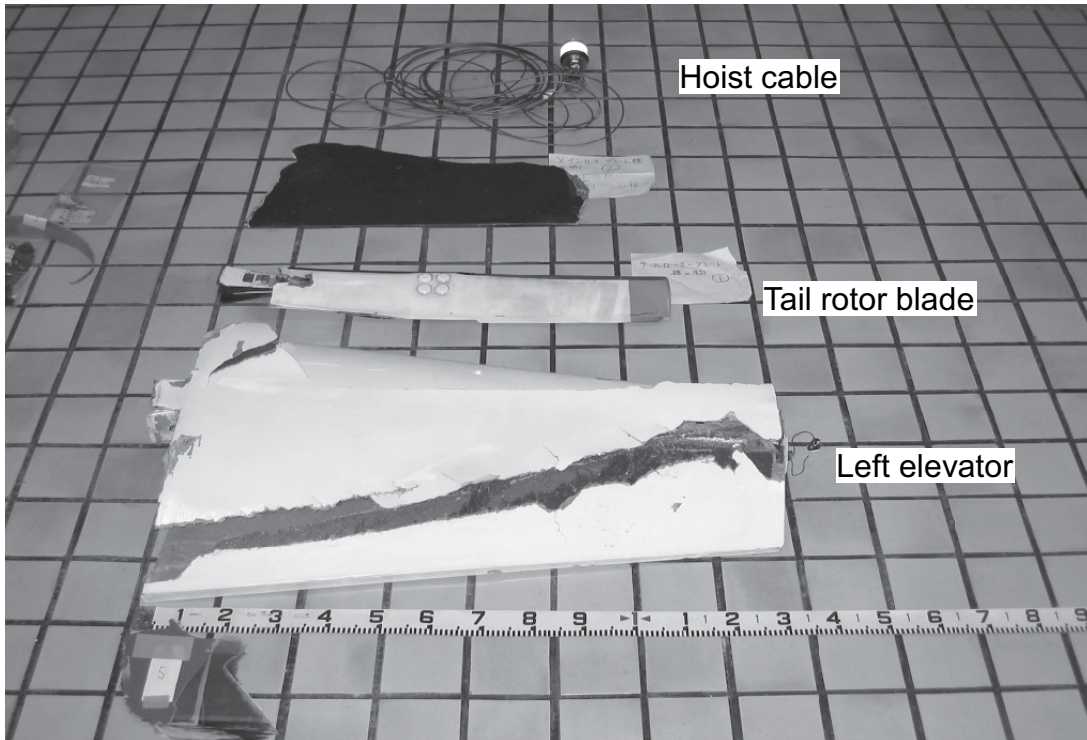
Picture 4 Recovered debris

(1) Three severed main rotor blades (MRBs) and an elevator were recovered from the sea surface. It was obvious that three MRBs were severed by the impact into the sea upon landing. The MRB measured span-wise about 2.3m, 2.5m and 3.5m respectively. They were all severed about one meter away from each main rotor hub.

Left elevator was severed at the root and it had a big span-wise crack.

(2) One tail rotor blade was recovered on the bow deck of the ship. It was obvious it was severed due to the aircraft's contact with the bow of the ship. The outer blade end was rounded and the paint was scratched off.

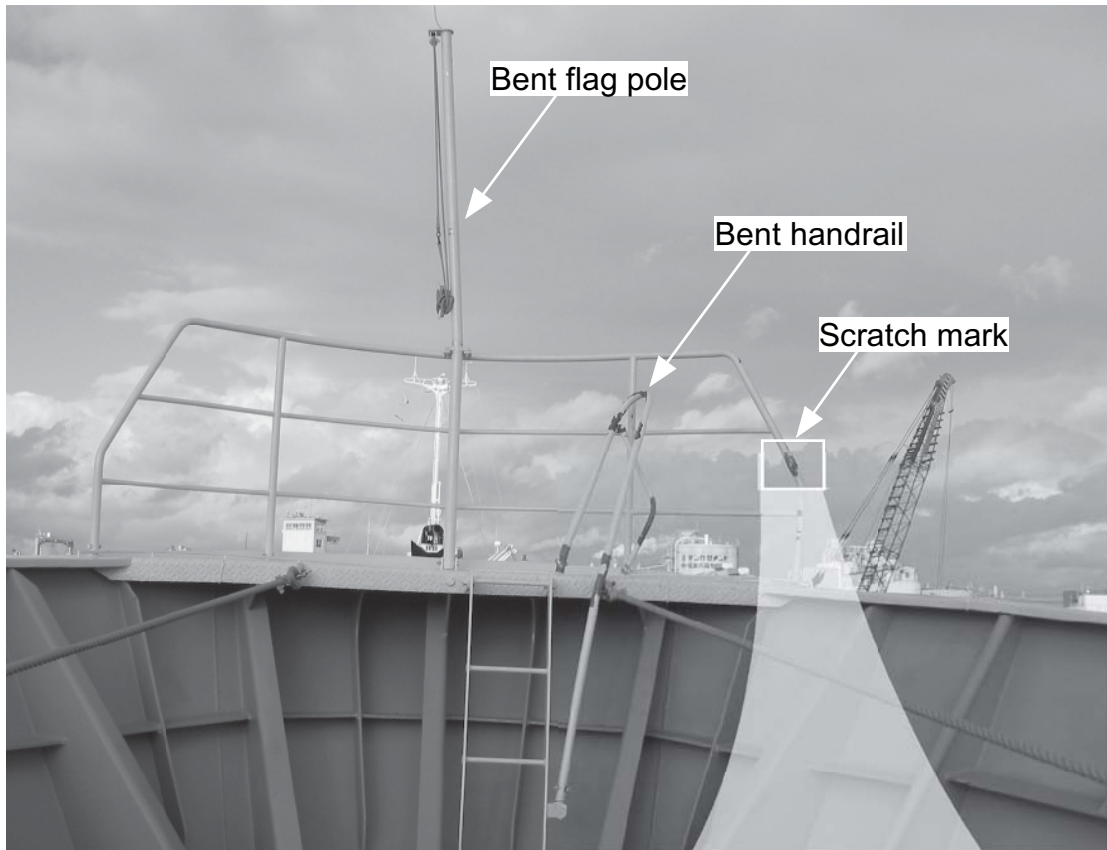
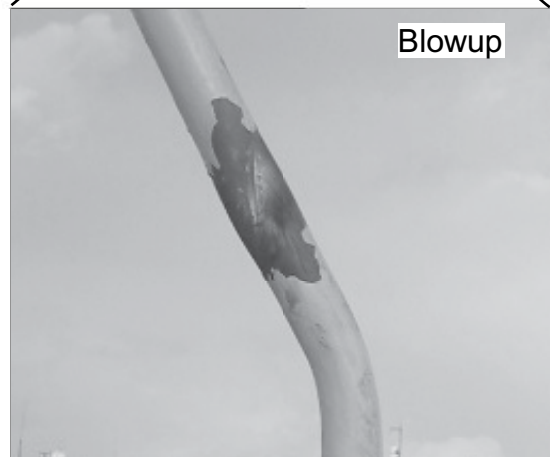
Picture 5 Damages left on the ship

(1) The ship's flag post in the bow was bent to port at the attachment point to the handrail on the bulwark.

(2) The vertical handrail beside the ladder under the flag post was bent to starboard at its base with three scratches at its top and two scratches at the height of bulwark.

(3) Part of paint on the handrail was scratched off and it was dented to the depth of about 5mm. The shape of the dent formed an arc, and it was estimated to be dented by a high velocity rotating object.

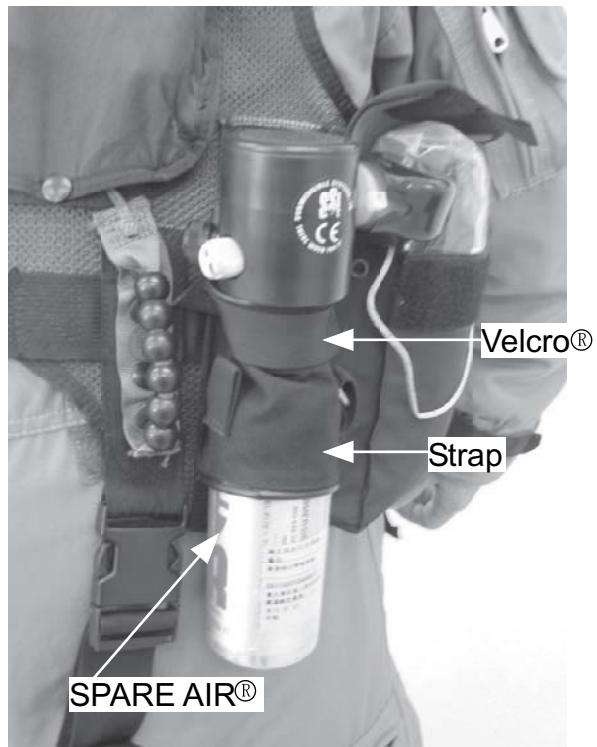
Picture 6 SPARE AIR®

Because I had a ditching training, I didn't feel scared when the water rushed in after landing. I knew the difficulty of removing the oxygen bottle from the life vest.

I'm not equipped with a SPARE AIR®.

Modifications for quick removal of the SPARE AIR® were made to life vests and they were distributed to each air base.

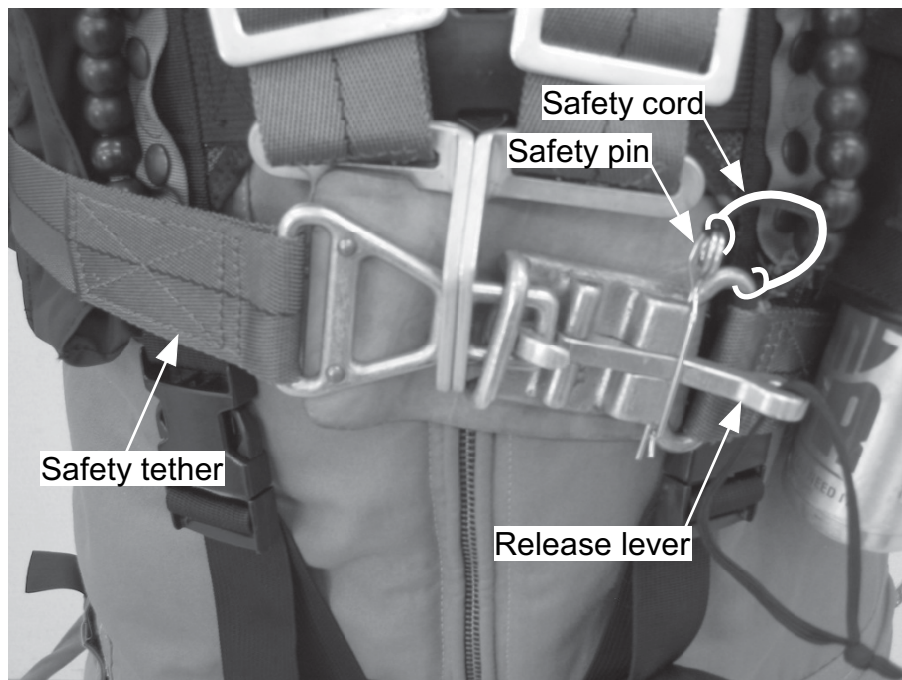
Picture 7 Buckle, Safety tether

In order to be released from the aircraft, cabin occupants have to undo the harnesses or do something to the tether. For the former, (a) the occupant has to unbuckle the belt or (b) loosen shoulder harnesses and belt and undo the harness. For the latter, the occupants have to (c) cut the tether with a knife or something or (d) unlock the anchor from the cabin fitting.

Option (a) requires quick and sure release of the safety pin. Option (b) requires loosening of three points and undoing the harness. Option (c) raises an issue of safe utilization of sharp knives under confusion by all occupants at the same time. Option (d) raises question of quick locating one's anchor to the cabin fitting and a released tether may be trapped by some aircraft components during evacuation.

Therefore improvement should be made onto the safety tether to make it possible for a wearer to release himself with gloved hands under emergency situations.
