AIRCRAFT ACCIDENT INVESTIGATION REPORT
INJURY TO A GROUND OPERATOR DURING CARGO SLING
OPERATION

SHIKOKU AIR SERVICE CO., LTD.

BELL 412EP (ROTORCRAFT), JA6977

MIYAKONOJO CITY, MIYAZAKI PREFECTURE

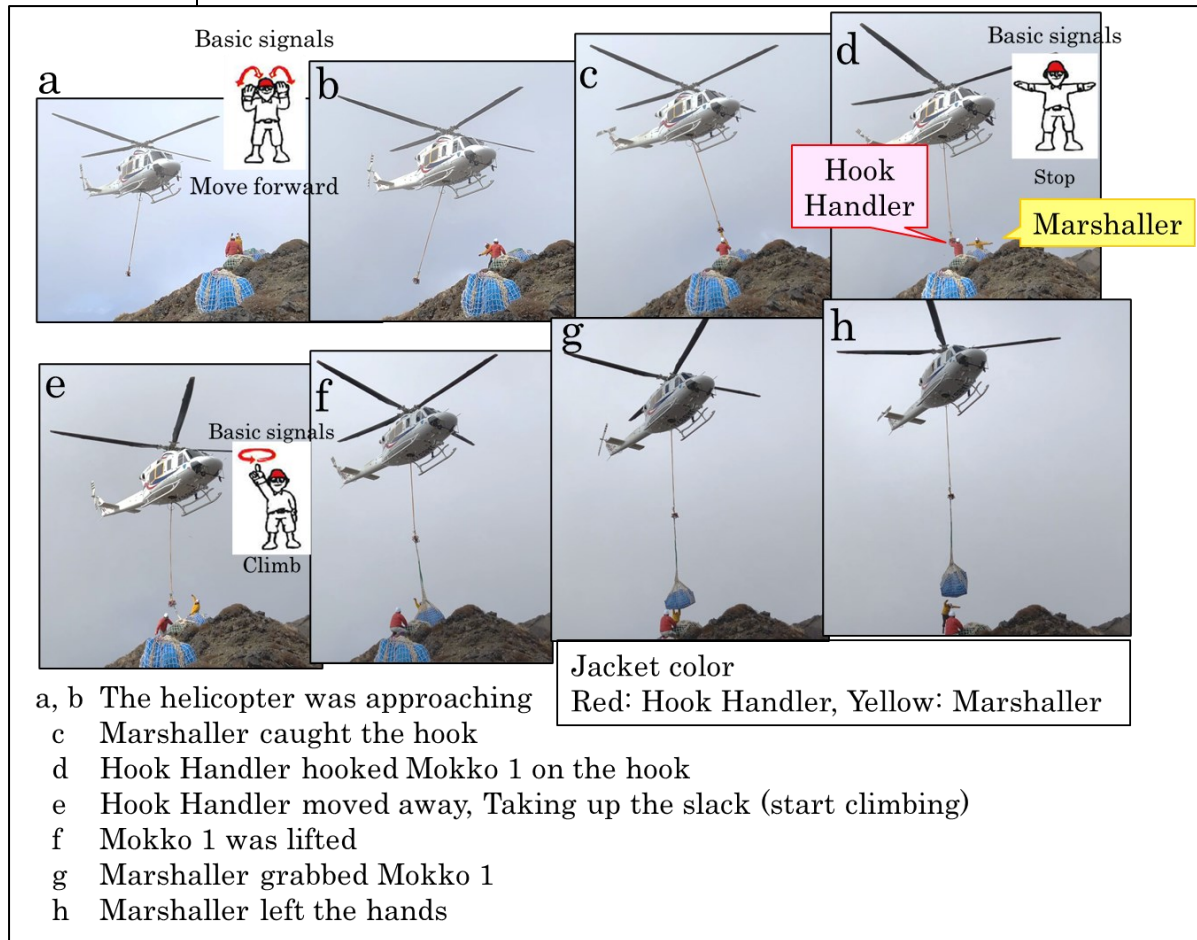
Figure 4: Still Image of Video Recording

According to the video recording (see Figure 4), the Marshaller was sending a “Move forward” signal to the helicopter at the left side of Mokko 1 (Figure 4, a)

The helicopter stopped moving forward slightly behind rather than directly above Mokko 1, however, as the hook was swinging back and forth (Figure 4, b), the Marshaller went to get the hook to its timing of swinging forth (Figure 4, c and Figure 5), and after handing the received hook to the Hook Handler, the Marshaller moved away for safety by taking three or four steps back (moved to ahead of the left side) while sending a “Stop” signal (Figure 4, d and Figure 6).

e and Figure 6). The Marshaller confirmed that Mokko 1 was hooked up and sent a “Climb” signal at the position (Figure 4, e).

When reporting the situation to the captain, saying “Soon tension shall be applied (meaning that the sling wire cables will be taut)”, “The cargo will be lifted” (see Figure 4, f), the onboard operator confirmed that Mokko 1 came close to the Marshaller, and the Marshaller grabbed Mokko 1 by hands but immediately left the hands, and fell (Figure 4, g and h). After that, in the next time when the onboard operator saw the Marshaller, the Marshaller was lying on the mountainside slope. The captain confirmed through the mirror that the Marshaller located in the left side contacted with Mokko 1 to fall and slide down on the slope in face down.

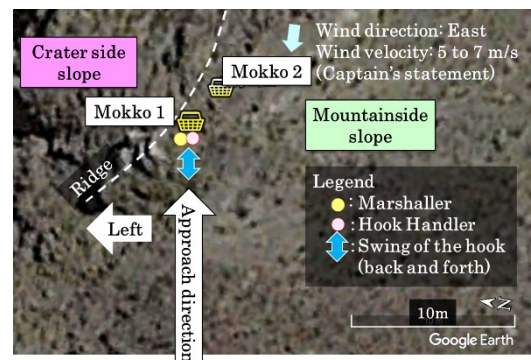
Figure 5: Positions at the time of Catching the Hook (estimated)

Turning around from the right side of Mokko 1 to its left side where the Marshaller was, the Hook Handler received the hook from the Marshaller and hooked it on Mokko 1 and moving again to the right side of Mokko 1 and further moving away for safety to the right side of Mokko 2 about 3 m away (Figure 4,

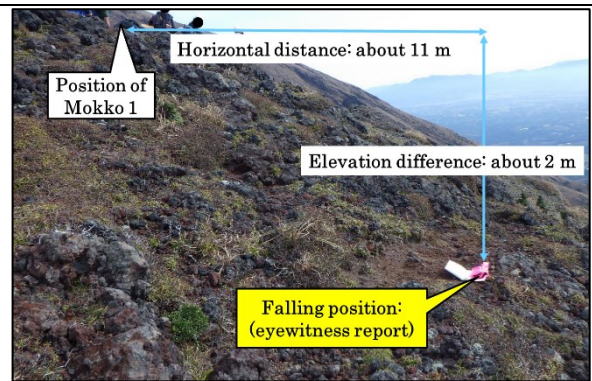
Figure 7: Falling Position of the Marshaller

According to the ground operator who witnessed the Marshaller’s falling, the falling position of the Marshaller was on the mountainside slope about 11

m ahead of the center position of Mokko 1, the elevation was about 2 m lower than the ground surface where Mokko 1 was placed (see Figure 7).

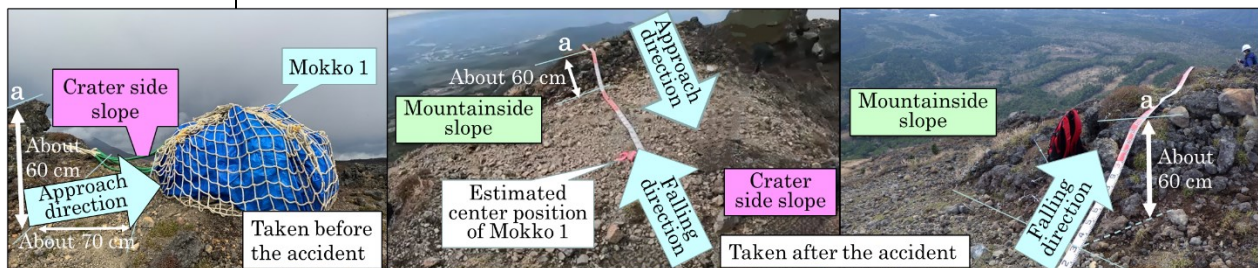
Figure 11: Mokko 1 and its Surrounding Area

The Mokko 1 had been placed selecting relatively plane place of the summit ridge. Around Mokko 1, there was a slope on the crater side from the left to behind and a slope on the mountainside from the right to ahead of it (see Figure 10). In addition, about 70 cmahead of Mokko 1, there was a rock with about a height of 60 cm (“a lofty rock” according to the statement of the Marshaller) (Figure 11 a).

The Marshaller felt that the area around Mokko 1 was narrow and had no room topographically in comparison to the site of other many Heli Cargo Transport the Marshaller had ever experienced.

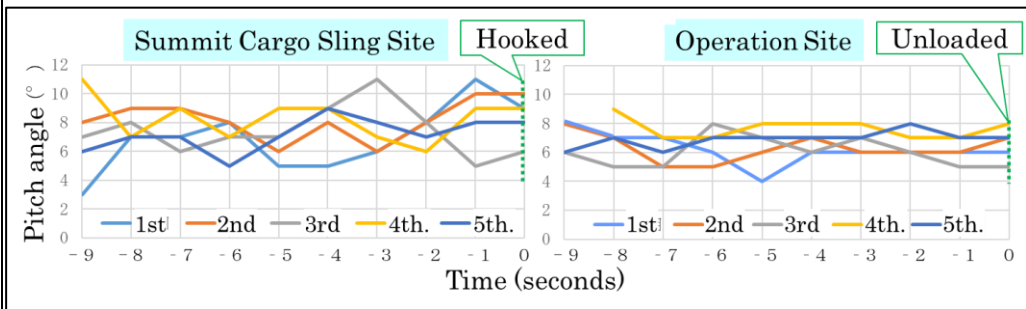
Figure 12: FDR Records
(Comparison of Changes in Pitch Angle at the Time of Hovering)

Based on the records on the FDR, regarding the change in pitch angle at the time of hovering which affects the slung hook and the back-and-forth swing of the Mokko, Figure 12 shows for nine seconds before the hook was slung at the Summit Cargo Sling Site and for about nine seconds before the cargo was unloaded at the Operation Site, respectively, from the first through fifth times separately.

As a general trend, up and down changes in pitch angle at the time of hovering were remarkable at the Summit Cargo Sling Site where the range of change was 8° at the maximum (the 1st: +3° to +11°) and rather large, on the other hand, at the Operation Site, up and down changes in pitch angle were gentle and the range of change was 4° at the maximum (the 1st: +4° to +8°) and rather small.

The JTSB concludes that from the statement of the captain, video recording and the change in pitch angle recorded on the FDR, it is most likely that at the Summit Cargo Sling Site, the helicopter was subject to the wind blowing up from the crater (disturbance), thus its hovering attitude and position were not stable. And this probably created the deviation between the positions of Mokko 1 and the helicopter, which probably contributed to Mokko 1 coming closed to the Marshaller side when Mokko 1 was lifted away from the ground.

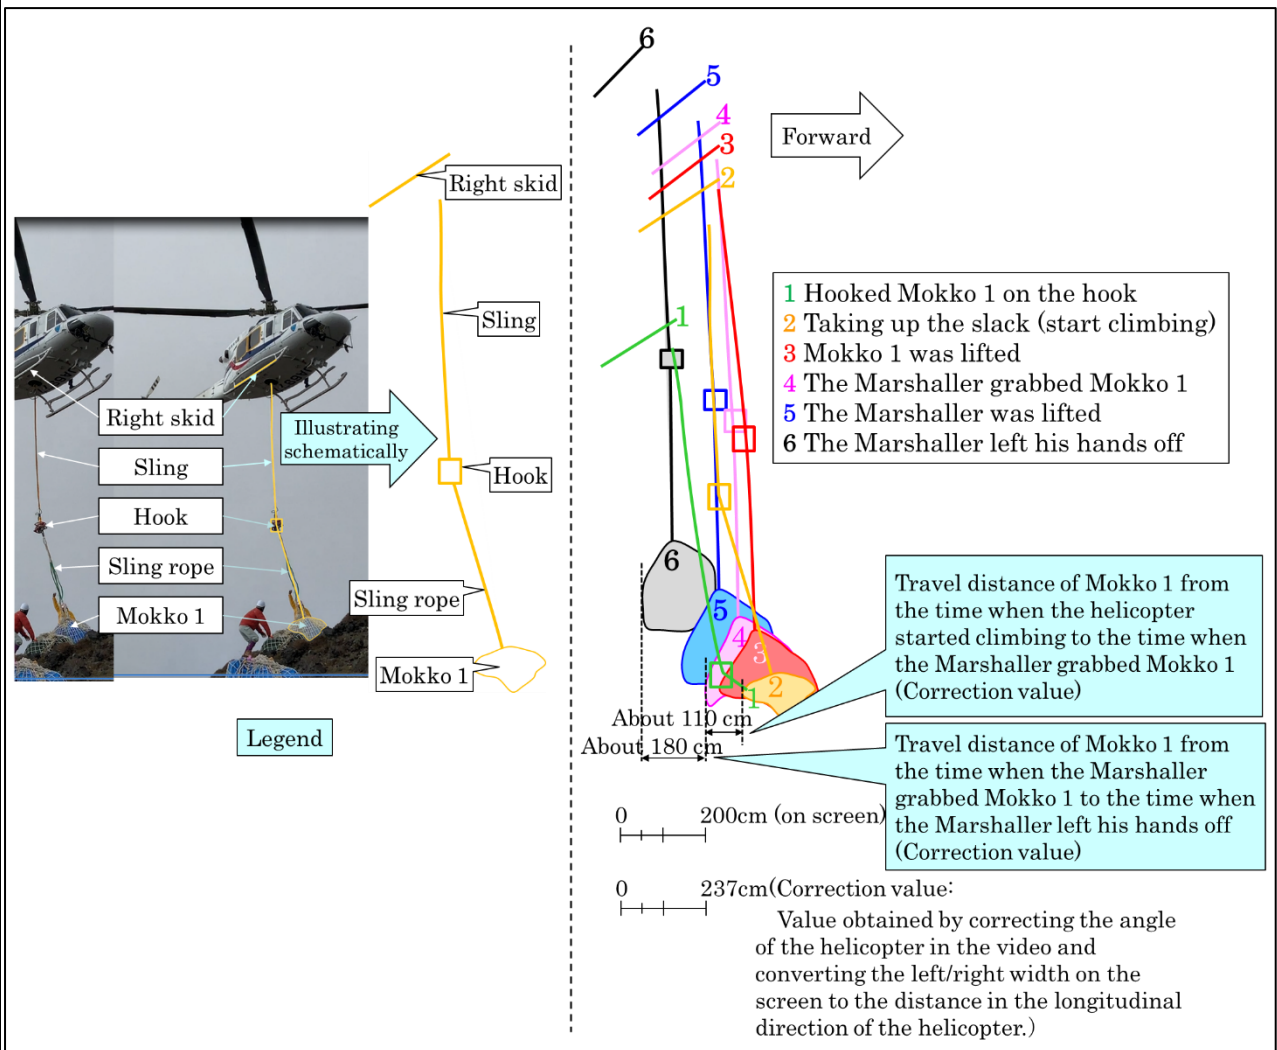
Figure 13: Travel Distance of Mokko 1

When the Hook Handler hooked Mokko 1 on the hook, the helicopter was most likely in the position shown in Figure 13, 1, back to Mokko 1. After that, although the helicopter Moved forward while climbing to Figure 13, 2 from to Figure 13, 1. in order to eliminate the slack, it was highly probable still back to Mokko 1. It is most likely that the helicopter continued to climb, thus Mokko 1 was away from the ground being swung backward at the same time, coming close to the Marshaller (Figure 13, 3).

Unable to avoid the approaching Mokko 1, the Marshaller more likely grabbed Mokko 1 reflexively, and at this time, the position of Mokko 1 was likely about 110 cm backward the position where Mokko 1 had been originally placed (Figure 13, 4).

After that, the Marshaller was lifted along with Mokko 1 (Figure 13, 5), and left the hands from Mokko 1 immediately after that, but Mokko 1 had been probably moved further about 180 cm backward while being lifted (Figure 13, 6). In addition, Mokko 1 was lifted while being swung backward, and the helicopter climbed while moving backward, which possibly caused the Marshaller to fall as if being thrown away further backward from the position when the Marshaller had left the hands. The height to which the helicopter climbed from the time when the Marshaller

grabbed Mokko 1 to the time when the Marshaller left the hands from it, was likely about 1 m because of analysis from the length of sling (about 5 m) and the change in the position of Marshaller's hands (Figure 14). From this, the height the Marshaller had fallen was possibly about 3 m, calculated by adding the difference in altitude of about 2 m to the helicopter's climb of about 1 m, therefore, when landing on the ground, the Marshaller most likely had a strong impact, resulting in sustaining injuries.

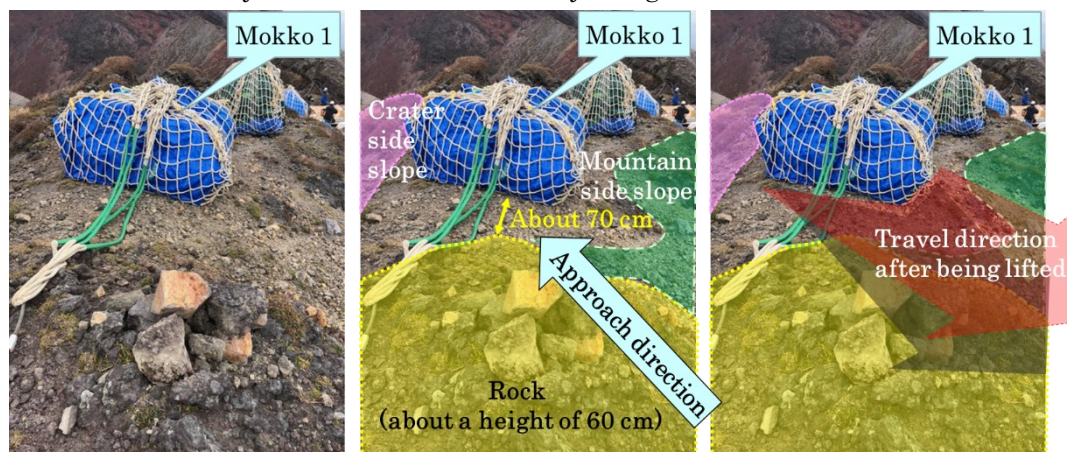
Figure 15: The Position of Refuge near Mokko 1

The left of Figure 15 shows the situation around Mokko 1 before the accident, and when additionally drawn were a rock with about 60 cm height located about 70 cm to the left front of Mokko 1 in yellow, crater side slope in left back in pink and mountainside slope right front in green, it is as shown in the center of Figure 15. Besides, when additionally put the travel direction (opposite to the approach direction), in which Mokko 1 probably moved after being lifted at the accident, in red, it is as shown in the right of Figure 15, showing that the Marshaller was probably unable to secure enough space for refuge in the area on the left side of Mokko 1 where the Marshaller was sending signals. Furthermore, according to the video recording, the Marshaller had only taken three or four steps back before sending a climb signal to the helicopter, thus, the Marshaller was more likely unable to take necessary refuge action when Mokko was lifted.

Before the helicopter started climbing for eliminating the slack, the Marshaller should have moved away for safety with the Hook Handler to the vicinity of the second Mokko located on the right side, however, the Marshaller probably stayed on the left side of the helicopter because of necessity to send signals to the onboard operator seated on the left side on the helicopter.
