AIRCRAFT ACCIDENT INVESTIGATION REPORT

SERIOUS INJURY TO A GROUND OPERATOR DURING CARGO

SLING WORK,

Bell 412EP (Rotorcraft), JA6977

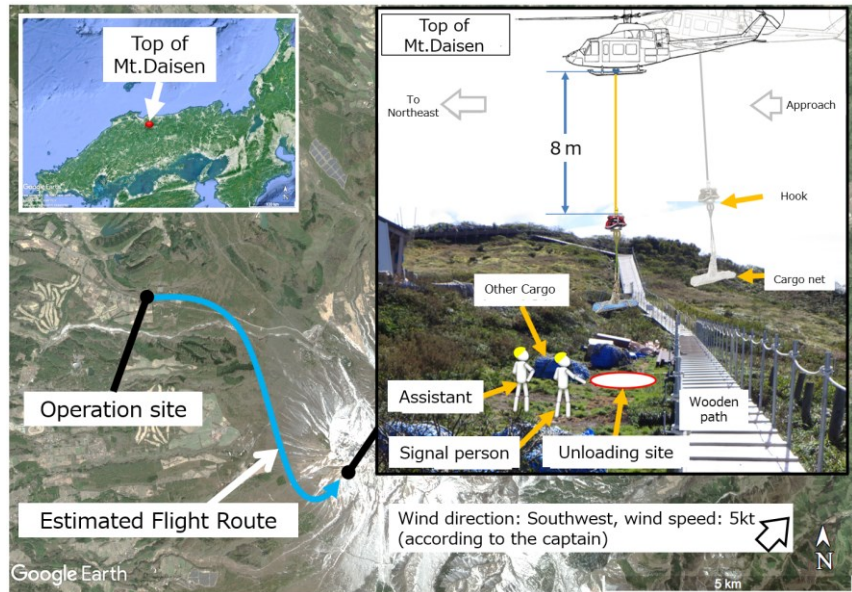
Figure 1: Outline of the Helicopter Flight

At about 10:20, the helicopter lifted a Cargo net from the loading site and headed to the top of Mt. Daisen for its 6th transport. (See Figure 1)

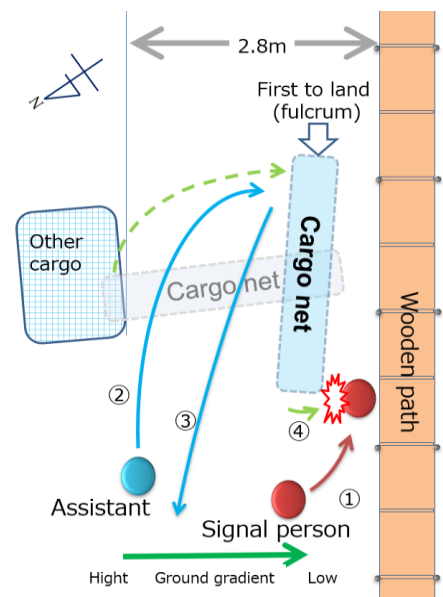
Figure 2: Image of unloading site

At the time the Cargo net moved to the appropriate position, although the Cargo net did not sway and was stable, since the Cargo net was close to the renovated wooden path, the signal person thought that some assistance might be required to prevent contacting the Cargo net with the wooden path. Thus, the signal person moved toward the wooden path while sending a "Lower down" signal to the onboard mechanic. (Figure 2①)

The assistant pushed clockwise the end of the Cargo net that was overlapping the other cargo when the Cargo net was lifted due to the climb of the helicopter, and adjusted the direction of the Cargo net so that the direction of the long side of the Cargo net could be parallel with the wooden path. (Figure 2②)

The signal person confirmed the Cargo net that had gradually descended and the situation of assistant's assist work. When the end of the cargo net on the assistant's side touched the ground first, the signal person assumed that the cargo net would not swing and instructed the assistant to move for the next work area. Receiving the instruction, the assistant moved for the next work

area site on the west side of the unloading site. (Figure 2③)

Distracted by the assistant moving between the Cargo net and other cargo, the signal person took the eyes off from the Cargo net when the end of the Cargo net hit the signal person's left foot. (Figure 2④)

The unloading site was an area approximately 2.8 m wide between the other cargo and the wooden path, and the ground was not flat with a slight downward slope from the other cargo side to the wooden path. (See Figure 2)

As for the swing of the Cargo net, it is highly probable that although the Cargo net was stable while the helicopter was descending, the end of the Cargo net that touched down first served as a fulcrum, and the end of the cargo net that did not touch the ground swung toward the wooden path. And the wind blowing down by the main rotor more likely affected in addition to the fact that the ground of the unloading site sloped downward toward to the wooden path.

It is highly probable that the Cargo net hit the signal person because during unloading, the signal person was in the range where the Cargo net could swing and reach.

The company needs to ensure that ground operators are fully aware of the ground work (unloading) precautions that the company has established. In addition, if assistance work such as adjusting position or direction of suspended cargo is expected, it is required that the work should be done in a way that allows assistance work to be conducted in the safe position even if the suspended cargo swings, for example by attaching a rope for assistance work.

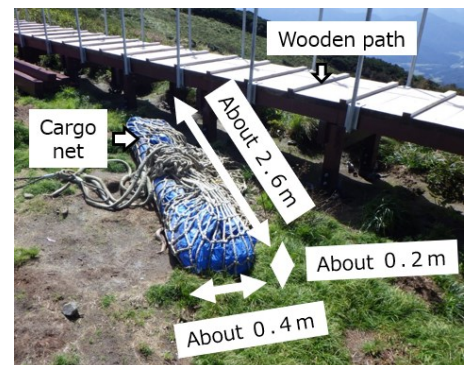
Figure 3: Cargo net

The cargo involved in this accident was the one with materials wrapped in a blue sheet and covered entirely with cargo net, and was approximately 2.6m long, 0.4 m wide, 0.2 m high, and the weight was approximately 832 kg. (See Figure 3) Besides, no rope for assistance work was attached to the Cargo net.

The reason the signal person was in the range where the Cargo net would swing, and reach was certainly because the rope for assistance work was not attached to the Cargo net, and it was necessary for the signal person to touch Cargo net directly.

The company needs to ensure that ground operators are fully aware of the ground work (unloading) precautions such that they must closely monitor the movement of the aircraft and suspended cargo, and that after instructing the unloading site, they must move away to safe position even if the suspended cargo swings. In addition, if assistance work such as adjusting position or direction of suspended cargo is expected, it is required that the work should be done in a way that allows assistance work to be conducted in a safe position even if the suspended cargo swings, for example by attaching a rope for assistance work.
