**AIRCRAFT SERIOUS INCIDENT
INVESTIGATION REPORT**

**ALL NIPPON AIRWAYS CO., LTD.
J A 7 0 1 A**

ENGINE INTERIOR DAMAGE
ALL NIPPON AIRWAYS CO., LTD.
BOEING 777-200, JA701A

AT AN ALTITUDE OF APPROXIMATELY 32,600 FT,
ABOUT 90 KM WEST OF TOKYO INTERNATIONAL AIRPORT
AT AROUND 08:44 JST, DECEMBER 13, 2013

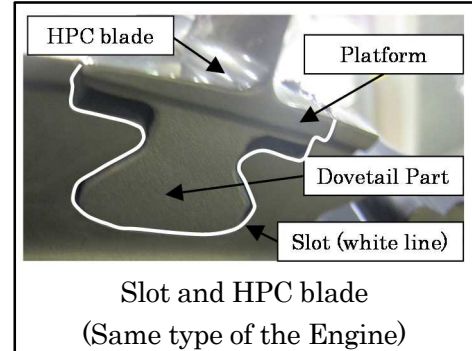
2. HPC

The HPC is made of 11 stages in total. The first stage blades of HPC (stage 5) were severely damaged around the entire periphery of disc, and all the blades were either fractured at the airfoil roots, or missing from the grooves for installing the blades on the disk (hereinafter referred to as “slot”). All the blades of the second stage (stage 6) blades of HPC were fractured at the airfoil roots. There was also a damage in the area aft the second stage blades of HPC that were probably caused by the fractured blades of the first and the second stage blades of HPC.

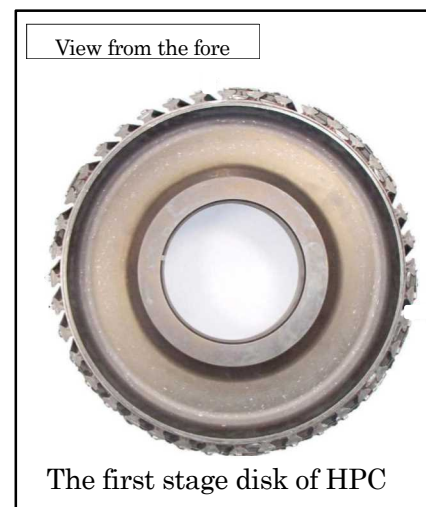
Forty HPC blades are installed on the first stage disk of HPC. These blades are installed by setting the dovetail parts of the blades into the slots, and fixed by swaging the pin-shaped blade lock fittings inserted between the bottoms of the dovetail parts and the disk. In addition, silicon rubber had been applied on the installed parts.

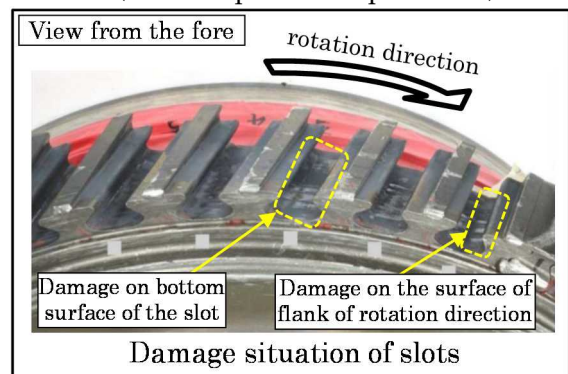
With regard to the situation of the first stage disk and blades of HPC of the Engine, the blades had fallen off from their 16 slots; on the contrary, the parts of the blades (dovetail parts and platforms) were remaining in 24 slots, but the airfoils were fractured on the platforms. In 16 slots among the 24 slots where parts of the blades were remaining, the blade lock fittings were missing, whereas

<p>the blade lock fittings were remaining in eight slots.</p> <p>There was a damage on the surface of flank of the slots in the disk rotation direction where the blades had fallen off; besides, there were severe scratch marks on the bottom surfaces of the slots.</p> <p>The blades in which their blade lock fittings were missing have shifted toward the rear of the slots, and there was a severe damage at the edges of the blade platforms by coming into contact with the rear stator vanes. Besides, traces of installing the blade lock fittings and traces of applying the silicon rubber were remaining.</p> <p>2. Abnormal damage slot in the first stage disk of HPC</p> <p>Among the slots in the first stage disk of HPC where the blades fell off, there was one slot which has an abnormal damage that was different from other slots. In the said slot, the damage was on the reverse flank of the slot rotation direction, and there was almost no damage on the bottom surface and the surface of the flank of the slot in the rotation direction.</p> <div data-bbox="877 622 1458 1003" style="border: 1px solid black; padding: 5px;"> <p style="text-align: center;">Damage situation of slot with abnormal damage</p> </div>																					
<p>2.4 Personnel Information</p>	<p>(1) PIC Male, Age 62 Airline transport pilot certificate (Airplane) April 2, 1991 Type rating for Boeing 777 November 5, 2009 Class 1 aviation medical certificate Validity : April 2, 2014</p> <p>(2) First Officer Male, Age 47 Airline transport pilot certificate (Airplane) November 6, 2008 Type rating for Boeing 777 September 13, 2004 Class 1 aviation medical certificate Validity : September 28, 2014</p>																					
<p>2.5 Aircraft Information</p>	<p>(1) Type: Boeing 777-200 Serial number: 27938, Date of manufacture: July 9, 1997 Certificate of airworthiness: 98-052 Validity: During the period in which the aircraft is maintained in accordance with the Maintenance Management Manual</p> <p>(2) Engines</p>

On the first stage disk of HPC, severe scratch marks were found on the bottom surfaces and the surfaces of flanks of the slots in the rotation direction in all the slots, except for one slot with an abnormal damage. However, the damage on the bottom surfaces and the surfaces of flank of the slots in the rotation direction that were found in other slots were not found in the said slot.

With regard to the situation of the damage that the fractured blades caused to the structure of the slots, it is somewhat likely that the situation will be different between the blades which became the origin and the secondary fractured blades, thus it is somewhat likely that the blade installed in the said slot was the origin.
