**AIRCRAFT ACCIDENT
INVESTIGATION REPORT**

**JAPAN COAST GUARD
J A 7 2 7 B**

DAMAGE TO THE AIRFRAME DURING LANDING JAPAN COAST GUARD, BOMBARDIER DHC-8-315, JA727B SENDAI AIRPORT AT ABOUT 15:58 JST, MAY 30, 2015

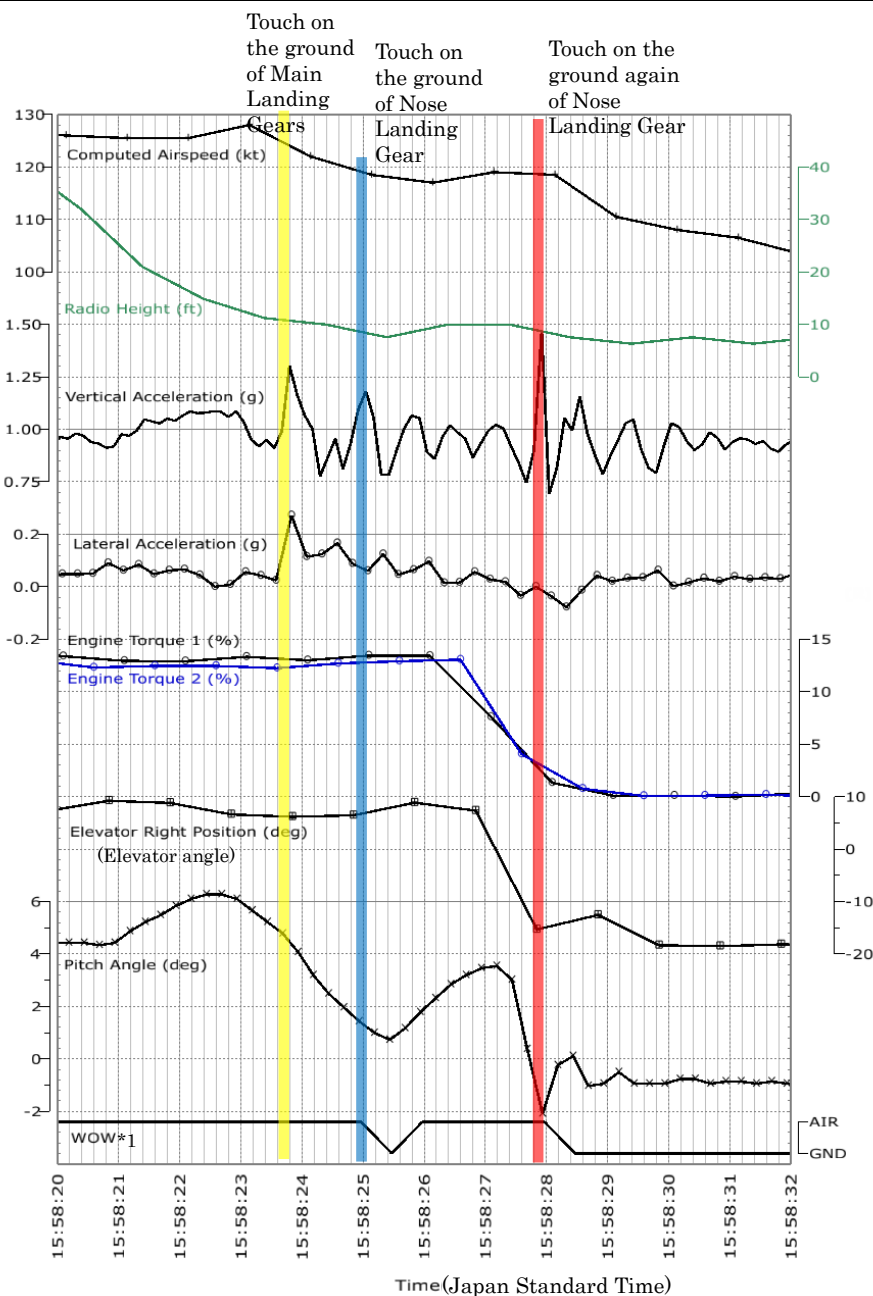
Figure 2 FDR records during the time of the accident

<p>According to the records of FDR and CVR, the pitch angle started to be moved upward at around 15:58:21 and the elevator angle was changed to the nose-down direction from the time when the pitch angle exceeded 6°. At around 15:58:23, the pitch angle started to be moved downward and continued moving downward after the main landing gear touched the ground at around 15:58:24, then at around 15:58:25, the nose landing gear touched the ground once. The elevator angle was changed to the nose-up direction again soon before the nose landing gear touched the ground, and the pitch angle was moved upward after the nose landing gear touched the ground once. At around 15:58:27 when the pitch angle exceeded 3.5°, the elevator angle was largely changed to the nose-down direction and at around 15:58:28, the nose landing gear touched the ground again. The recorded value of vertical acceleration (G) of this time was +1.47. In addition, impact sounds were recorded in CVR.</p>

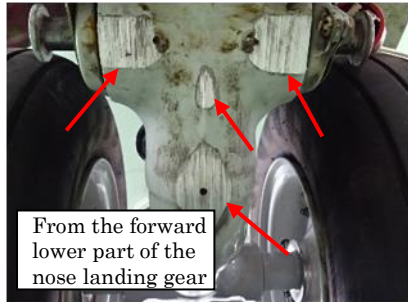
From the forward lower part of the nose landing gear

Abrasion status of the lower part of strut for the nose landing gear

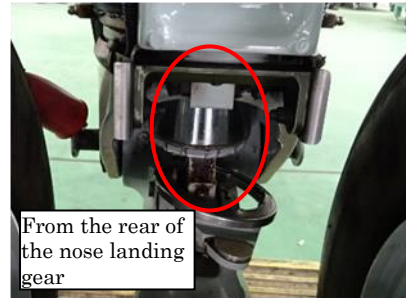
From the rear of the nose landing gear

Damage condition of components of shock strut for the nose landing gear

<p>In this accident, it is probable that the nose of the aircraft suddenly downed and the nose landing gear strongly touched down on the ground after the main landing gear touched the ground in the landing, therefore the components of the nose landing gear were damaged and the fuselage skins of the airframe was deformed.</p> <p>Regarding the fact that the nose landing gear of the aircraft strongly touched the ground on the ground, it is probable that it was because that the captain who considered worry of tail contact performed the sudden and large control for moving the nose downward, when the nose-up attitude tended to be too excessive after the nose landing gear touched the ground once and the nose upped again.</p>

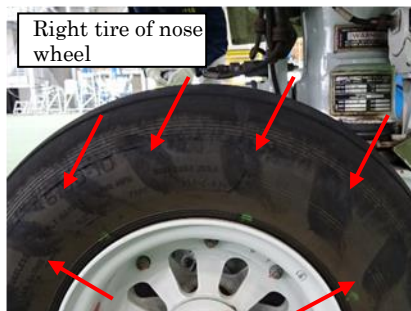
Right tire of nose wheel

Deformed marks on tire

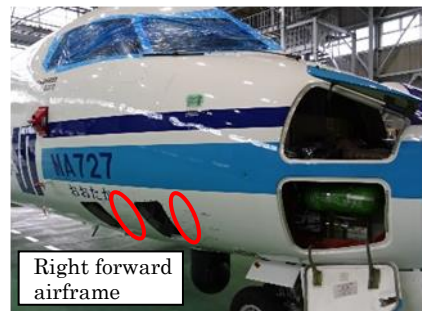
Right forward airframe

The deformation to the airframe

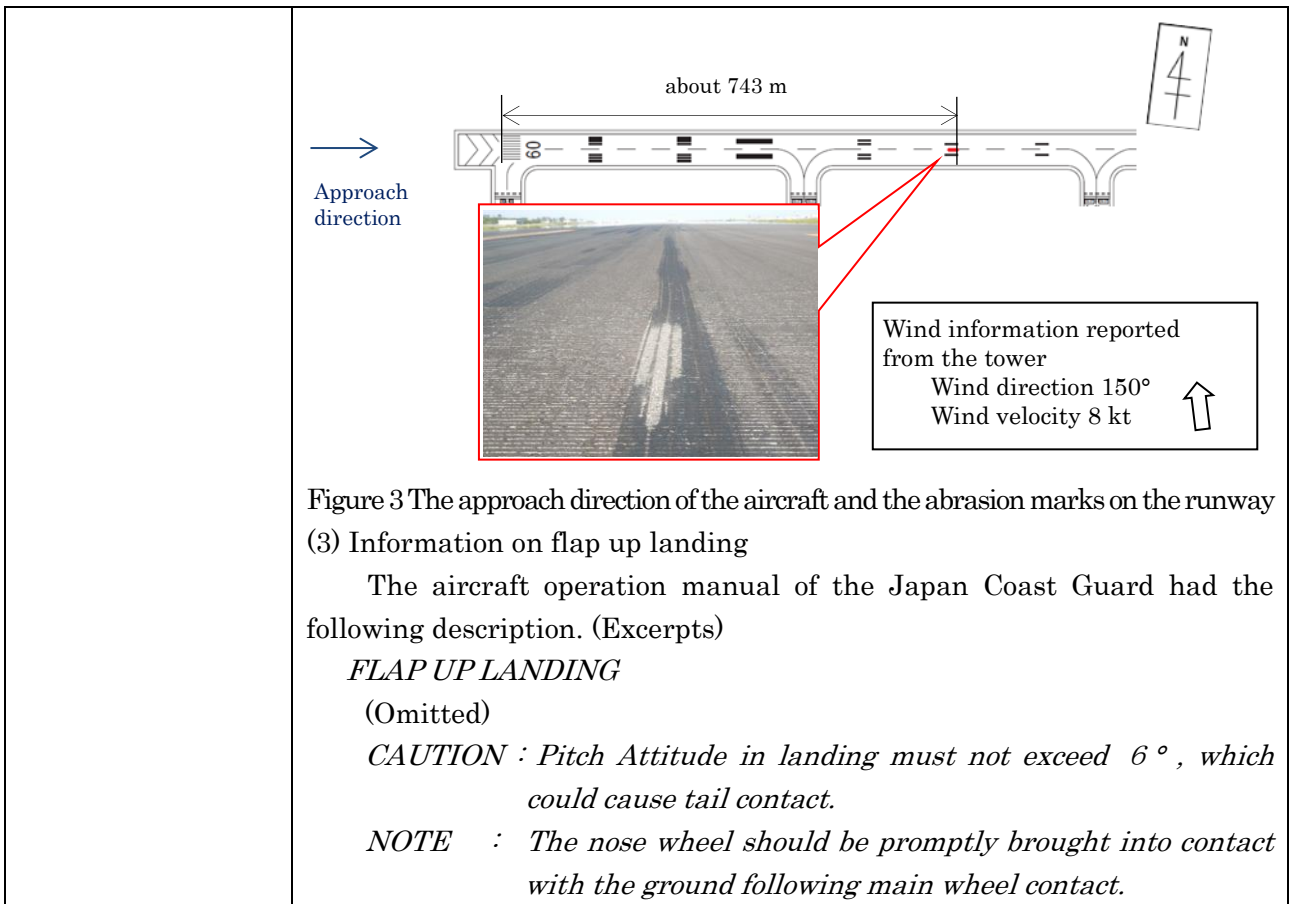
Figure 3 The approach direction of the aircraft and the abrasion marks on the runway

2.7 Additional Information	<p>(1) Information on flight recorder</p> <p>The aircraft was equipped with U.S. Honeywell's FDR which can retain about 25 hours data and U.S. Honeywell's CVR which can retain about 2 hours data, both of which retained the records when the accident occurred.</p> <p>The time calibration for the flight recorder was performed by making time signals recorded in the air traffic control communication records correspond to VHF wireless transmission signals and air traffic control communication recorded in the flight recorder.</p> <p>(2) Information of accident site</p> <p>The runway 09 in the Airport where the accident occurred is 3,000 m in length and 45 m in width and had scratched marks of about 2.2 m in length at about 743 m from the runway 09 threshold and about 5 m right side (south) of the runway center line in the approach direction.</p>
