AI2008-01

# AIRCRAFT SERIOUS INCIDENT INVESTIGATION REPORT

1. SKYMARK AIRLINES INC.  
BOEING 767-300, JA767F
2. ALL NIPPON AIRWAYS, Co., Ltd.  
BOEING 777-200, JA8967  
NEW CHITOSE AIRPORT, JAPAN  
AT AROUND 21:09 JST, JUNE 27, 2007

November 28, 2008

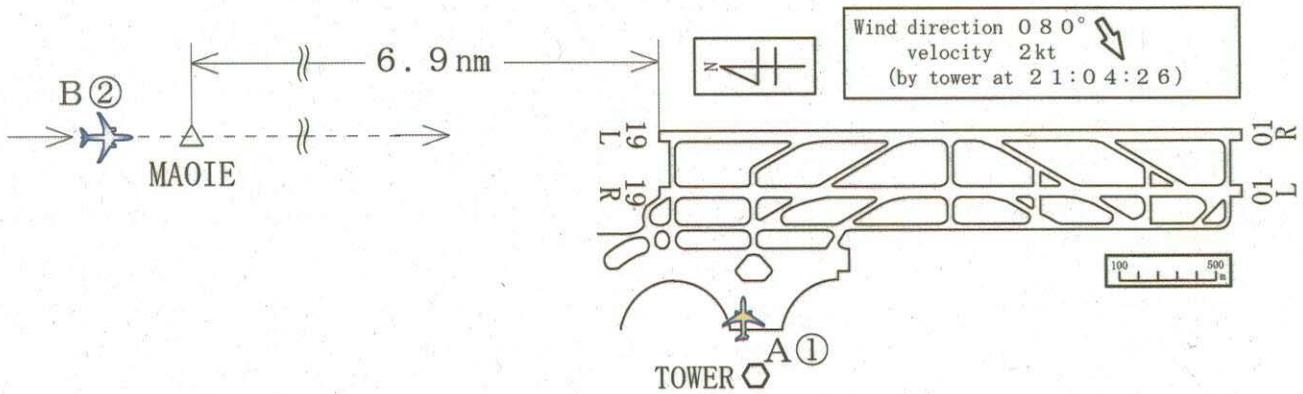
1. Aircraft A started to taxi ~ Issued landing clearance for Aircraft B

- ① at 21:04:11, A started to taxi from spot 18
- ② at 21:04:26, B got landing clearance

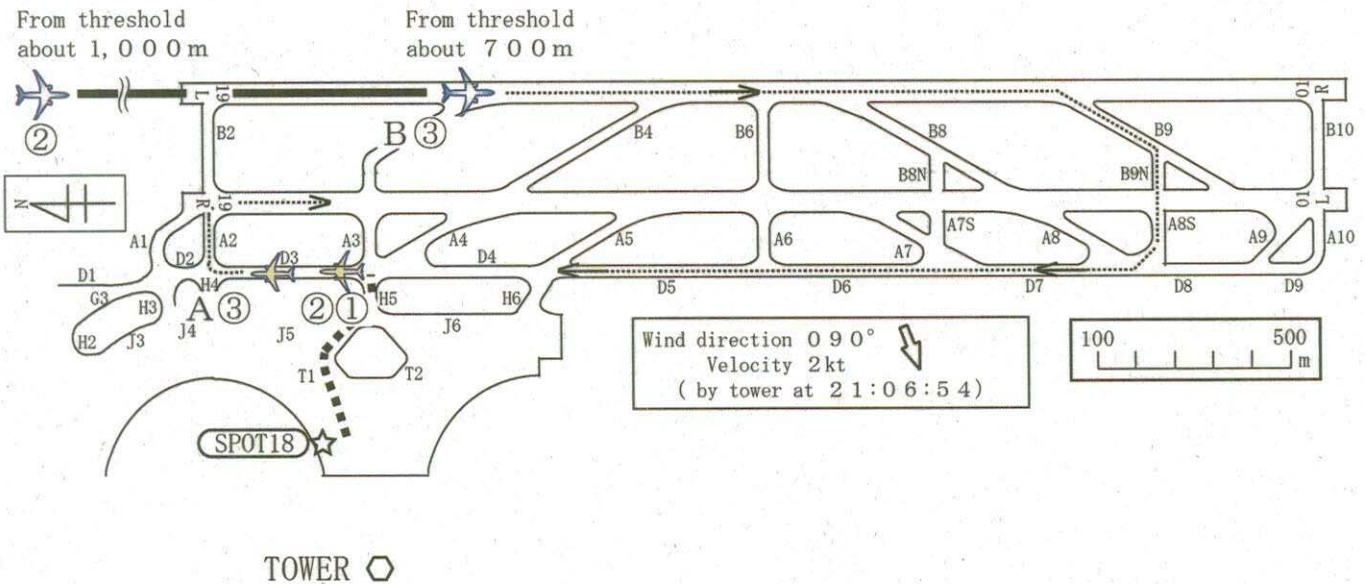
2. Takeoff clearance for Aircraft A ~ touchdown of Aircraft B

- ① at 21:06:51, A ready for takeoff
- ② at 21:06:54, TOWER cleared A for takeoff
- ③ at 21:07:20, B touched down

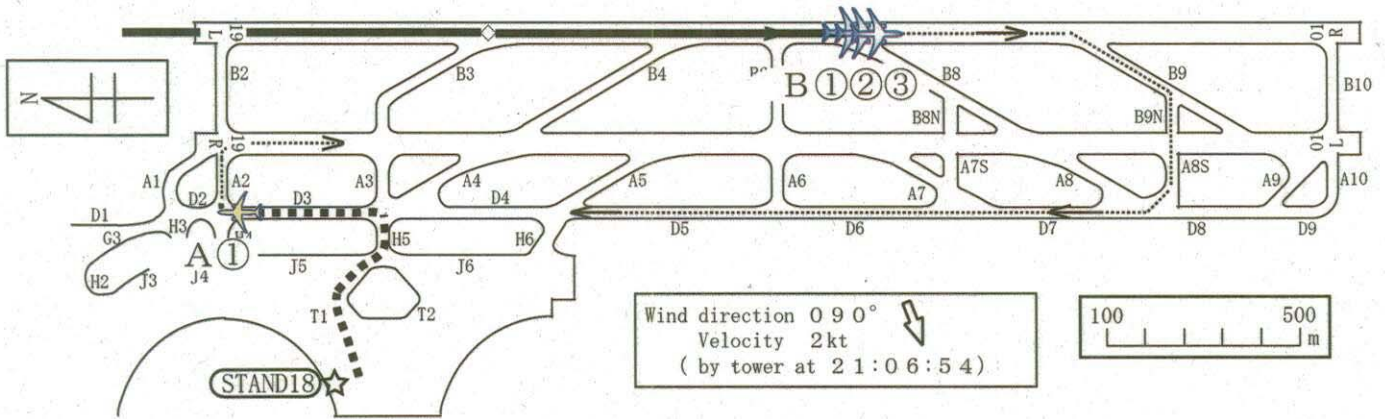
3. Aircraft B landing roll ~ change of PF ~ crossing 19 R

- ① at 21:07:41, B landing roll at 60kt
- ② at 21:07:44, B PF changed to FO
- ③ at 21:07:50, Tower cleared B to cross 19 R

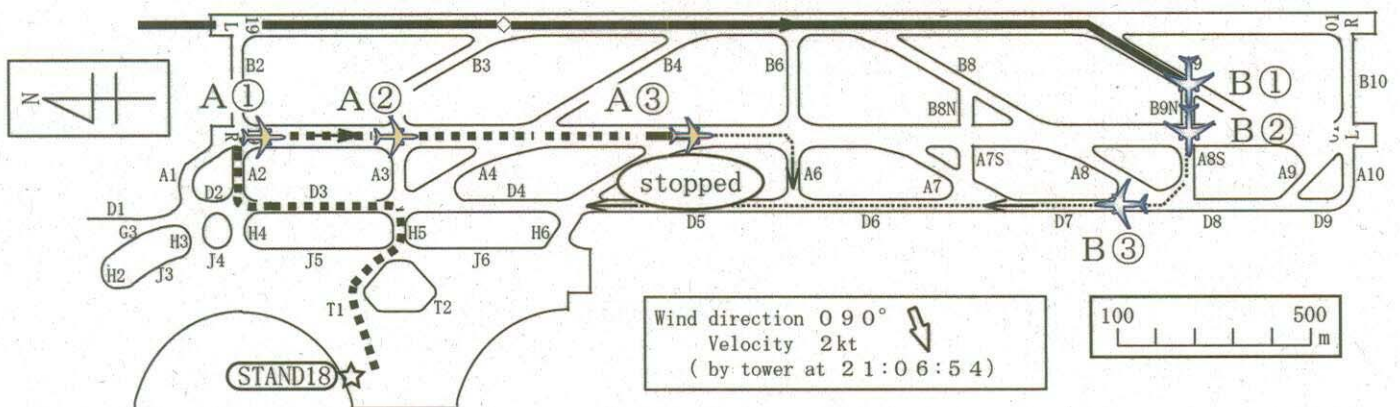
4. A taking off run ~ rejected ~ stopped

- ① at 21:08:52, A Lining up runway doing rolling takeoff
- ② at 21:09:12, A decided to reject
- ③ at 21:09:43, A stopped

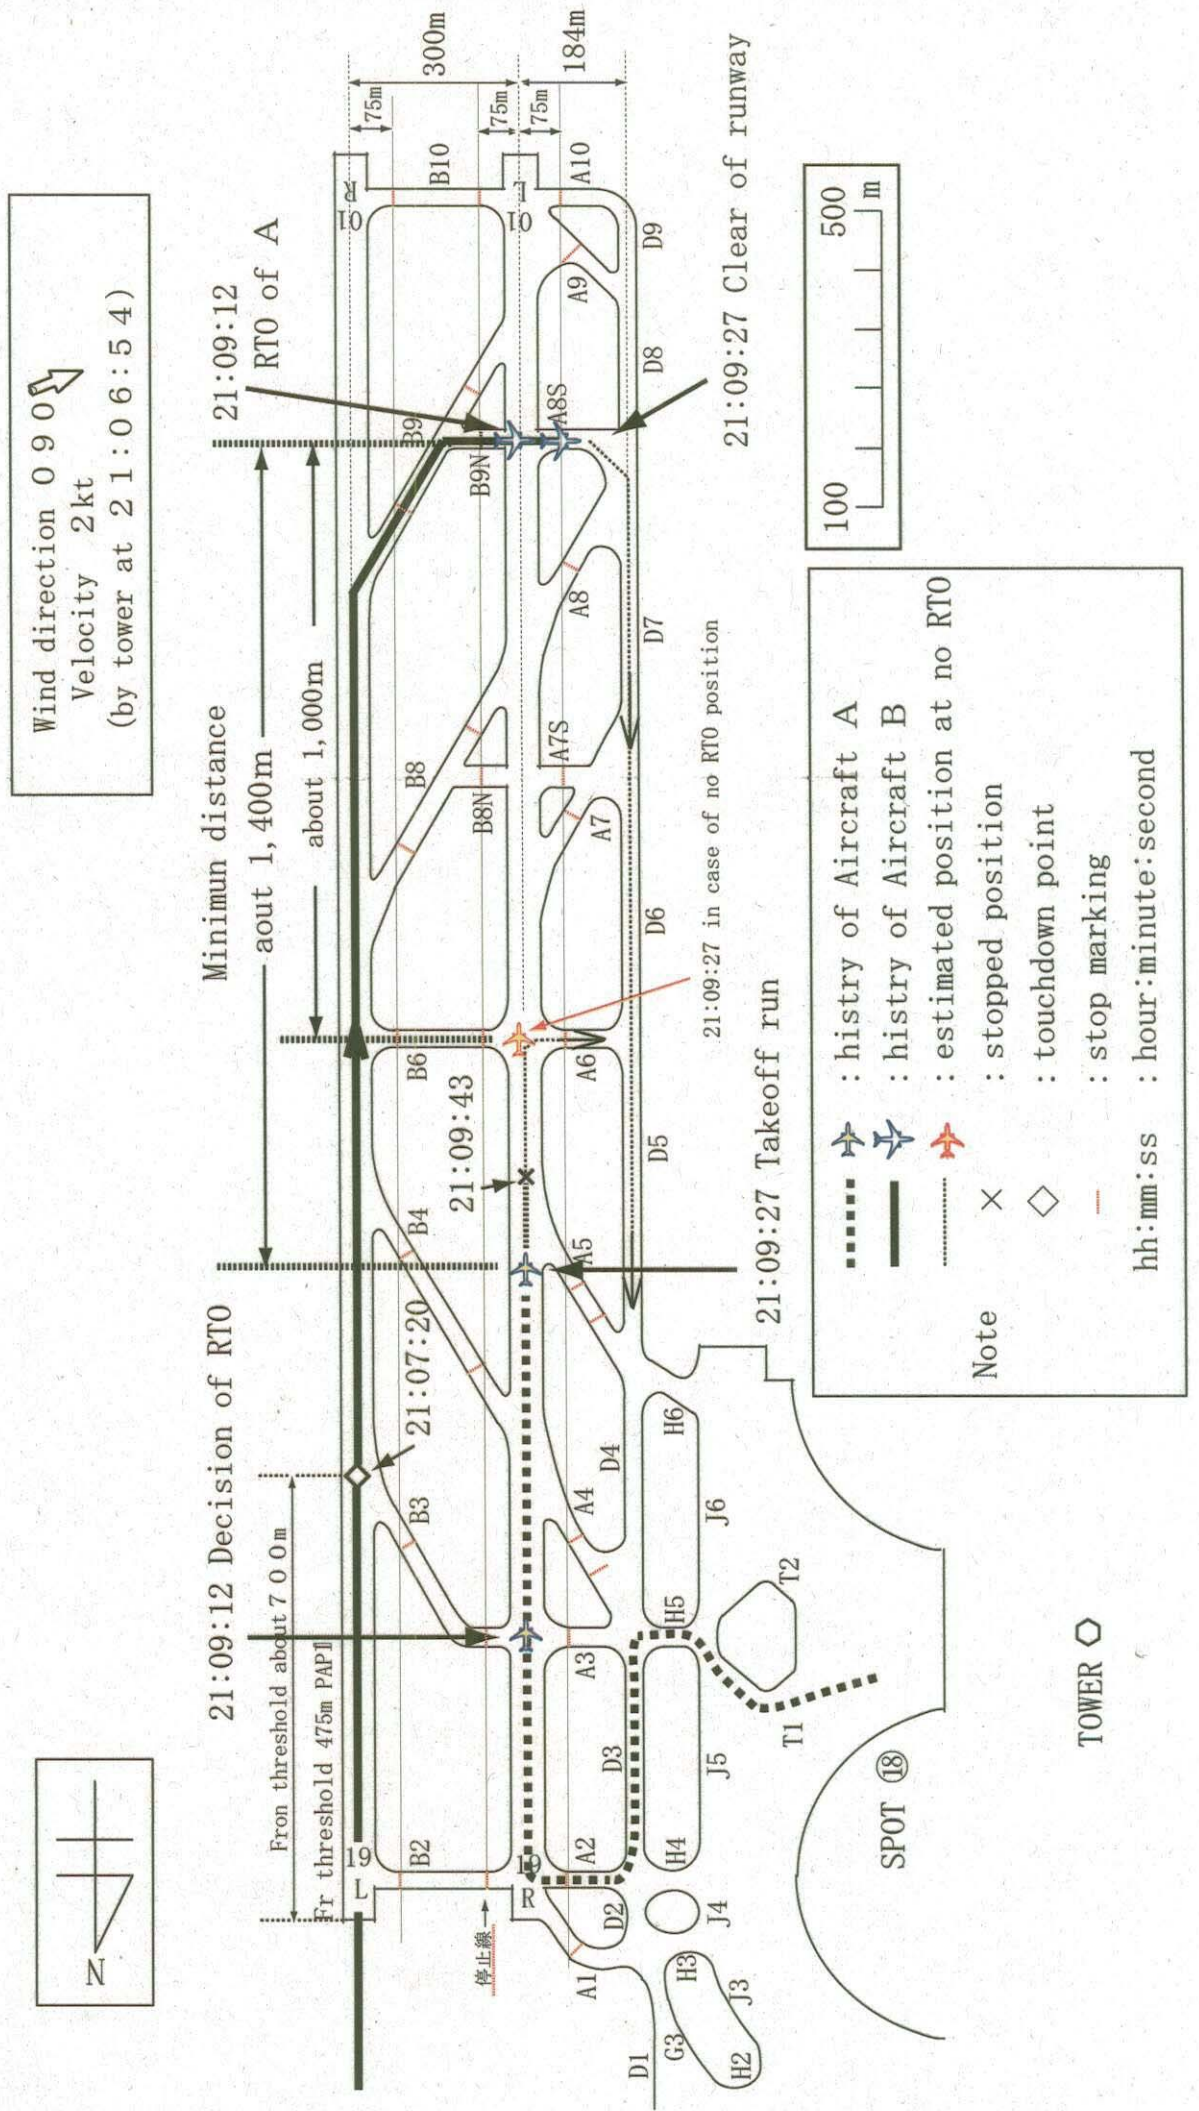
# Figure 2 Situation of Closeness between Aircraft A and B

(Based on DFDR records of both aircraft)
