AIRCRAFT ACCIDENT INVESTIGATION REPORT

AIRCRAFT DAMAGE DUE TO ROLLOVER DURING LANDING

ROBINSON R22 BETA (ROTORCRAFT), JA7875

TOYAMA CITY, TOYAMA PREFECTURE

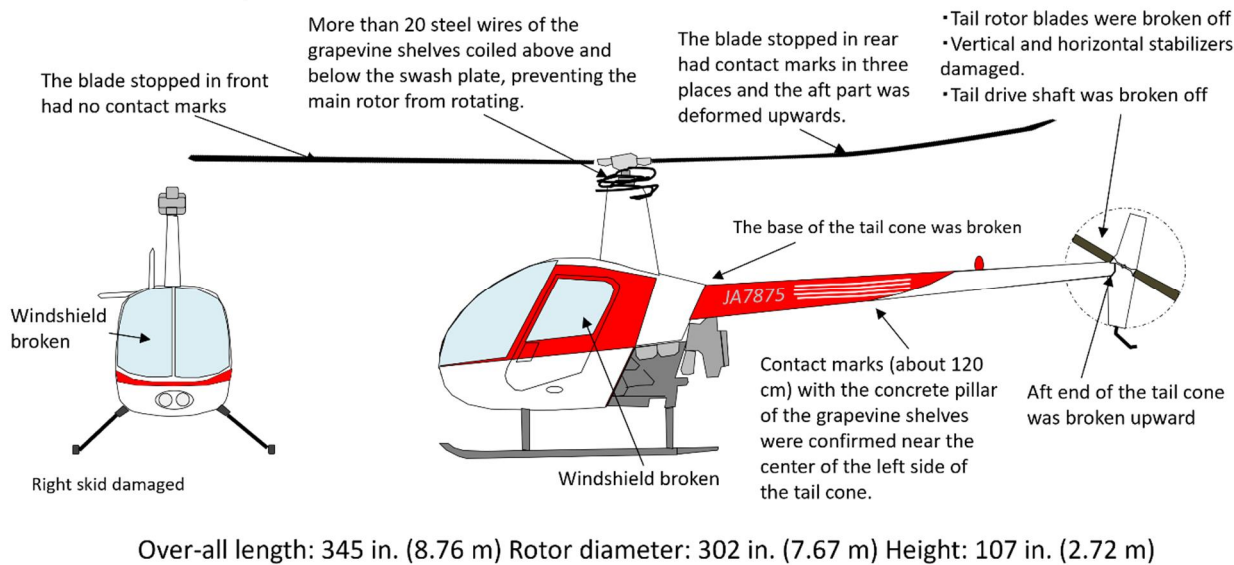
Figure 3: Damage to the Helicopter

- a Fuselage: (Figure 3 and Figure 4)
 - (a) Cockpit right front windshield and the left door window were broken.
 - (b) The base of the tail cone was broken.

- (c) Contact marks (about 120 cm) with the concrete pillar of the grapevine shelves were confirmed near the center of the left side of the tail cone.

- (d) The aft end of the tail cone was broken upward.
 - (e) Vertical and horizontal stabilizers damaged.
- b Main Rotor System
 - (a) More than 20 steel wires of the grapevine shelves coiled above and below the swashplate, and the collective pitch control^{*3} (hereinafter referred to as “the Collective”) was stopped to its uppermost position, preventing the main rotor from rotating freely. (Figure 3 to Figure 5).)

- (b) The blade that stopped in front had no contact marks, while the blade that stopped in rear had contact marks in three places and the aft part was deformed upwards.

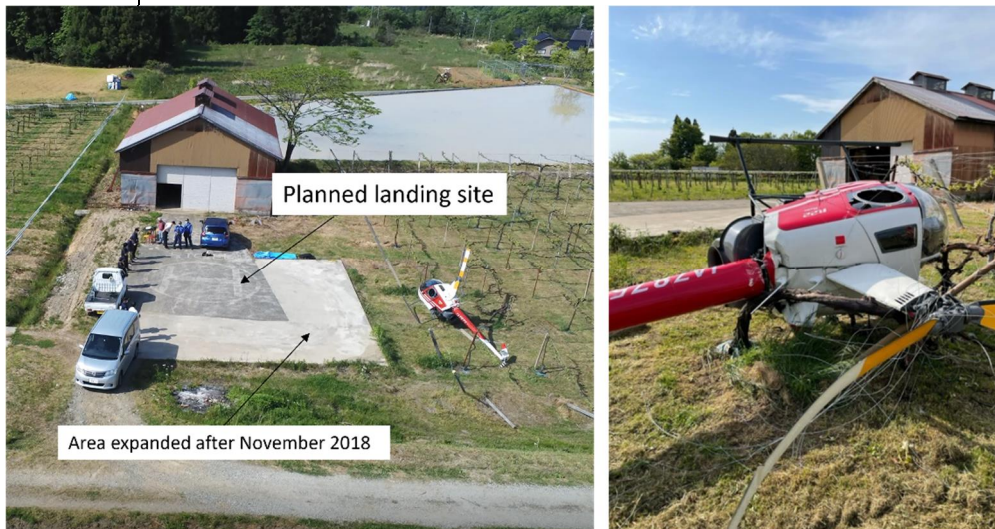
Figure 4: Rollover Situation of the Helicopter

At 15:32, as shown in Figure 2, as the helicopter approached the Old Operation Site from its south side, it encountered a strong westerly wind and lost directional control shortly before touchdown, rolling over with its leaning against the grapevine shelves on the east side.

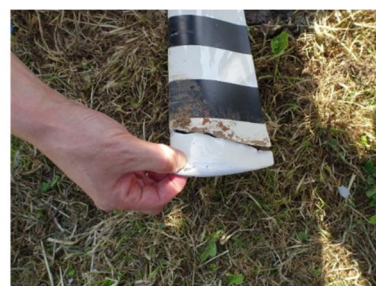
Figure 6: Broken Tail Rotor Blades

- c Tail Rotor System
 - (a) The tips of the tail rotor blades were broken off and scattered about 30 m the west of where the helicopter rolled over. (Figure 6 and Figure 9)

- (b) The tail drive shaft was broken off.

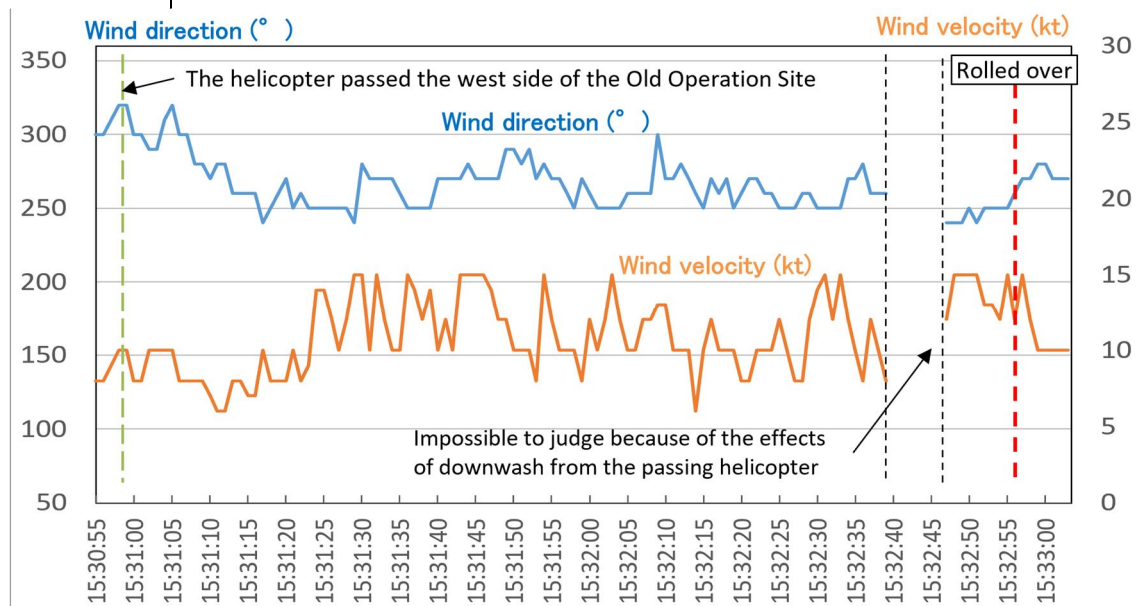
Figure 8: Changes in Wind Direction and Wind Velocity as Measured by of the Wind Direction Indicator near the Old Operation Site

(3) According to the wind direction indicator installed at the Old Operation Site, the accident site, the changes in wind direction and wind velocity immediately before the accident as shown in Figure 8. (This was created by confirming the movement of the wind direction indicator captured on surveillance camera video.)

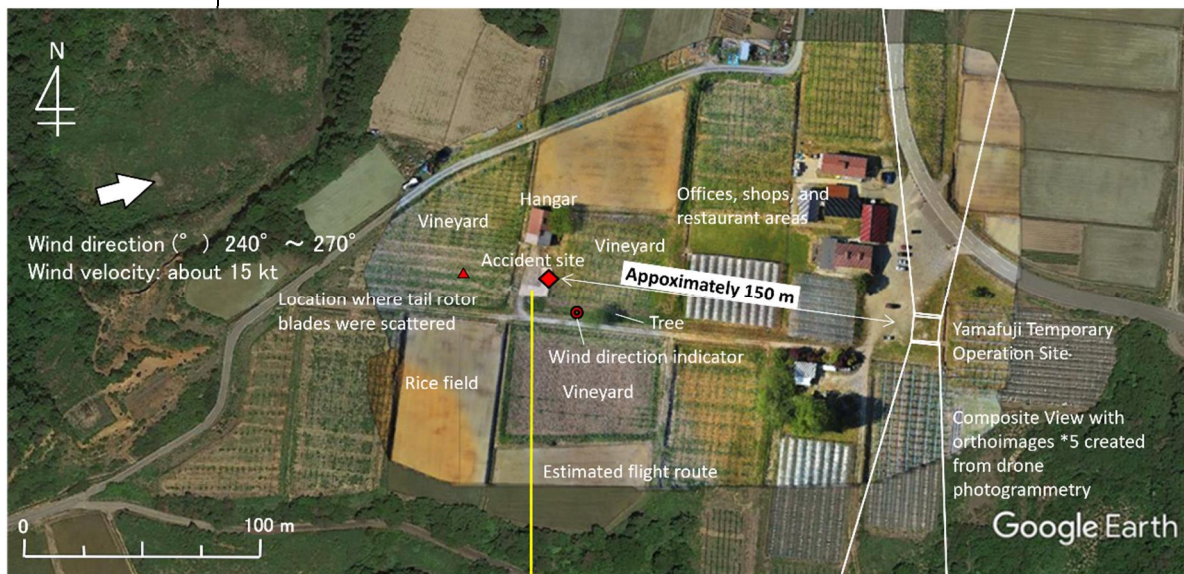
Figure 9: Facilities in the vicinity of the Accident Site and their Locations in relation to the Operation Site

The site where the helicopter rolled over had been used as an operation site with a permit until 2018, but at the time of the accident, the operation site that had been applied for and approved by the Ministry of Land, Infrastructure, Transport and Tourism was approximately 150 m east of the accident site, as shown in Figure 9. (See 2.8 (6) for details of how to apply for an operation site)

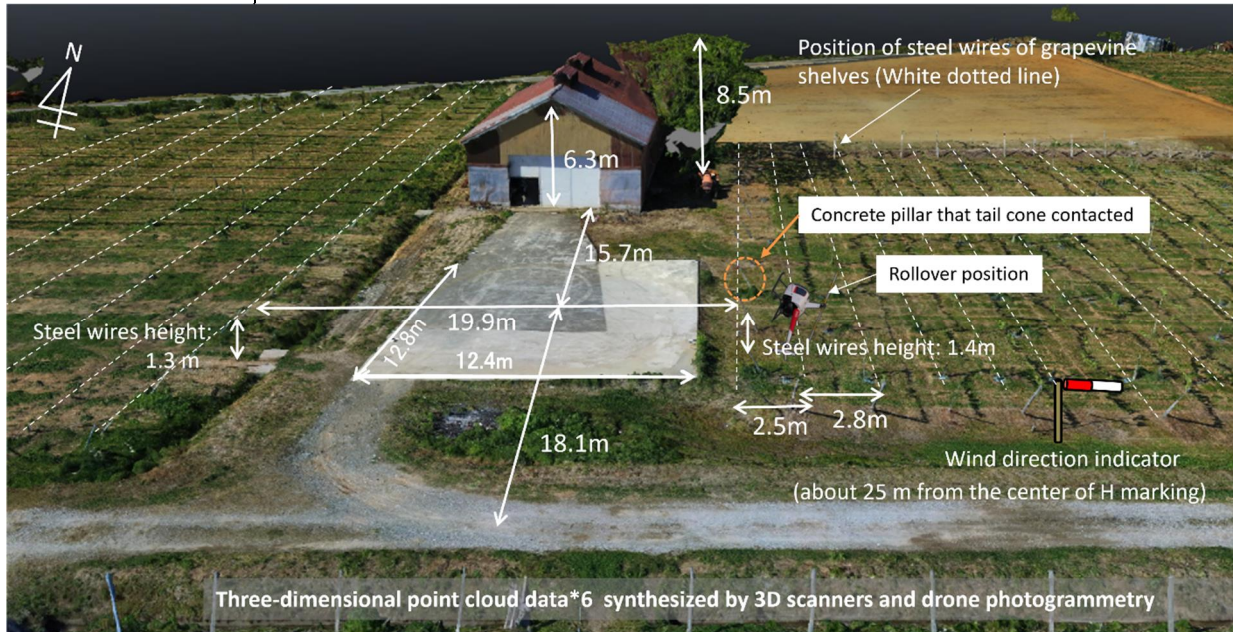
Figure 10: Size of the Old Operation Site and Obstacles in its Vicinity

The Old Operation Site where the accident occurred, as shown in Figure 10, was a concrete paved area with a hangar on its north side and a wind direction indicator approximately 25 m to the south-east. In addition, there were the grapevine shelves approximately 1.3 to 1.4 m high on the east and west side of the Old Operation Site, and the helicopter rolled over, when the steel wires from the eastern grapevine shelves coiled around it.

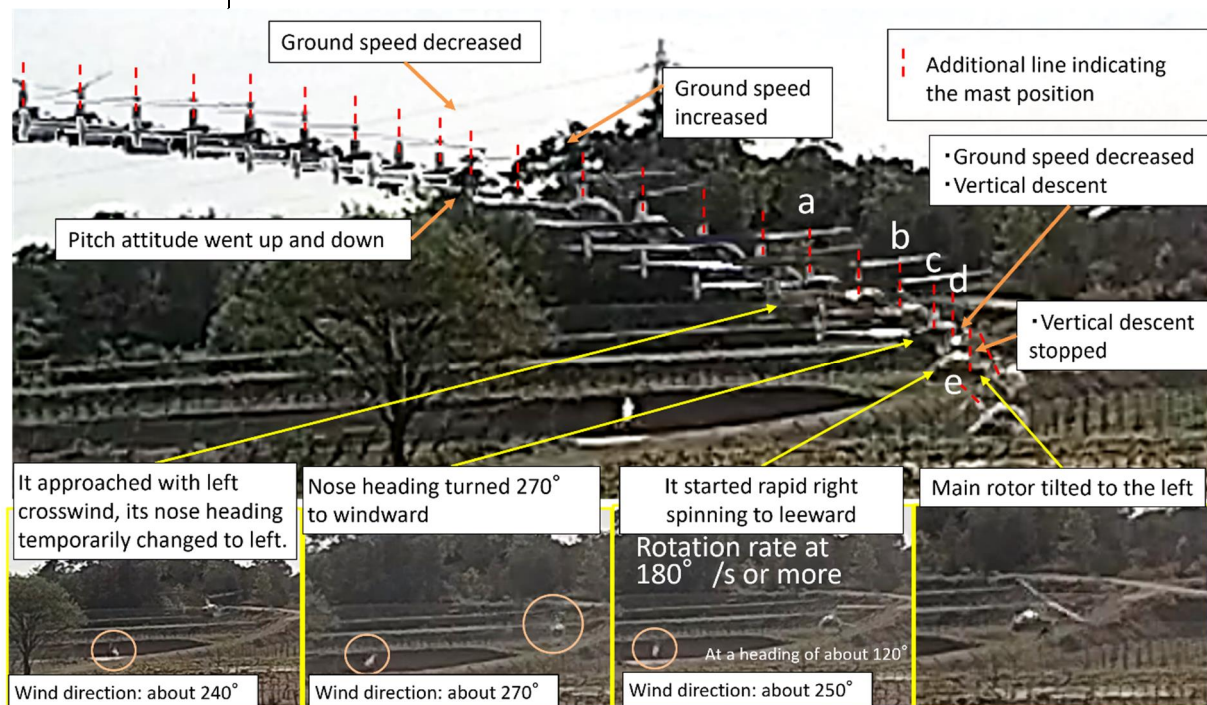
Figure 11: The helicopter's continuous movements during approach (every second)

The helicopter did not have any equipment to record flight track and others, but the video from the surveillance camera installed east of the accident site recorded the helicopter at the time of the rollover and the changes in the movement of the wind direction indicator. In addition, the helicopter's continuous movements at the time of the accident were as shown in Figure 11.

The helicopter approached with a crosswind from the left (a), and as it descended vertically near the Old Operation Site(b), its heading suddenly turned to the left in the direction of the wind (c). Immediately afterwards, the helicopter started to spin 180°s to the right (d), contacted the steel wires with the main rotor tilted to the left (e), and then continued to spin to the right with the nose up after contacting, causing the helicopter to roll over to the right with the nose

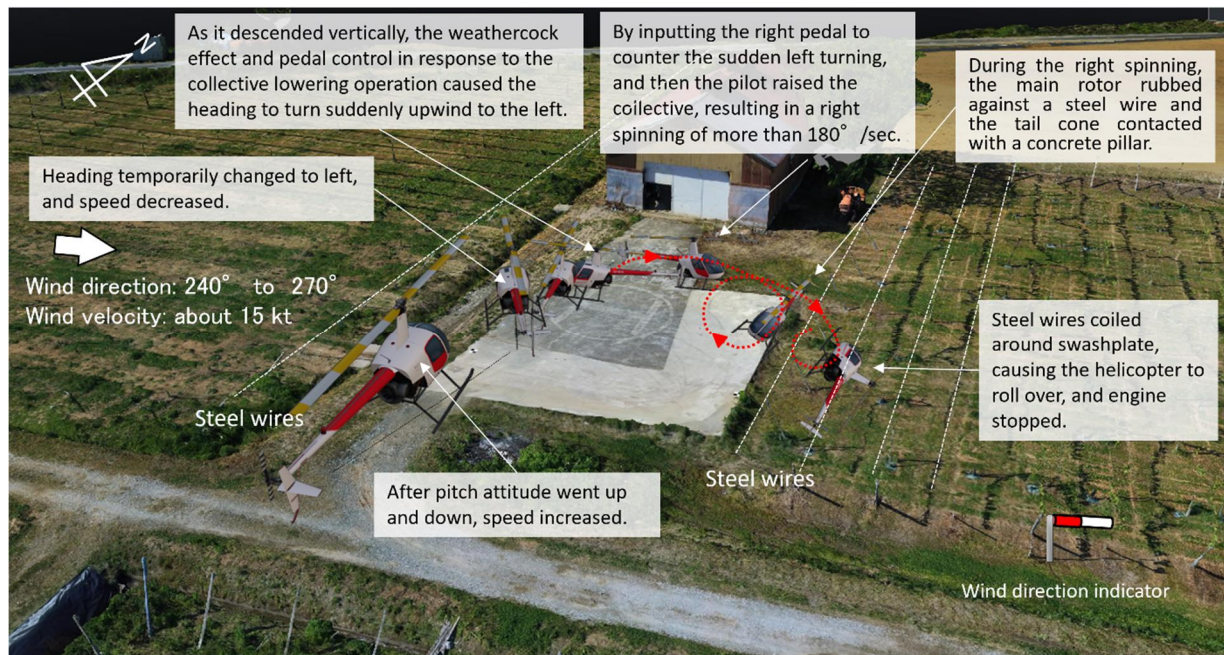
Figure 14: Composite View of the Helicopter's Rollover

After that, the helicopter started to spin around to the right with a heading of changing rate of over 180°/s, the rotor disc tilted to the left while moving eastward, and the main rotor blades rubbed against the steel wires of the grapevine shelves, causing the helicopter to pitch up, the wires coiled around the swash plate, and the helicopter rolled to the right. The pilot stated that the helicopter's heading swung significantly to the left, so he inputted on the right pedal to stop the swing and try to correct it. As shown in Figure 11, the vertical descent stopped immediately after the sudden right spinning began, so it is highly probable that when the nose turned suddenly to the left into the wind, the pilot suddenly applied the right pedal, and then raised the collective to stop the vertical descent, which increased the torque, accelerating the right spinning and causing the helicopter to be LTE.

As to the reason the main rotor tilted to the left and hit the steel wires, because while the helicopter was approaching in receiving the wind blowing from the left, the pilot probably made a cyclic input to the left to maintain the approach path. It is probable that when the helicopter started a rapid spinning to the right, as the cyclic was held to the left, the main rotor left began to tilt to the left, and it spun while the center of rotation shifted outwards. Therefore, the cyclic was possibly held to the left until the main rotor rubbed the steel wires. In addition, the pilot stated that the pilot was trying to recover, and the passenger stated that to stop the helicopter moving forward, the passenger operated the cyclic grip which was at up position. During the rapid right spinning of more than 180°/s, the cyclic operation to tilt the main rotor rearwards would have probably worked with a delay, therefore, the cyclic operation by the passenger had possibly affected the nose up of the helicopter that occurred after the main rotor blades rubbed the steel wires. It is probable that the rapid right spinning to be the LTE was mainly due to the pilot's pedal inputs and the collective operation, and the influence of the flight control performed in the left seat was limited, however, in the past helicopter rollover accidents, there are

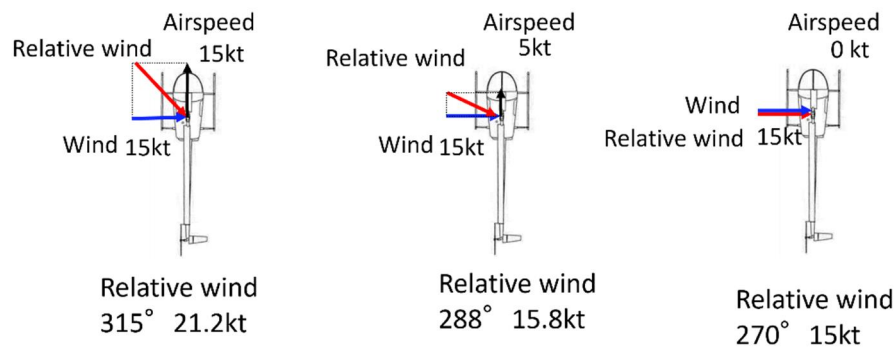
Figure 15: Examples of Changes in Relative Wind Direction and Velocity due to Decrease in Airspeed

<p>(1) Influence of Weather</p> <p>The JTSB concludes as follows.</p> <p>On the day of the accident, the weather was fine and calm, but in the afternoon, a slightly strong wind blew from north to northwest in the Toyama region. According to aeronautical weather observations for Toyama Airport from 15:00 to 16:00, the wind direction changed from 010° to 300° and the wind velocity was 9 kt. In addition, according to the movement of the wind direction indicator captured in surveillance camera video, the wind direction changed largely between 240° and 270°, and the wind velocity changed between 10 kt and 15 kt during the helicopter's approach, as shown in Figure 8. These changes in wind direction and velocity were close to the Flight Manual wind limitation values for surface wind, wind shear and turbulence, which were most likely to have affected control in low-speed flight.</p> <p>(2) Flight from Approach to Rollover</p> <p>The JTSB concludes as follows.</p> <p>As shown in Figure 11 and Figure 14, the helicopter approached the Old Operation Site from the south side, receiving the wind from the left rear and left side. The helicopter slowed down before approaching the road on the south side of the Old Operation Site, but the pitch attitude went up and down, and the ground speed temporarily increased. This temporary increase in ground speed was more likely caused by the influence of the pilot's flight control or the wind blowing from the left rear.</p> <p>Near the landing mark H, the helicopter's heading temporarily changed to the left, the ground speed decreased, and the helicopter's heading suddenly turned to the left during a vertical descent. As for the cause of this, as shown in Figure 15, it is possible that the decrease in airspeed and the change</p>

in relative wind direction and speed to the left made the weathercock effect likely to occur, and that the pilot lowered the collective in order to descend, which reduced the thrust of the main rotors, and the input of the right pedal was insufficient to compensate for the decrease in the torque, causing the nose to turn 270° upwind.

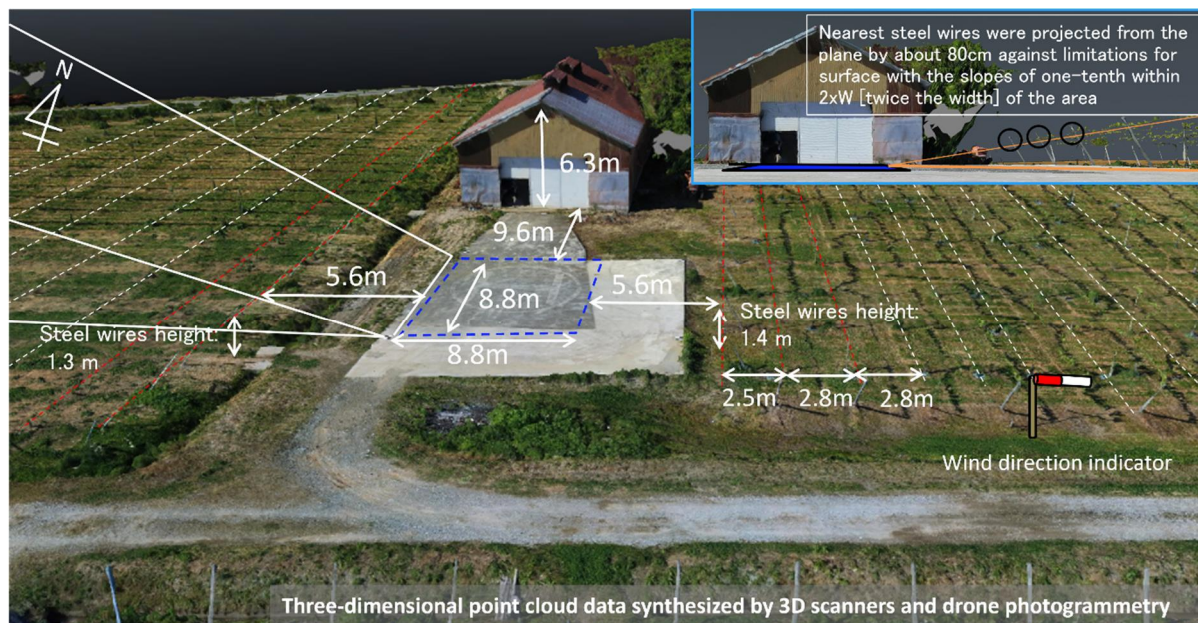
Figure 16: Confirmation of the Requirement for the Take-off and Landing Area and Others

As a result, it was confirmed that the following did not meet the requirements. (See Figure 16)

- a. Within the transition surface, which is twice the width of the take-off and landing area, three rows of grapevine shelves on the east side were projected from and above the surface with a slope of one-tenth (the first row was projected from the surface by 80 cm).
- b. Within the area of the departure route and approach route, two rows of grapevine shelves on the western side were projected from and above the surface with a slope of one-eighth.

When the helicopter started a rapid right spinning and moved to the right, the main rotor tilted to the left and rubbed against the steel wires protruding 80 cm above the transition surface of the first

row of the grapevine shelves on the east side. It is possible that if the transition and approach surfaces had been secured in accordance with the standards for the operation site, and the helicopter had chosen the approach path from a 110° direction, as applied for, and approved in 2018, the helicopter would not have approached with a tailwind from the left side and the rapid change in nose heading could have been avoided.

In order to avoid contact with obstacles, even if the helicopter's attitude is unstable due to an unforeseen situation, it is necessary to apply for and improve the operation site in accordance with the requirements for limited surface, take-off and landing area and others, and to operate it by obtaining a permit.
