**AIRCRAFT ACCIDENT  
INVESTIGATION REPORT**

**PRIVATELY OWNED  
JA7907**

AIRFRAME DAMAGED BY ROLL-OVER UPON LANDING  
ODAIRA, ITOIGAWA CITY, NIIGATA PREFECTURE, JAPAN  
AT AROUND 15:13 JST, MARCH 18, 2017

PRIVATELY OWNED  
ROBINSON R44 (ROTORCRAFT), JA7907,

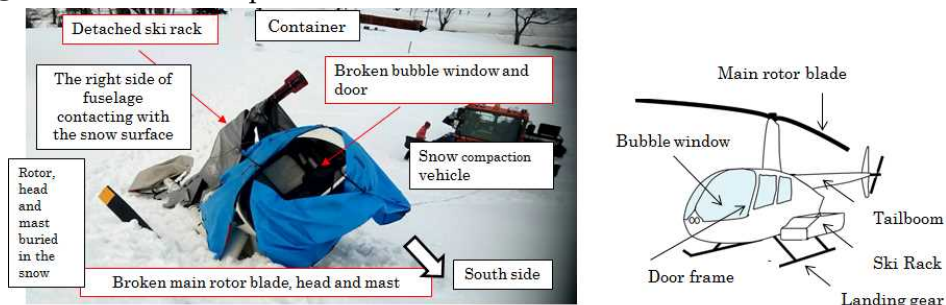
Figure 2: The Rotorcraft right after the Accident  
(The picture taken by a passenger right after the accident before the fuselage was moved)

The bubble window (fuselage front wind shield) was broken, the tip of one of the two rotor blades was broken and protruded from the snowy surface, but the other was buried in the snow with its head and mast. The Rotorcraft halted lying on its right with its nose facing the south. (See Figure 2) The ski rack, which was equipped on the left side of its fuselage, was detached and fell off about three meter southwest upward along the snowy slope from there.

- (1) Extent of Damage to the Rotorcraft: Destroyed
- (2) Damage to parts of the Rotorcraft
- ① Bubble window and door frame were broken.
- ② Main rotor blades were broken.

- ③ Main rotor head and mast were broken.
- ④ Ski rack was dropped.

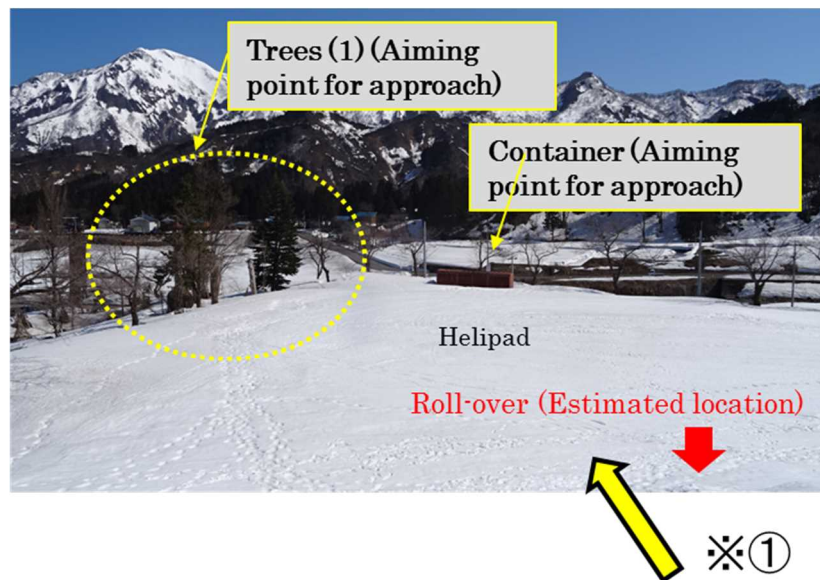
Figure 3: Situation in the Accident Site

Seen from the roll-over location on the snowy slope, the Helipad (Container side in the northeast) and the slope come together in the snow and looked all flat. (See Figure 3)

※①: Seen from the roll-over location on the snowy slope, the Helipad (Container side in the northeast) and the slope come together in the snow and looked all flat.

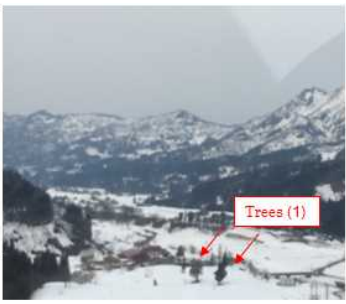
① Aiming the trees (1), the Rotorcraft approached from a little high altitude. (at about 15:12:40, 28 seconds before the accident occurred)

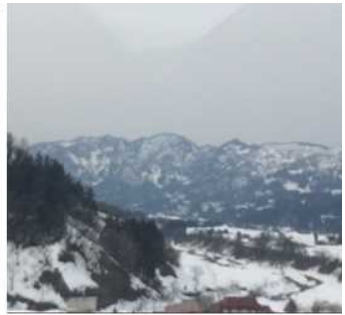
② After passing over the Helipad, the Rotorcraft commenced taking a steep turn and nosediving. (at about 15:12:53, 15 seconds before the accident occurred.)

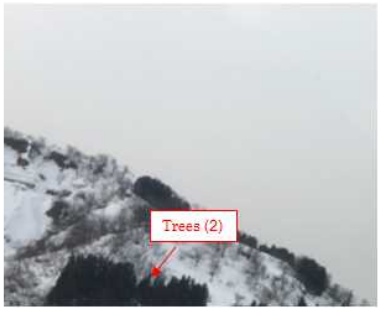
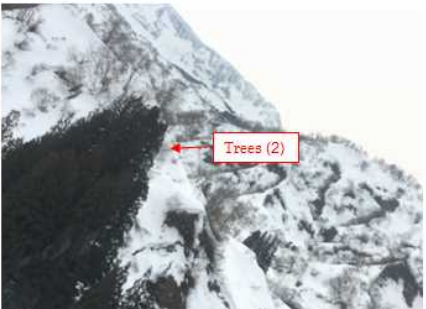
③ While taking a steep left turn with a deep bank angle and nosediving, the Rotorcraft avoided the trees (2). (at about 15:12:59, nine seconds before the accident occurred)

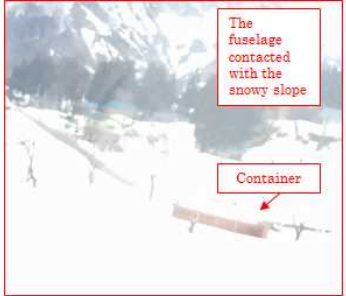
⑧ The Rotorcraft touched the snowy slope with its left side. Its main rotor touched the snowy slope. (at about 15:13:08, when the accident occurred)
