AIRCRAFT ACCIDENT INVESTIGATION REPORT

CRASH PRIVATELY OWNED ROBINSON R22 BETA, JA7975 HADANO CITY, KANAGAWA PREFECTURE AT ABOUT 06:48 JST, OCTOBER 7, 2021

December 20, 2024

Adopted by the Japan Transport Safety Board

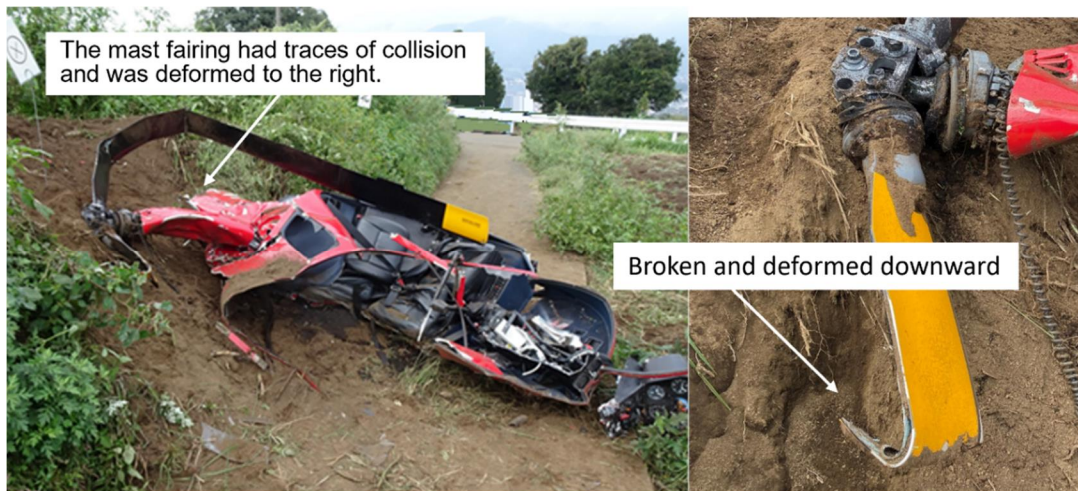
Figure 3: Crashed Helicopter Lying at the Accident Site

Fuselage : Damaged, cockpit and airframe of the helicopter were significantly deformed, and the tail cone was separated.

Main rotor system : Broken, deformed, partially scattered.

Engine : Damaged (partially deformed)

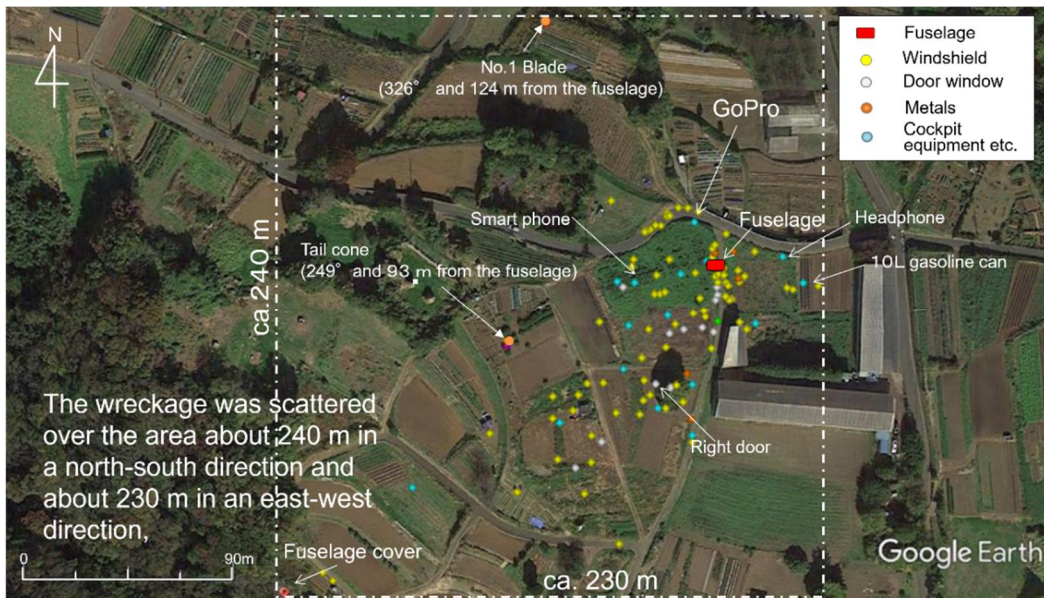
Figure 7: Scattered Wreckage near the Accident Site

As shown in Figure 7, its wreckage was scattered over the area about 240 m in a north-south direction and about 230 m in an east-west direction, and most of the windshields and door windows fell from the fuselage concentratedly in a south-west direction. The tail cone dropped at 249° and 93 m from the fuselage, and the broken No.1 main rotor blades (hereinafter referred to as “No. 1 Blade” (The same goes for “No.2 Blade”)) dropped at 326° and 124 m from the fuselage.

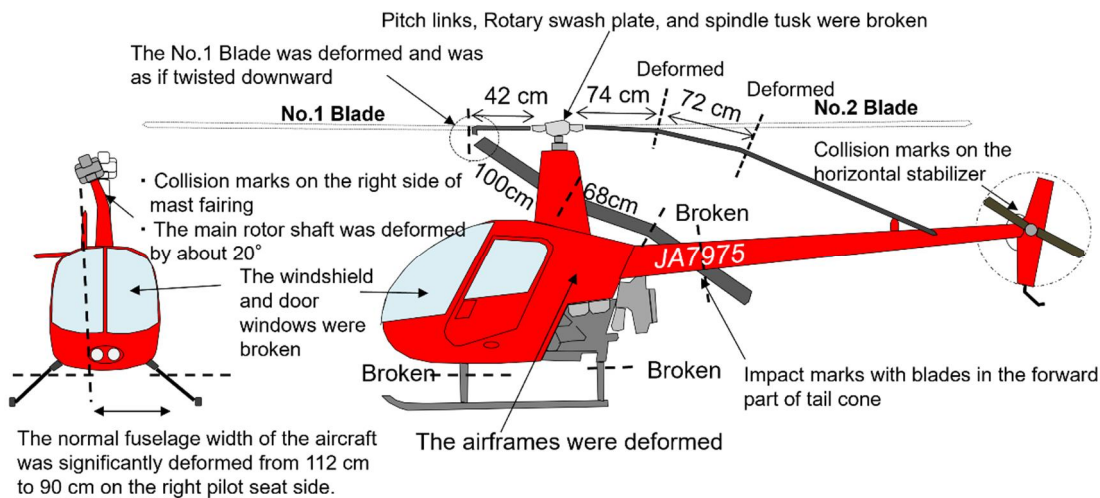
Figure 8: Overview of Helicopter Damage

- a. The mast fairing had traces of collision with the main rotor blades.
- b. The fuselage width of the aircraft was compressed and deformed from 112 cm to 90 cm.
- c. The frame of the cockpit was deformed, and the windshield and door windows were broken and scattered.
- d. The tail cone broke off at the location of the impact mark with the main rotor blades in the forward part. In addition, the horizontal stabilizers had traces of collision with the main rotor blades.

- a. Two main rotor blades were deformed at several places, and the No.1 Blade was deformed and broken at about 42 cm from the spindle as if twisted downward and scattered. (See Figure 8 to Figure 10, and Figure 12)

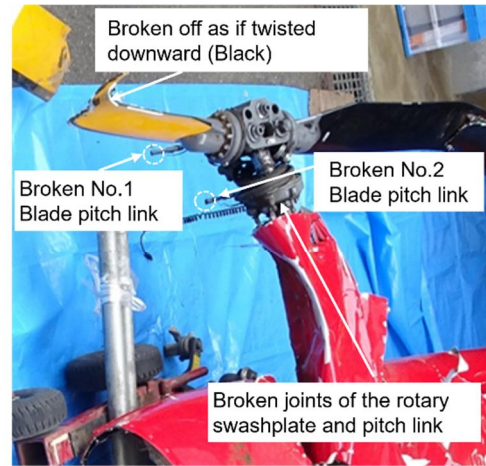
Figure 12: Fracture around the Main Rotor Hub

- d. The rotary swashplate on the No.1 Blade side were broken at the overhanging root. (See Figure 11, Figure 12, Figure 15, and Figure 16)
- e. The No.1 Blade pitch link was broken at the joint of swashplate and the No.2 Blade pitch link was broken at the joint of blade. (See Figure 11, Figure 12, and Figure 15)

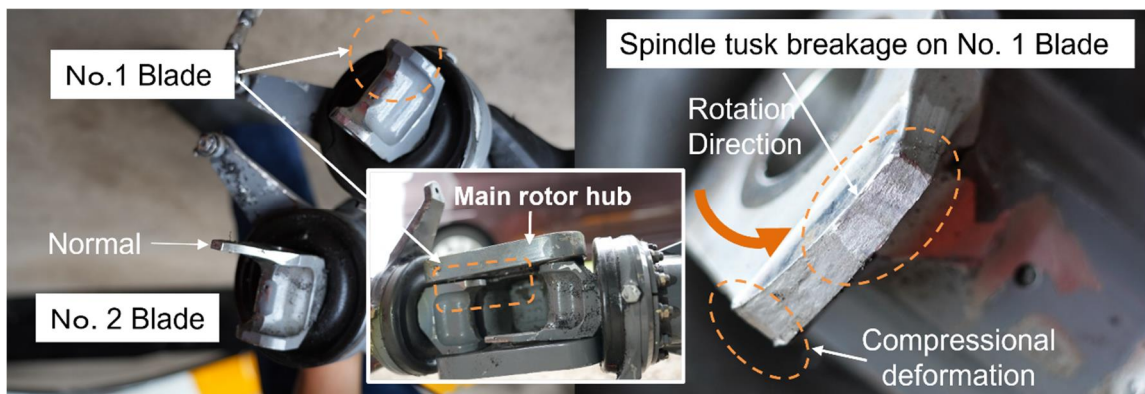
Figure14: Damage to the Spindle Tusk

- f. The spindle tusk of the No. 1 Blade had its tip scraped off and rotated in the direction of the underside of the No. 1 Blade, which was partially compressed and deformed. (See Figure 11 and Figure 14)

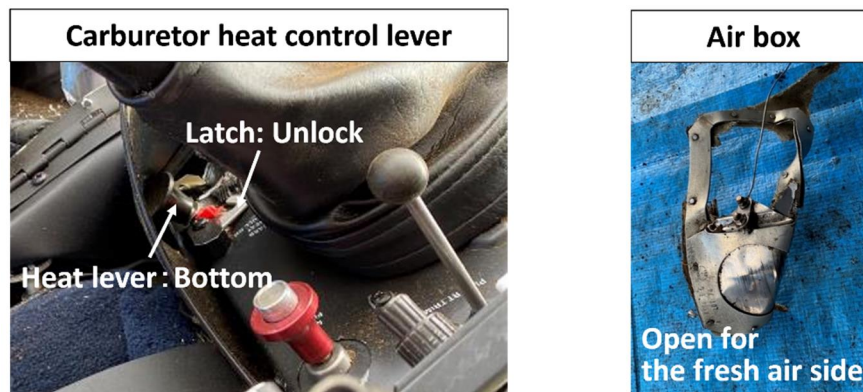
Figure 17: Carburetor Heat in Use

- a. There was no anomaly in the engine, and GoPro audio information recorded the sound of the engine running at the time of the crash.
- b. The latch of the carburetor heat control lever was unlatched but in the off position. (Figure 17, Left)
- c. The slider valve inside the airbox, which is attached to the lower part of the engine

had been opened for the fresh air side but closed for the hot side. (Figure 17, Right)

As described in 2.8.2, the carburetor heat control lever was unlatched but not adjusted during flight. Carburetor ice is an engine failure that does not leave a trace, but the environmental and equipment operating conditions at the time the LOW RPM was activated were as follows:

As described in 2.11.4, at high humidity and when in doubt, assuming conditions conducive to carburetor ice, carburetor heat should be applied as required. In addition, full carburetor heat should be used during run-up to preheat the induction system and as shown in the picture in Figure 5A, it is important to re-confirm that carburetor heat has been applied when it is confirmed that there are drops of water on the cockpit window in flight.

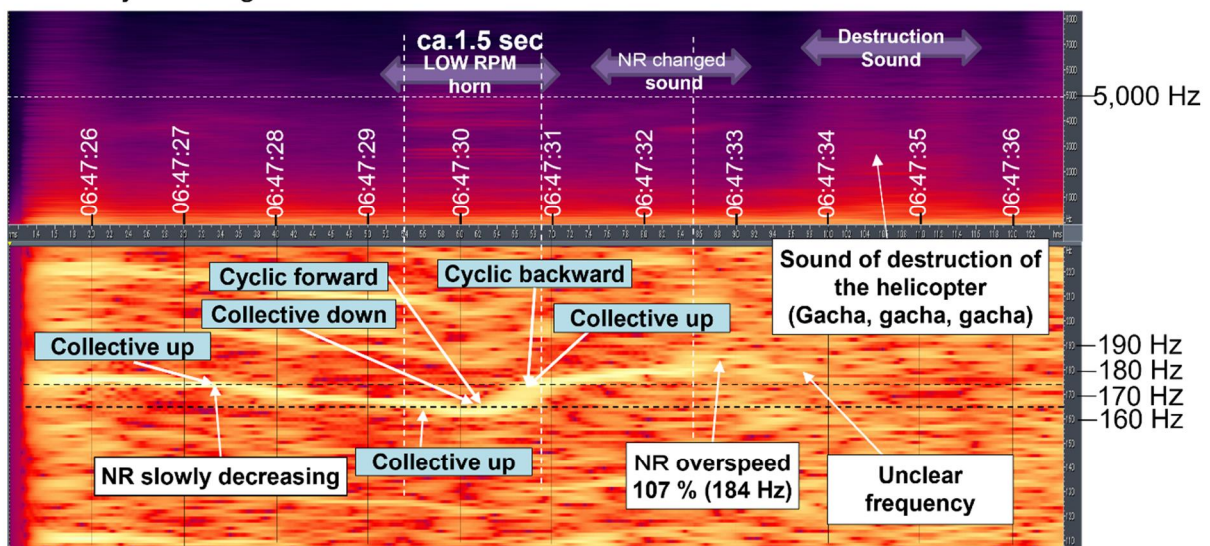
Figure 23: Acoustic Analysis for the NR

- (1) As shown in Figure 23, the collective was upped and the NR slowly dropped below 102.5% from approximately 2 seconds before the LOW RPM HORN was activated. It is probable that the engine power could not be maintained, and the engine entered a LOW RPM condition.
- (2) Normally, the RPM governor^{*21} automatically adjusts the engine power to maintain the adjusted value of NR, 102 to 104 % RPM. As described in 2.11.4, if carburetor ice occurs, the RPM governor will automatically open the throttle to compensate for the buildup of ice in the early stages of development, thus typical symptoms of carburetor icing are not noticeable to the pilot. As the ice gets worse, the throttle will reach fully open and engine power cannot be increased, by the governor or the pilot, therefore, the NR will decrease

It is probable that NR of the helicopter decreased due to a decrease in engine power caused by carburetor ice, or due to insufficient engine power for the rapid climb caused by upped the collective, or due to both occurring simultaneously, resulting in a lack of engine power required to rotate the main rotors.

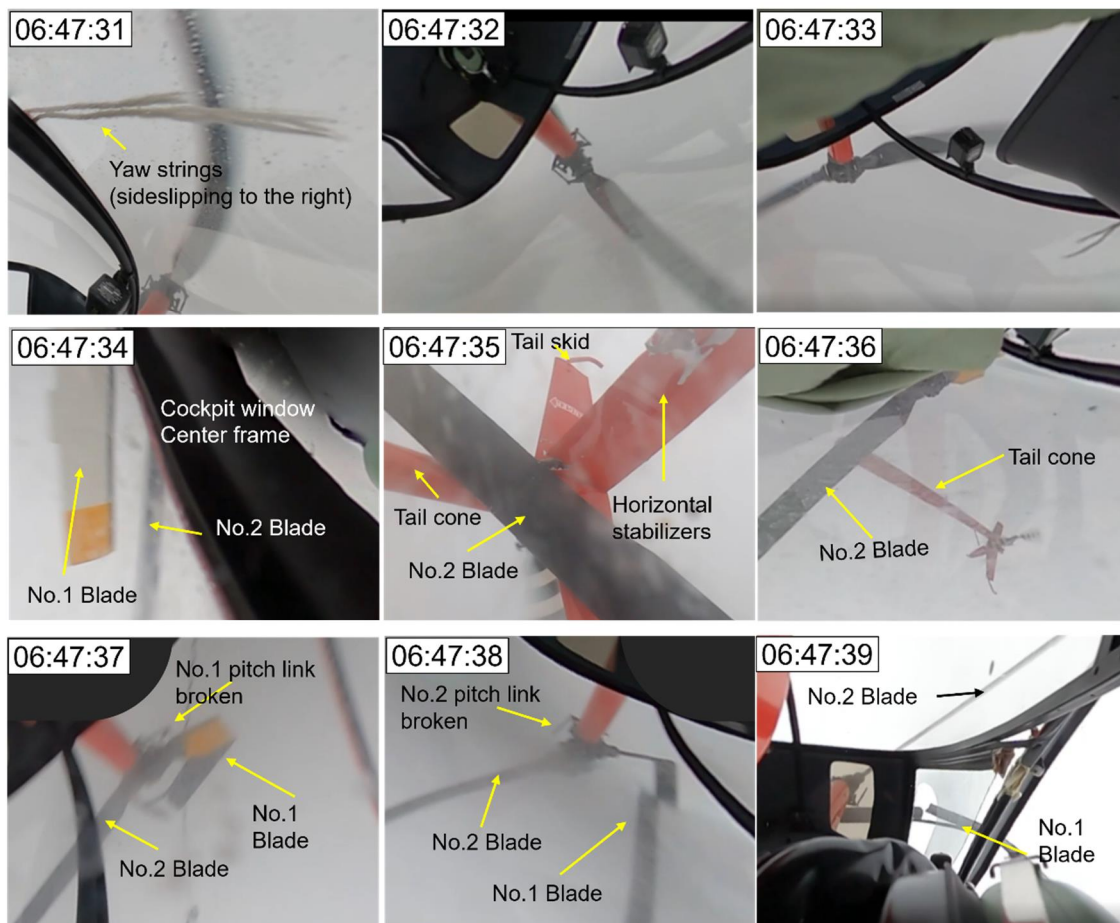
Figure 24: How the Helicopter Ended up with the Catastrophic Mast Bumping (edited from GoPro video)

The GoPro had recorded video showing the main rotor blades were broken off while the helicopter was continuing to roll to the left between 06:47:31 and 06:47:34, leading to the catastrophic mast bumping, as shown in Figure 24. On the image in the video recorded at 06:47:34, the No.1 Blade is reversed, with the two blades in a parallel position. And from the damage state and direction of deformation of each component, as described in 2.11.5, that the

main rotor teetering angle exceeded the design limit, and excessive loads were applied to the pitch links and swashplate while the No.1 Blade spindle tusk came into hard contact with the droop stop, and it is highly probable that the catastrophic mast bumping occurred, resulting in damage to the main rotor system.

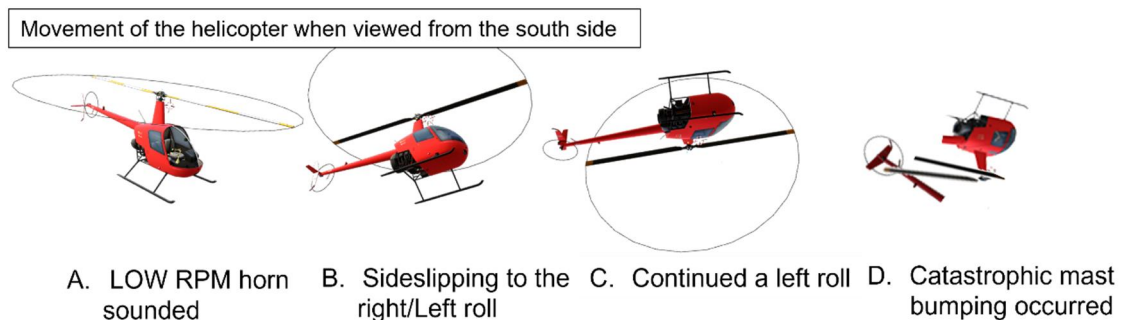
Figure 26: Condition of the Helicopter from LOW RPM HORN to Mid-air Breakup

Figure 26 is the visualization of the helicopter's condition from the LOW RPM HORN to mid-air breakup based on the video and metadata, showing the process leading up to catastrophic mast bumping in four phases.

- A. While the helicopter was climbing turn to the left through about 2,300 ft/min vicinity of about 3,400 ft, to lack of engine power, NR dropped below 97 % RPM, and at 06:47:29, the LOW RPM HORN was activated. At this time, the helicopter was put into an unstable low G flight condition, which caused the helicopter to roll to the right. The pilot heard the LOW RPM HORN, up to collective slightly, and approximately 0.5 seconds after the warning sound, the pilot abruptly pulled down the collective and moved the cyclic forward, as shown on the left in Figure 27. As a result of these operations, NR recovered but the low G flight condition worsened, resulting in a gravity acceleration of approximately 0 G condition. As shown on the right in Figure 27, at 06:47:30.8 seconds, as if surprised by the change in gravity acceleration, the pilot abruptly pulled up the collective and simultaneously moved the cyclic aft.

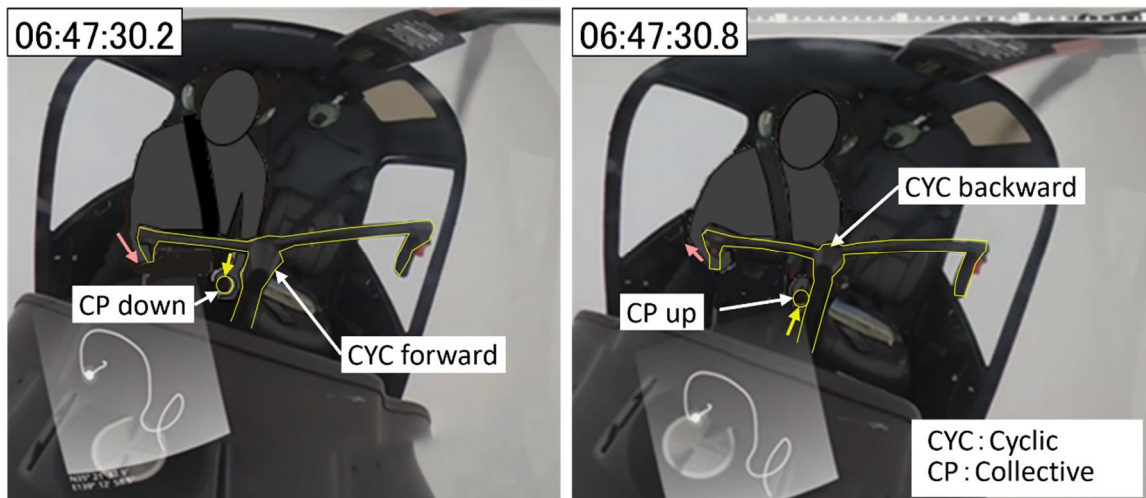
Figure 27: Abrupt Collective and Cyclic Control Movements
(created from GoPro video)

- B. After the collective was abruptly pulled up and the cyclic was moved aft at the same time, the helicopter began to roll to the left and entered a sideslip state to the right with the yaw strings^{*22} flowing directly to the side, as shown in the still image recorded at 06:47:31 in Figure 24. In addition, the collective was moved again during the left roll, the helicopter was continuously in a low G flight condition at about 0.5 G, flying
