AA2016-4

**AIRCRAFT ACCIDENT
INVESTIGATION REPORT**

**ORIENTAL AIR BRIDGE CO., LTD.
J A 8 0 1 B**

DAMAGE TO THE AIRFRAME DURING LANDING
ORIENTAL AIR BRIDGE CO., LTD.
BOMBARDIER DHC-8-201, JA801B
NAGASAKI AIRPORT
AT ABOUT 14:07 JST, FEBRUARY 12, 2014

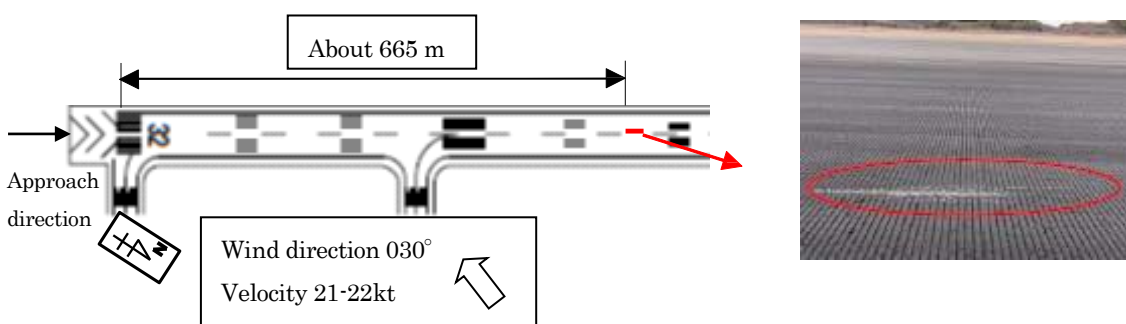
Diagram 1: The approach direction of the aircraft and the abrasion mark location on the runway

This abrasion mark was discovered when after the discovery of the damage to the nose landing gear of the aircraft was reported by the Company and the Japan Civil Aviation Bureau carried out runway inspection.

Photo: The abrasion mark on the runway

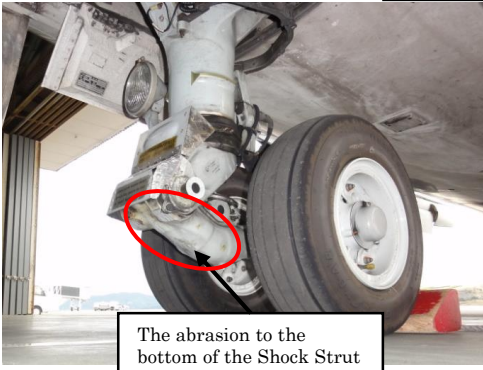
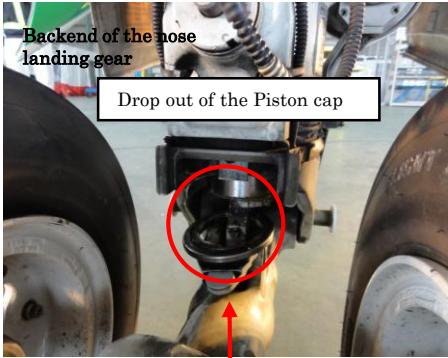
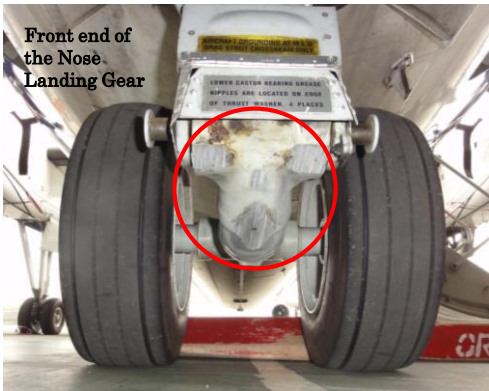
Damage to the Nose Landing Gear

(1) Nose landing gear: Partial attrition of the lowest end of the shock strut brace, damage to the shock strut parts, deformed marks to both tires.

It is probable that due to the heavy load on the nose landing gear of the aircraft, the nose landing gear trailing arm contacted the runway surface, and also that the shock strut of the nose landing gear had shrunk to the maximum, which then broken the piston cap of the bottom of the strut, and caused the deformation of the tires on the right and left. It is possible that the load could not be absorbed the damage to the nose landing gear alone, and due to the effect of this the right and left fuselage skins on the rear of the nose landing gear mounting areas were deformed.

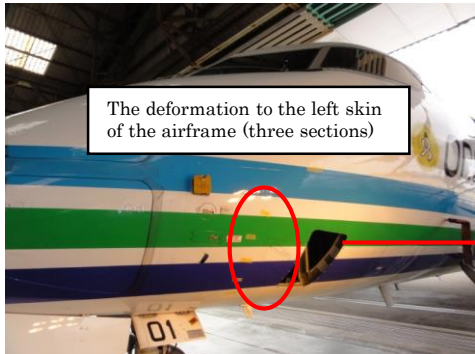
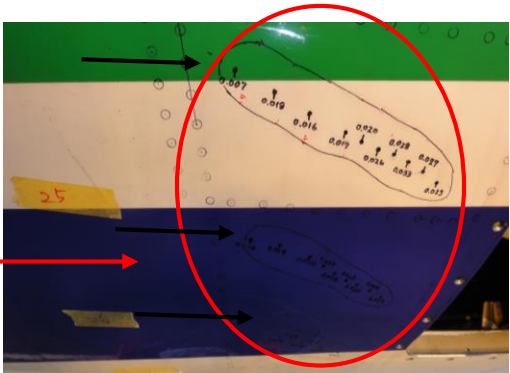
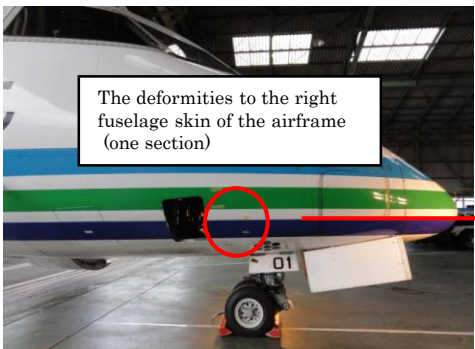
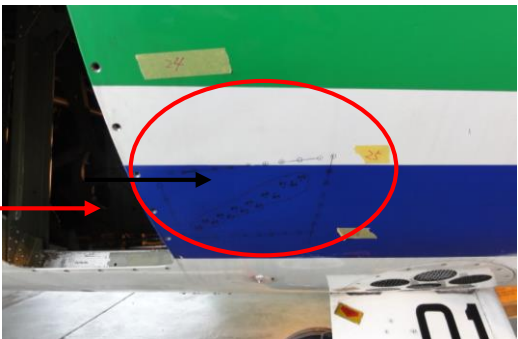
Damage to Fuselage Skin

(2) Fuselage section: Deformation of the right and the left fuselage skins on the rear of the nose landing gear mounting areas.

The right and left fuselage skins on the nose landing gear mounting areas were deformed (wrinkle) in three places on the left and one place on the right. These deformations were maximum 0.8mm in depth. The internal structural member of the deformed section had no damage uncountable.
