**AIRCRAFT SERIOUS INCIDENT
INVESTIGATION REPORT**

**PEACH AVIATION LTD.
J A 8 0 5 P**

AIRCRAFT DISABLED TO CONTINUE TAXIING DUE TO DAMAGED NOSE LANDING GEAR PEACH AVIATION LTD. AIRBUS A320-214, JA805P AT FUKUOKA AIRPORT, JAPAN AROUND 08:11 JST, MARCH 24, 2018

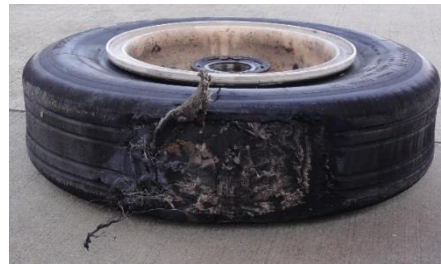
Figure 1: Damages to the tires

<p>2.2 Injuries to Persons</p>	<p>None</p>
<p>2.3 Damage to the Aircraft</p>	<p>(1) Extent of damage: Slightly damaged</p> <p>With regard to the nose landing gear, the nose wheels were turned about 90° clockwise to the axis, and the following damages were confirmed.</p> <ul style="list-style-type: none"> • Tires and wheels: Both left and right of them damaged • Torque links: Apex pin (described later) disconnected, the upper and lower torque links separated and dented

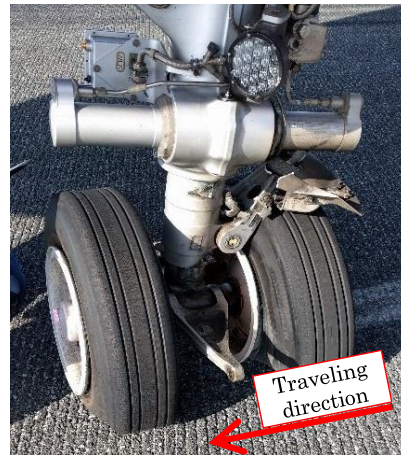
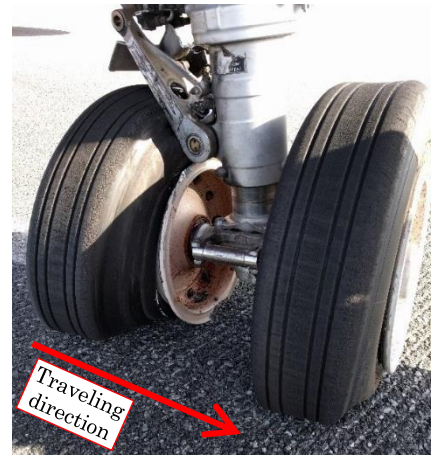
Figure 2: Damages to the nose landing gear

- Proximity sensor, Target support: Fractured
- Steering actuator: Impact marks on the cylinder

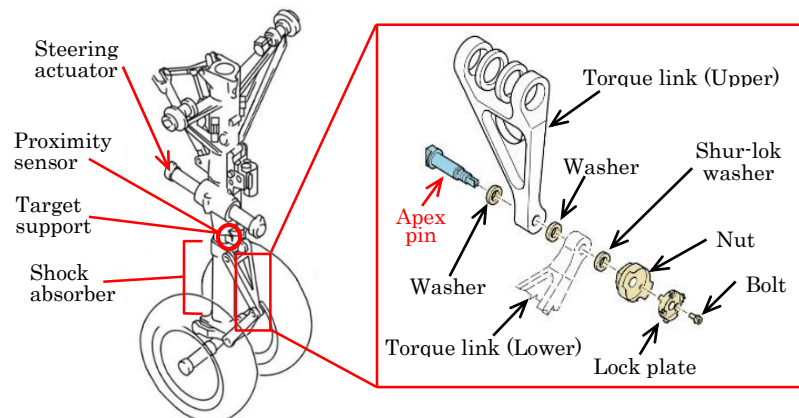
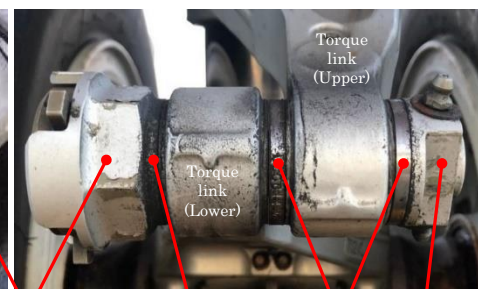
Figure 3: Parts around torque links

Nut, Lock plate, Shur-lok washer, Washers (two) and Bolt (yellow parts seen in Figure 3) missing

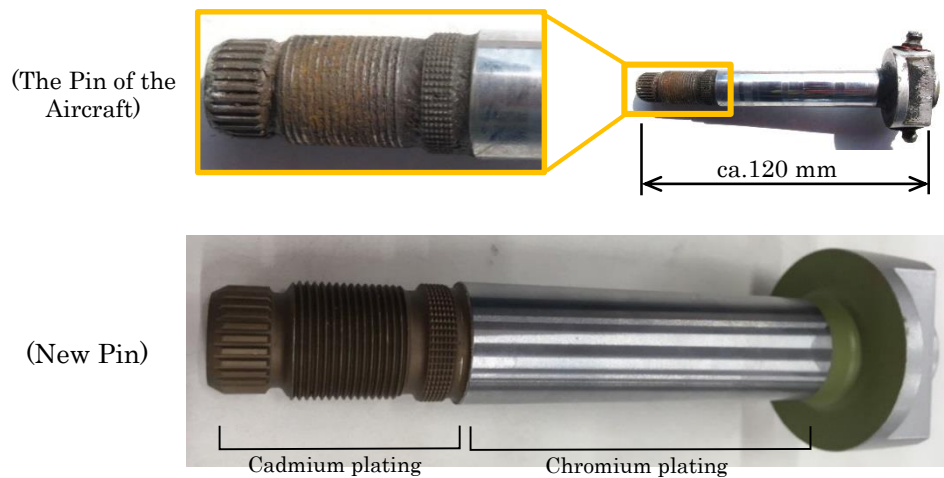
Figure 4: Apex pin

The Apex pin (hereinafter referred to as “the Pin”) to connect the upper and lower torque links of the NLG was recovered on the runway at Fukuoka Airport. Crest of the threads of the recovered Pin were found damaged and corroded (see Figure 4).

Those parts of the Pin assembly, such as Nut, Lock plate, Shur-lok washer, Washers (two) and Bolt were not retrieved in search around the runway at Fukuoka Airport. In addition, they were not found during the check on the runway, the taxiway and the apron of the departure airport, Kansai International Airport.

It is probable that the Pin disconnection occurred because the mechanical strength of the threads was deteriorated by corrosion developed on the Pin threads, the Pin assembly could not withstand the loading transmitting from the torque links to the nut during steering operations, and the nut was torn.

- ① Following this serious incident, the Aircraft Maintenance Manual was reviewed. As a result of this review, the Aircraft Maintenance Manual was updated by making the cleaning procedures in the detailed inspection on the Pin much clearer, and adding the inspection method regarding corrosion. Besides, the Pin installation procedures were updated to ensure that the grease application method and region were clarified.

- ② In the revised manual, it is required to clean carefully and dry all the Pin threads and splines, and to completely fill the threads and splines with reapplied grease.

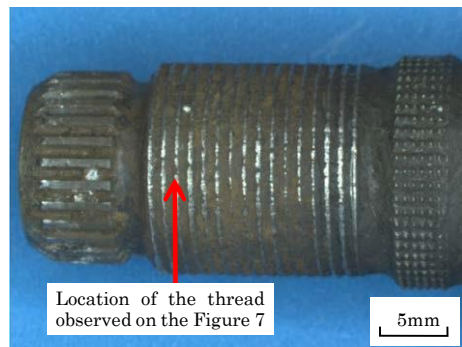
Figure 6: Enlarged photo of the Pin threads

- Crest of the threads have been found damaged and flattened. The maximum height measured is 0.202 mm when the specification requirement is greater than 0.613 mm.
- The threads were deformed indicating that the nut was pulled out of the Pin without the nut rotating.
- Rust was confirmed within the threads.

It was confirmed that many threads of the Pin were seriously

damaged due to the developed corrosion.

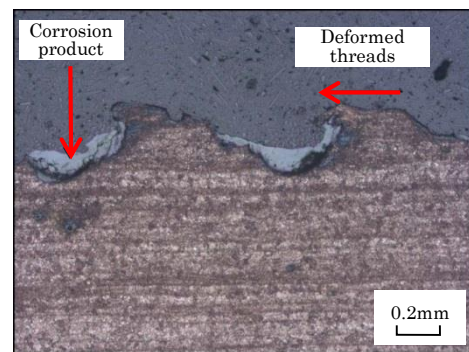
Figure 7: Micrograph showing the cross-section of Pin threads

It is probable that the corrosion of the Pin threads developed because the cadmium plating was damaged and the corrosion resistance of the threads of the Pin decreased.

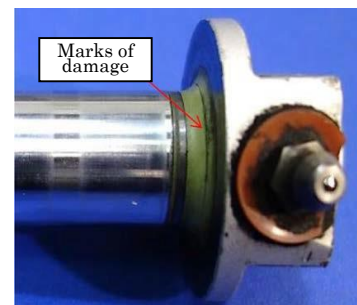
Figure 8: Damage to the paint under the head of the Pin

- c) Marks of damage were observed on the painted surface under the head of the Pin (see Figure 8).
- d) Abnormal wear marks were observed on the Pin chromium section (see Figure 9).

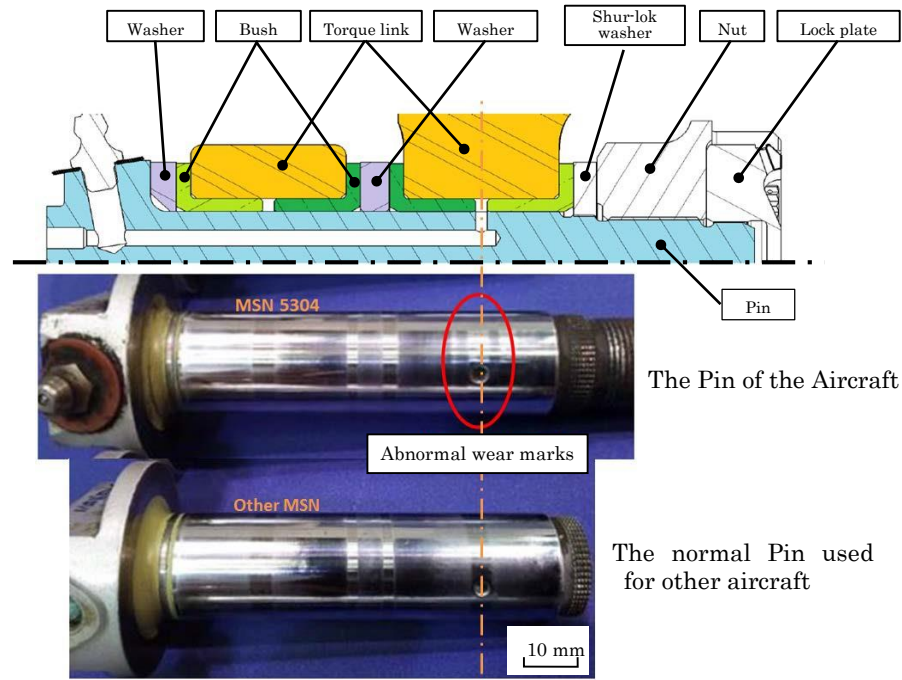
Figure 9: Comparison of the Pin wear marks

were observed on the chromium section of the Pin because the position of the torque link bushes were not consistent with the nominal assembly of the Pin.

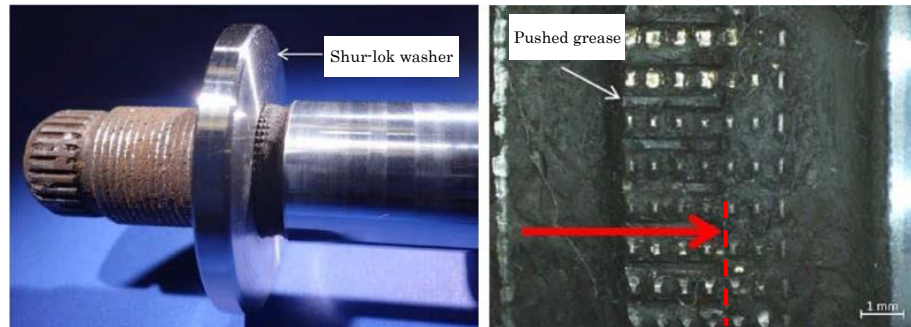
- e) The shur-lok splines were found fully filled with solid grease. When a new shur-lok washer was installed in the splines, the grease was pushed from the splines (see Figure 10). The installation of the shur-lok washer can prevent the rotation of the torque link joint from transmitting to the nut during operation of the shock absorber.

Figure 10: Old grease filling shur-lok splines
 (※The shur-lok washer was inserted to the red dash line.)

It is somewhat likely that due to the absence of the shur-lok washer, the gap between each part at the torque link joint became larger that facilitated water infiltration into the Pin and nut threads, in which the corrosion development was accelerated.
