**AIRCRAFT SERIOUS INCIDENT  
INVESTIGATION REPORT**

**Peach Aviation Limited  
J A 8 0 6 P**

## CASE EQUIVALENT TO LANDING ON A RUNWAY USED BY OTHER AIRCRAFT

PEACH AVIATION LIMITED, AIRBUS A320-214, JA806P  
ON RUNWAY 34L (RUNWAY A)  
AT TOKYO INTERNATIONAL AIRPORT  
AT ABOUT 01:03, NOVEMBER 30, 2019

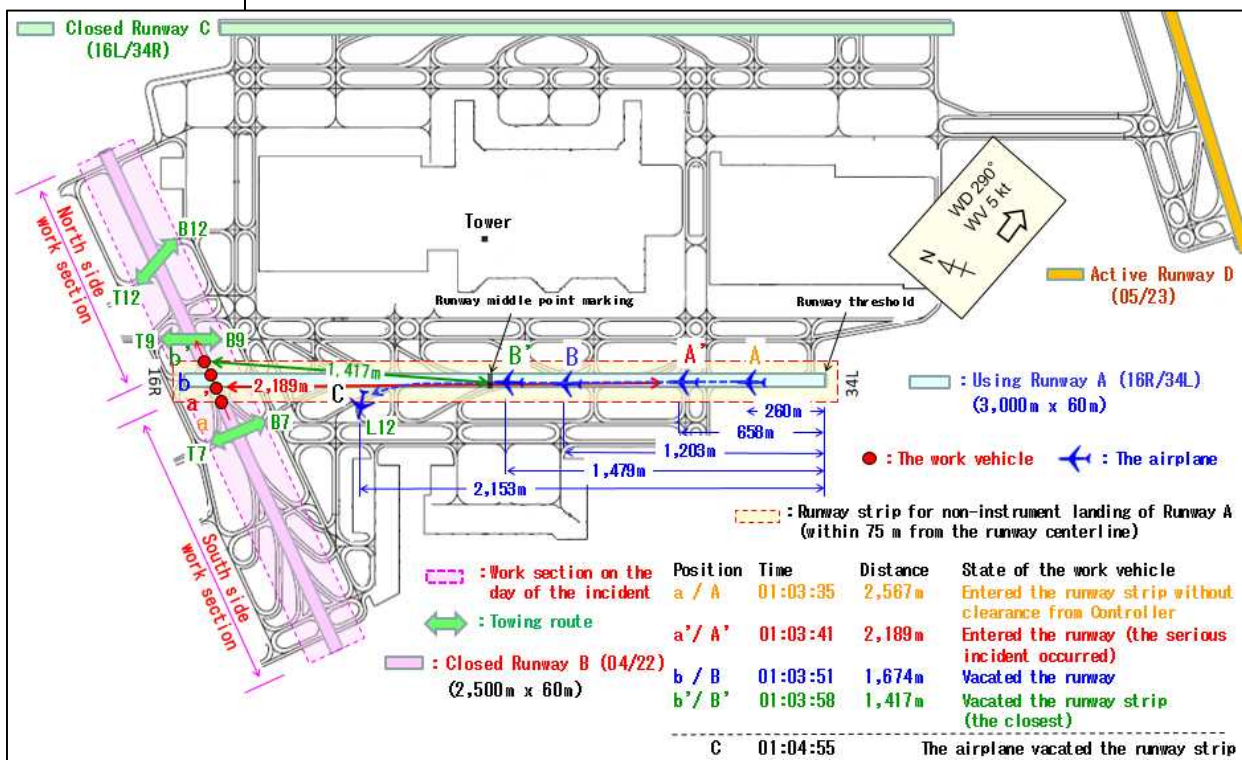
Figure 3: Position of the aircraft and the work vehicle

After that, Worker A visually checked for aircraft using Runway A at the shoulder of Runway A (30 to 35 m from the runway centerline), however at 01:03:41 (the position relations between the work vehicle and the airplane are shown in a'/A' in Figure 3), he started crossing Runway A without noticing the airplane immediately before the touchdown (at 658m after passing the threshold of Runway 34L).

At 01:03:51 (the position relations between the work vehicle and the airplane is shown in b/B in Figure 3), when the airplane passed in front of the halfway marking (at 1,203 m after passing the Runway 34L threshold), the work vehicle vacated Runway A.

At 01:03:58 (the position relations between the work vehicle and the airplane is shown in b'/B' in Figure 3), when the airplane passed immediately before the halfway marking (at 1,479 m after passing the Runway 34L threshold), the work vehicle reached the boundary of the runway strip of Runway A. At that point, the distance between the airplane and the work vehicle was 1,417 m. As Controller was visually checking the airplane and its surroundings from the airplane landing on Runway 34L to its vacating the runway to Taxiway L12, Controller did not notice that the work vehicle passed the intersection part between Runway A and Runway B.

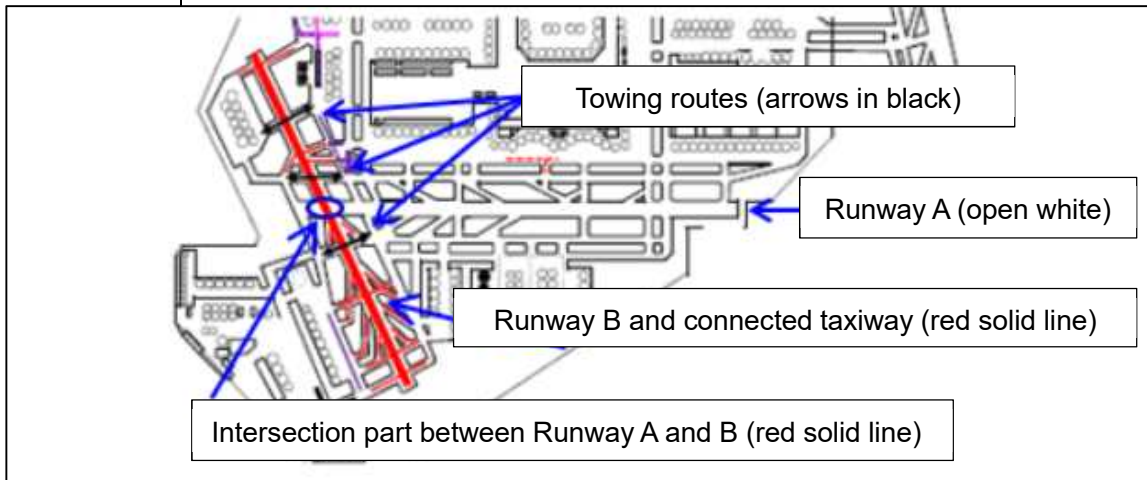
Figure 4: Weekly closure planning map (Excerpt from November 29, 2019)

The intersection part between Runway A and Runway B was filled in red meaning a closure in the closure coordination diagram, because the weekly closure planning map was referred to and copied, when the diagram was created. The intersection part in the weekly closure planning map was filled in red, probably because the weekly closure planning map is used for the NOTAM Issuance Coordination Document intended for Operators, however, it was not sufficient for the information intended for the construction workers, in addition, as failures were not exposed despite the repeated use of the same road map for long time, Flight Information Officer did not notice the risk possible for Workers to misunderstand the road map.

It is necessary to well consider the possible risk of misunderstanding by the construction workers and then how to describe the intersection part between Runway A and Runway B in the weekly closure planning map and the closure co-ordination diagram be elaborated.

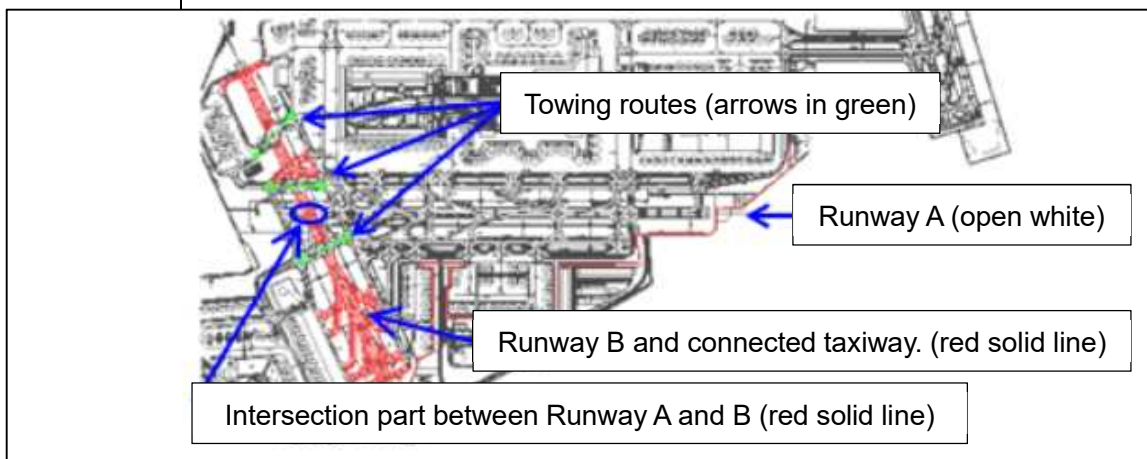
Figure 5: Closure co-ordination diagram (Excerpt from November 29, 2019)

Worker A confirmed that the intersection part between Runway A and Runway B was painted in red that means a closure in the closure co-ordination diagram added to the daily work schedule report. And at 01:03:35 (the position relations between the work vehicle and the airplane is shown in a/A in Figure 3) when the airplane passed through 260 m from the Runway 34L threshold, without requesting Controller to give him clearance for crossing Runway A, Worker A let the work vehicle enter the runway strip (within 75 m from the runway centerline) for non-instrument landing of precision approach of Runway A (Runway incursion\*<sup>2</sup> ) (Distance between the airplane and the work vehicle: 2,567 m).

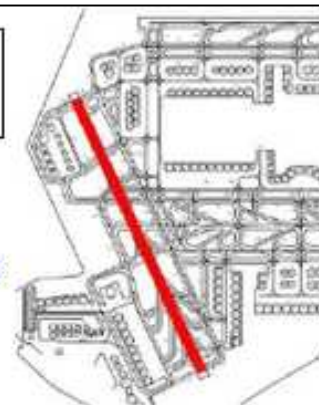
Figure 6-1: NOTAM concerning the closing of Runway B

When this serious incident occurred, at Tokyo International Airport, the following NOTAM (including graphic NOTAM) concerning the closing of Runway B and its connected Taxiway had been issued, but Runway A intersecting with Runway B was been active for take-off and landing, NOTAM concerning the closure for Runway A had not been issued. (See Figure 6-1, 6-2)
