AIRCRAFT ACCIDENT INVESTIGATION REPORT

NIPPON CARGO AIRLINES FLIGHT 62
BOEING 747-200F, JA8191
NEW TOKYO INTERNATIONAL AIRPORT, NARITA, JAPAN
OCTOBER 22, 2003

July 30, 2004

**AIRCRAFT ACCIDENT INVESTIGATION REPORT
NIPPON CARGO AIRLINES FLIGHT 62
BOEING 747-200F, JA8191
DAMAGE TO AIRCRAFT BY AFT FUSELAGE CONTACT WITH GROUND
NEW TOKYO INTERNATIONAL AIRPORT, NARITA, JAPAN
AT ABOUT 21:57 JST, OCTOBER 22, 2003**

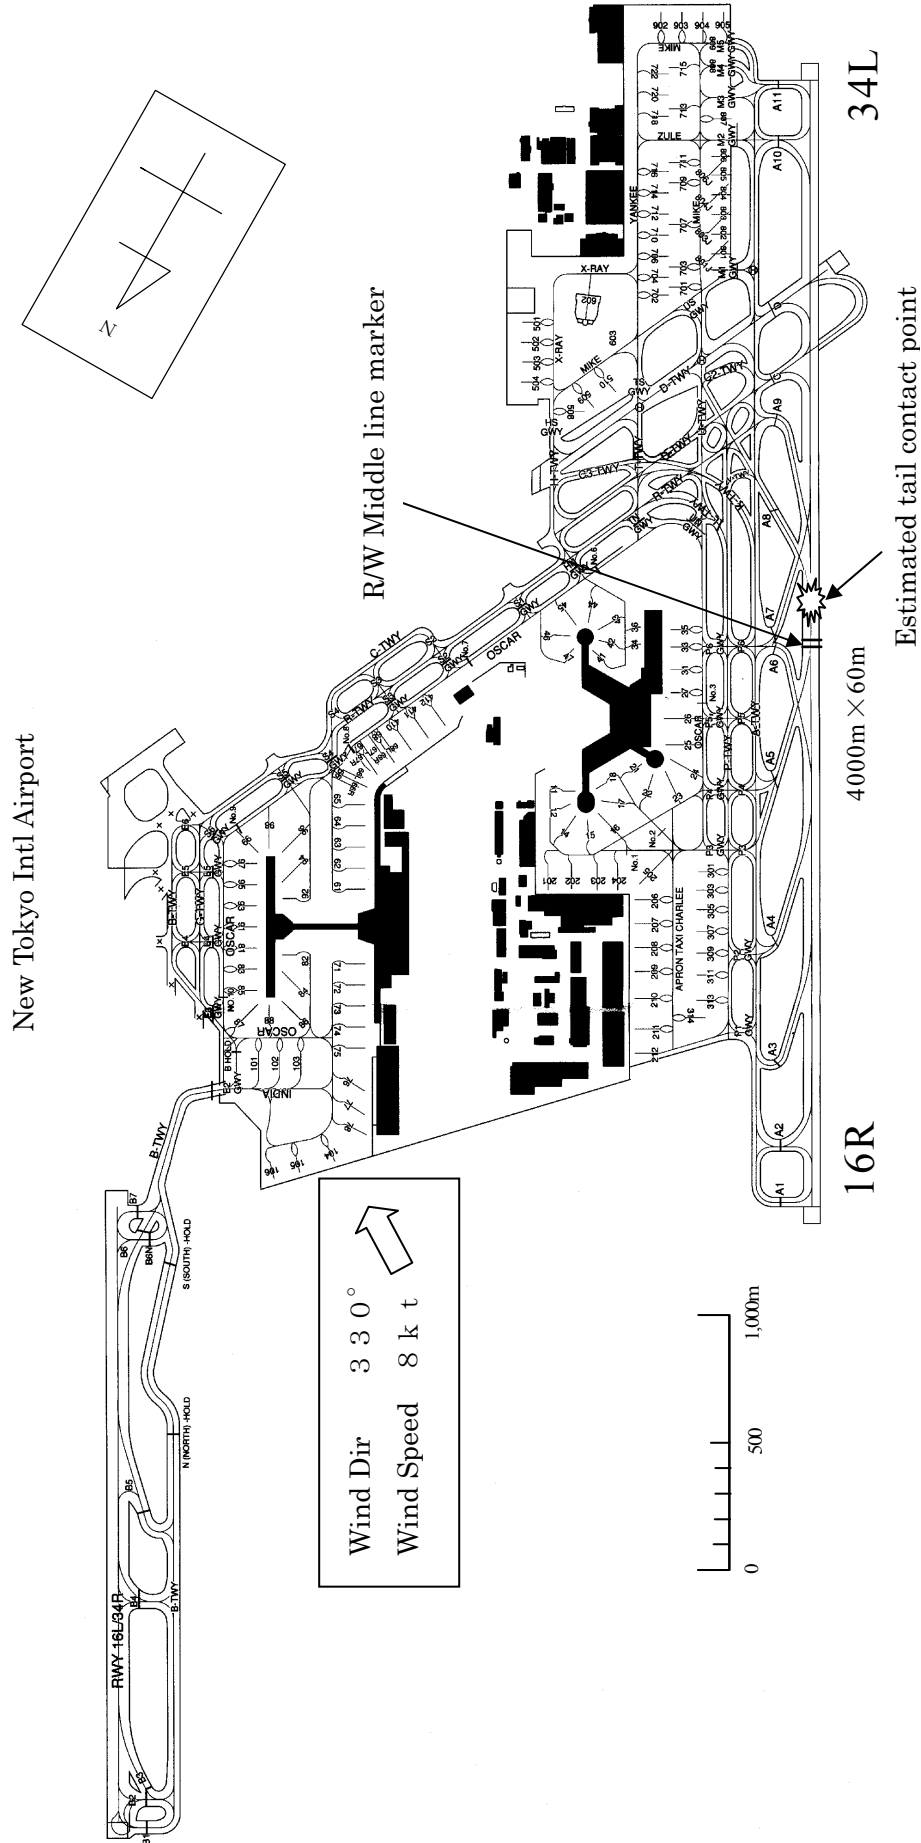
Figure 2 Estimated tail contact point

Based on DFDR recordings, at the time the aircraft pitch angle reached 11.9 degrees, the aircraft was around 1,620–1,690m from the point at which the takeoff started. Assuming that the start of the takeoff was around 150m inside from the threshold of the runway 34L, there ought to have been abrasion marks caused by the aircraft around 1,770–1,840m from the approach end of runway 34L; however, no marks that could be thought to have been made by the aircraft were found.

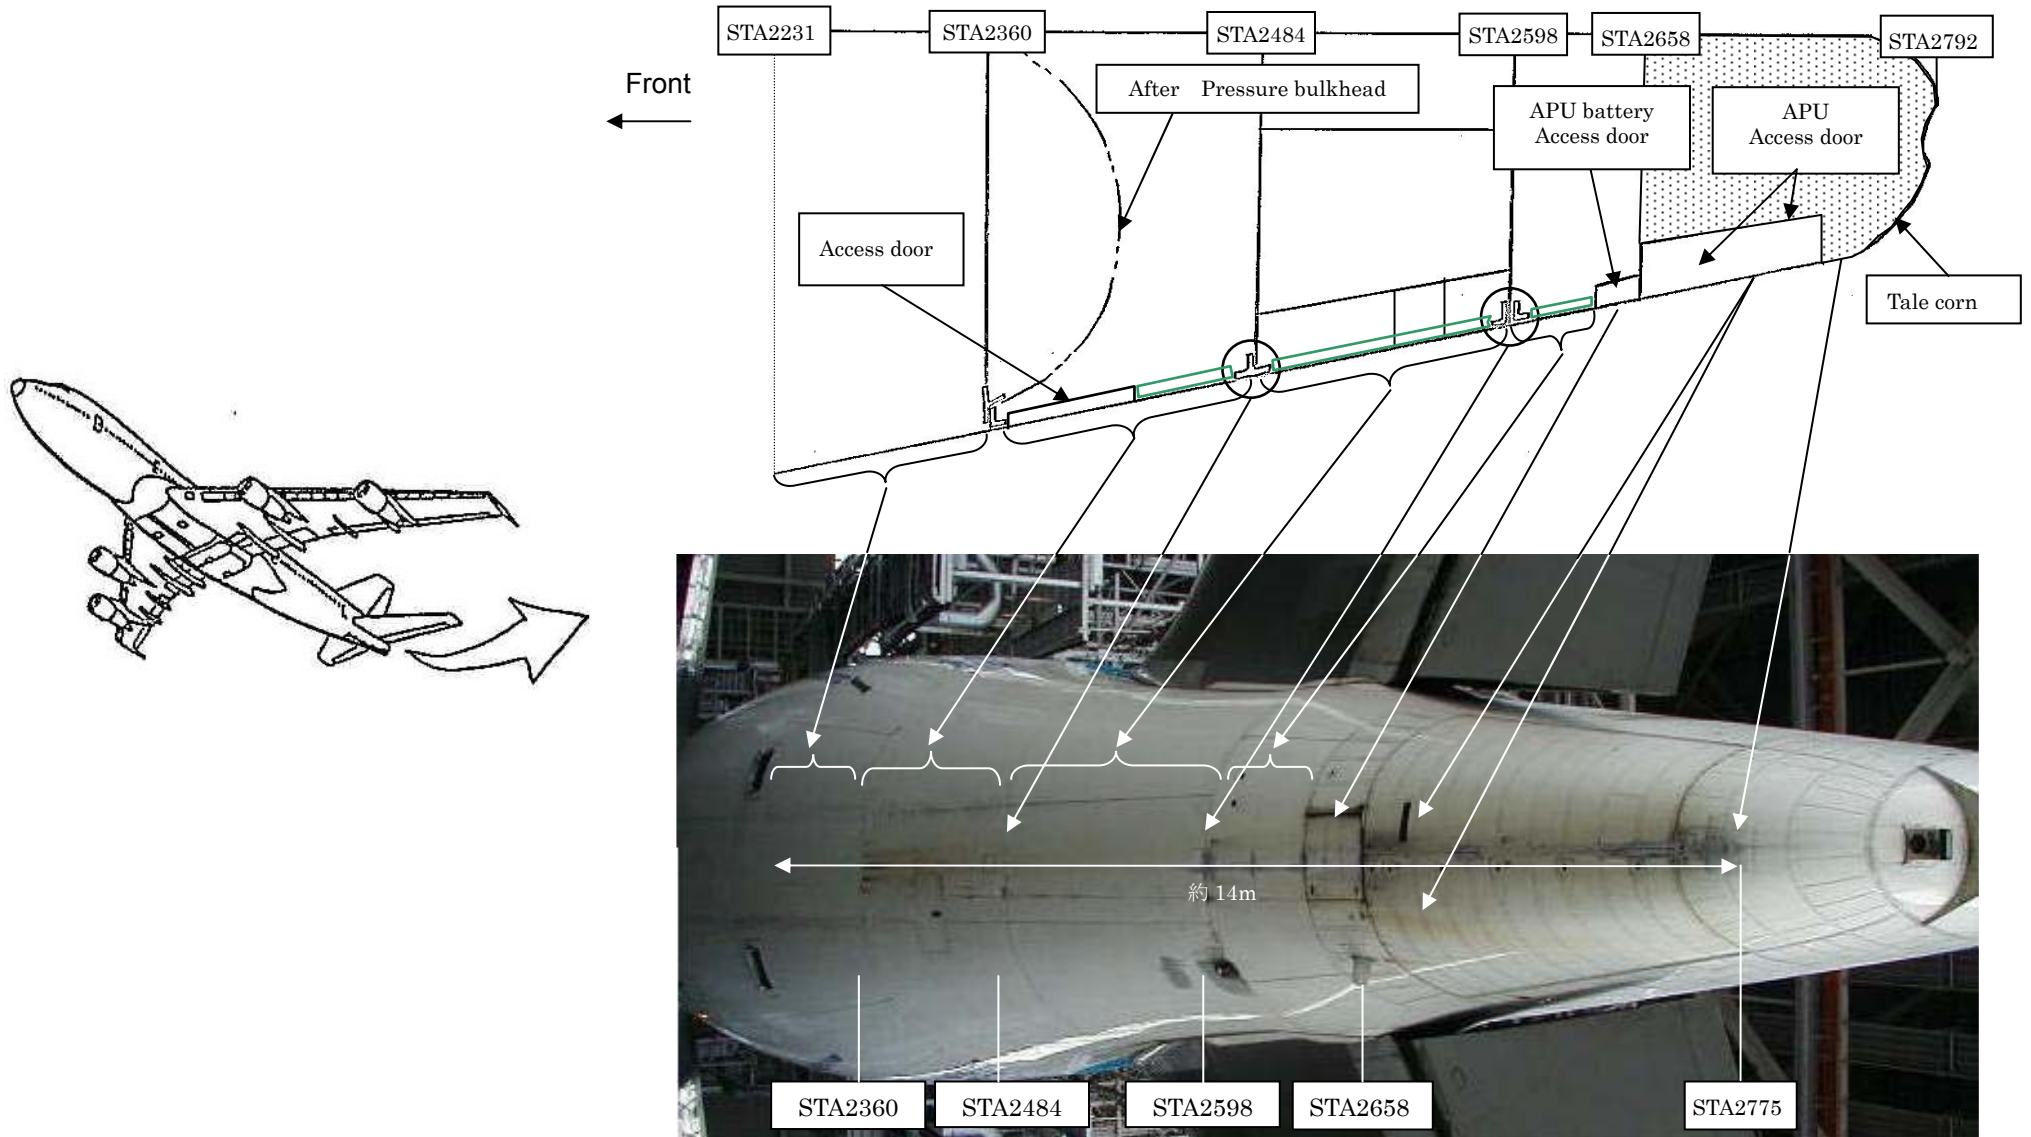
Figure 4 Damage Station

- ① Abrasions estimated as being damage caused by the tail contacting the runway were found on the aft lower fuselage skin for around 14m from stations (Note 6) 2231 to 2775. The abrasions became increasingly conspicuous moving aftwards.
- ② Deformation of the lower frames was found at Sta. 2484, 2598 and 2658, and cracks were found in some of these. Part of a lower stringer that passes through these stations was bent inwards.

Abrasions were found.

Abrasions, dents and cracks were found.

Abrasions and cracks were found.

Abrasions, dents and cracks were found on the bottom of the tail cone.

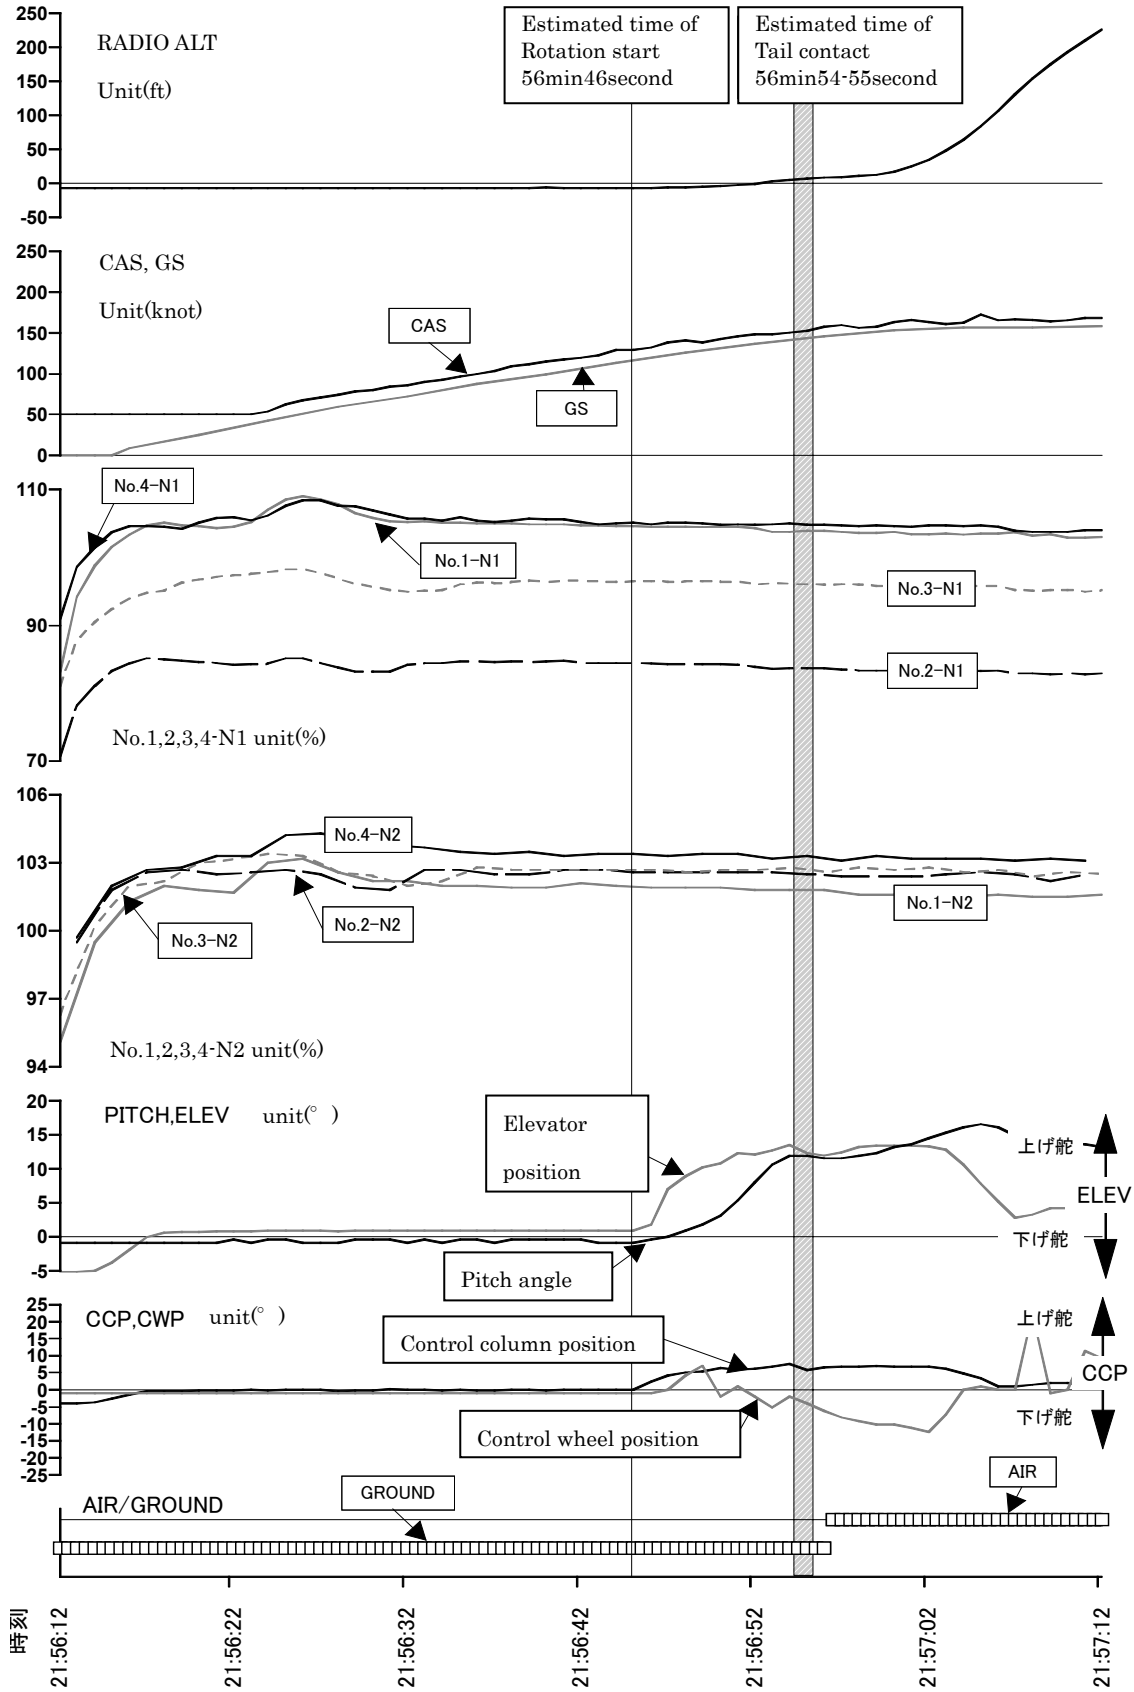
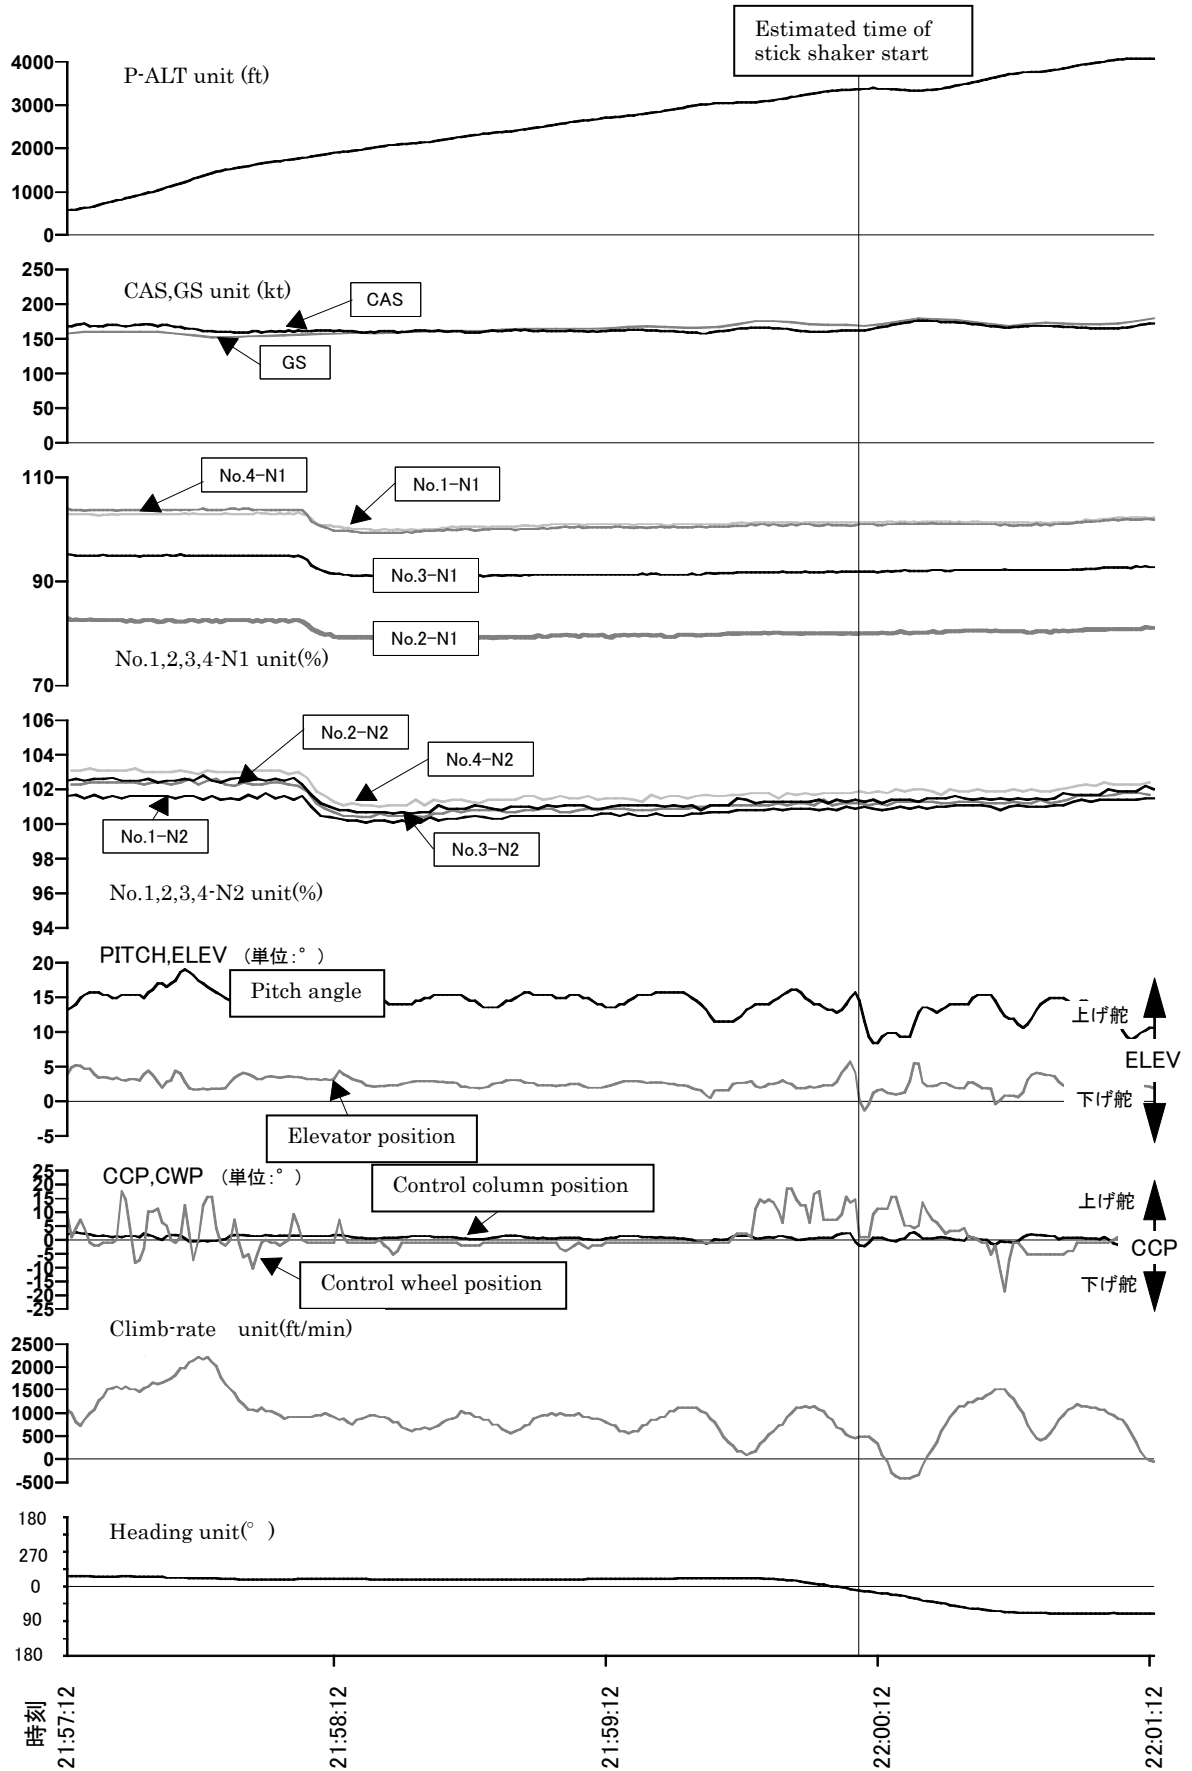
Figure9-1 DFDR Recording-1

- 2156:54–55: Pitch angle indicated its maximum value of 11.9 degrees while the AIR/GROUND (AIR/GRD) sensor was in GROUND mode.
- 2156:54: The control columns were pulled back to 7.5 degrees, the maximum value reached in the accident. The aircraft was approximately 1,620m from the start of the takeoff roll.

- 2156:55: The control columns returned to 5.8 degrees. The aircraft was approximately 1,690m from the start of the takeoff roll, and CAS was 153kt.
- 2156:56: CAS was 158kt, the control columns were pulled back to 6.6 degrees and pitch angle was 11.5 degrees. The AIR/GND sensor was in GROUND mode.

- 2156:57: The AIR/GRD sensor changed to AIR mode, and it was 11 seconds after the start of the rotation. CAS was 160kt, radio altitude was 9ft, the control column was pulled back to 6.7 degrees and pitch angle was 11.5 degrees.

At 21:56:54 and 21:56:55, pitch angle reached 11.9 deg. and CAS was 151kt and 152kt respectively. These airspeeds are more than 15kt slower than the 168kt V_R corresponding to the takeoff weight and thrust, and since the aircraft had therefore not yet attained sufficient airspeed to lift off, the body gear would have been at zero tilt and the oleos would have been in a compressed state. Based on the table in section 2.13.6, it is therefore estimated that the lower part of the aircraft's aft fuselage was in contact with the runway surface, and had started to be damaged by abrasion as described in section 2.3.2 as a result.

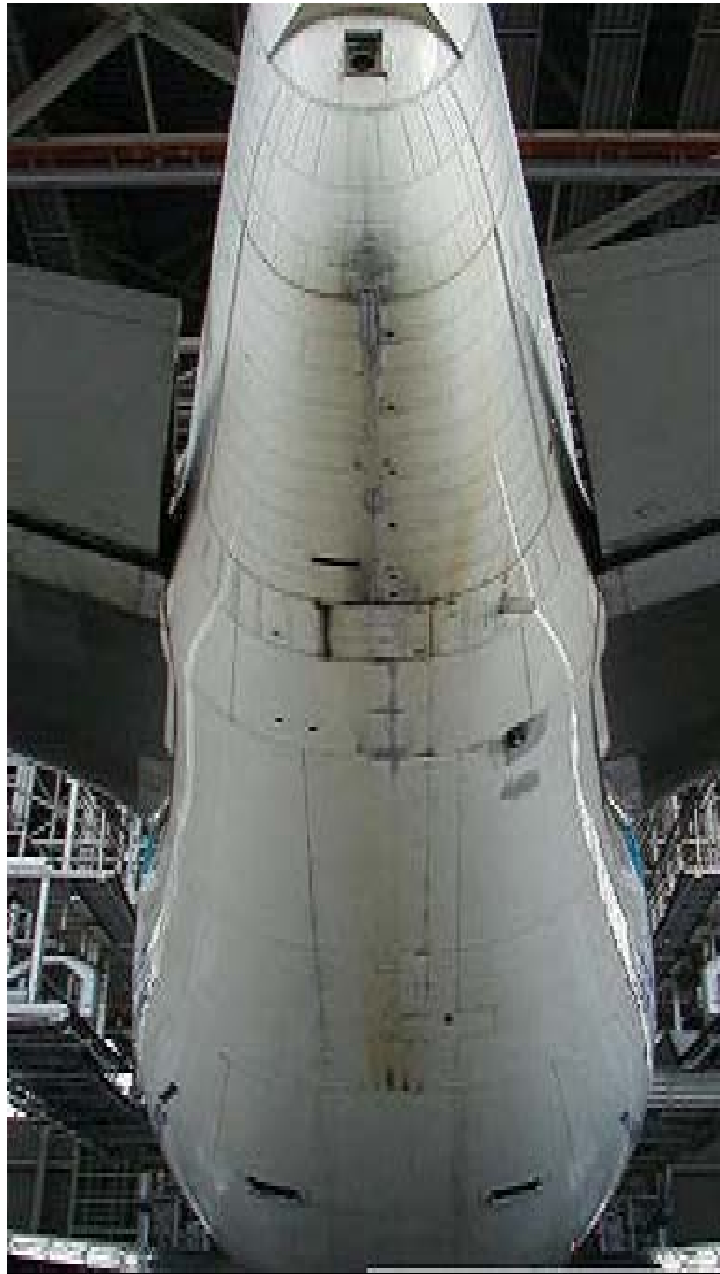
Photograph 1 Damage of the tail corn

In this accident, while the aircraft was taking off from Narita Airport, it is estimated that liftoff was delayed due to rotation being initiated at lower than the appropriate speed, and that the lower surface of the aft fuselage contacted the runway surface, causing it to be damaged.
