AIRCRAFT SERIOUS INCIDENT INVESTIGATION REPORT

September 11, 2025

Adopted by the Japan Transport Safety Board

Company	Academic Corporate Body Hiratagakuen
Type, Registration Mark	Eurocopter EC135P2+ (Rotorcraft), JA824H
Incident Class	Case equivalent to “landing on an unassigned runway” Case equivalent to the item (ii), Article 166-4 of the Ordinance for Enforcement of the Civil Aeronautics Act of Japan (item (xviii) of same Article)
Date and Time of the Occurrence	At about 13:45 Japan Standard Time (JST: UTC+9 hours), August 8, 2024
Site of the Incident	On the runway at Kobe Airport

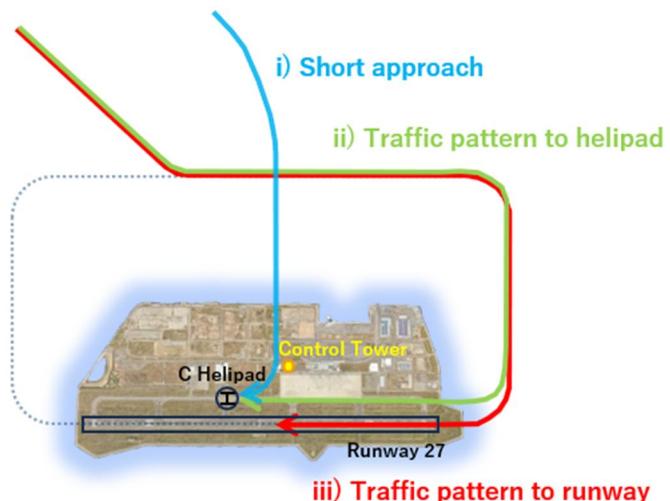
Figure 2: Helicopter Landing Route from the north of the airport

At the airport, the main landing route for helicopters coming from the north side of the airport when Runway 27 is in use is as shown in Figure 2. According to the ATC at the airport, non-training helicopters are often landed at the helipad using a short approach for time and fuel efficiency reasons, but if there are obstacles to the use of the helipad on the taxiway due to the departure and arrival of scheduled passenger flights and so on, they will instruct such helicopters to land on the runway. The pilot had initially anticipated a short approach return flight as shown in i) in Figure 2, but as the helicopter ended up following a preceding helicopter, the pilot expected a landing at the helipad via the traffic pattern shown in ii) in Figure 2.

(Other than above, landing can be made at the Grass-Area)
