**AIRCRAFT SERIOUS INCIDENT  
INVESTIGATION REPORT**

**JAPAN AIR COMMUTER**

**J A 8 4 7 C**

**JAPAN AIR COMMUTER CO., LTD.  
BOMBARDIER DHC-8-402, JA847C  
IN THE AIR, APPROXIMATELY 6 KILOMETERS  
NORTH-NORTHWEST OF TANEGASHIMA AIRPORT  
AT ABOUT 9:34 JST, MARCH 25, 2009**

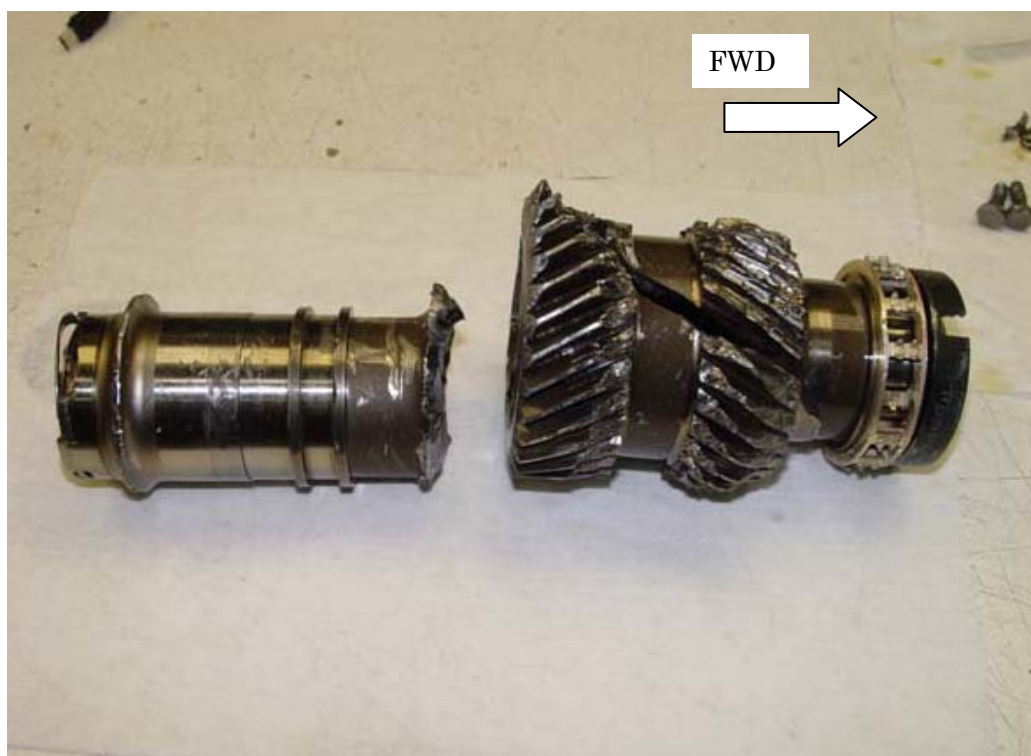
Photo 2 Fracture situation of RGB helical input gearshaft

- (1) The helical gear of the reduction gear box (hereinafter referred to as “the RGB”) helical input gearshaft (P/N 3122284-01A) was fractured, separated from the shaft, and split into two pieces.

- (1) The fractured RGB helical input gearshaft was examined using a scanning electron microscope (SEM). The results showed that the shaft had been fractured in the following process: A crack started from an inclusion situated below the surface of the

fractured RGB helical input gearshaft. The crack then propagated helically from the inside toward the outside of the shaft along its contour, and then an overload resulting from torsional stress led to the development of fatigue cracks, eventually causing the shaft to fracture.

- (6) Semi-quantitative analysis of the fractured RGB helical input gearshaft using EDA (energy dispersive spectroscopy analysis system) indicated that the major alloying elements of the base material were consistent with the compositional requirements. (See Photo 2, Photo 3, and Photos 6 to 9)

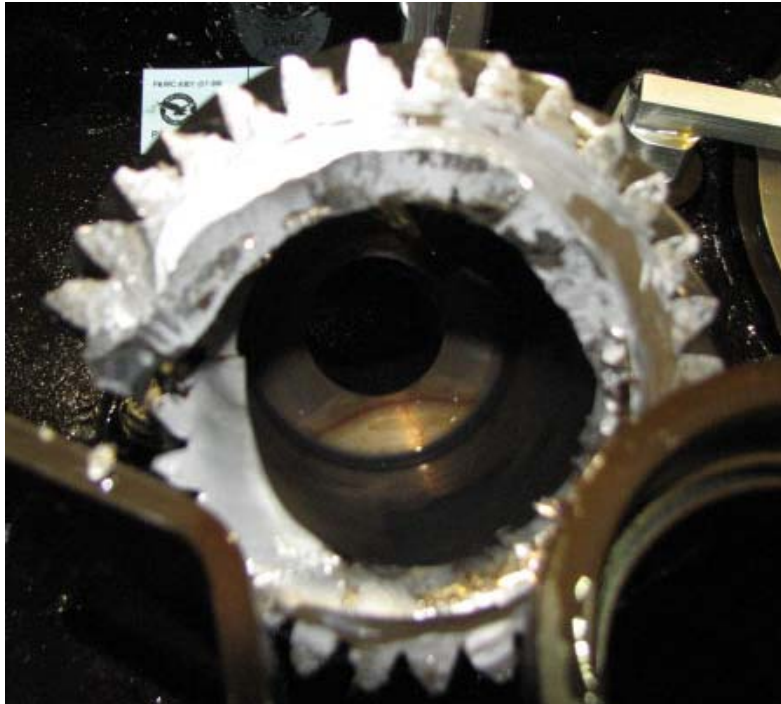
Photo 3 Fractured RGB helical Input gearshaft

- (2) The initial crack started at 0.03 inches below the surface of the helical gear teeth root fillet. The observed inclusion was 0.03 long and extended almost in parallel with the axis of the shaft.

- (4) From the estimated number of striations that were observed on the longest of the cracks, the final fracture would have resulted from high cycle fatigue\*<sup>7</sup> of 182,000 cycles.

It is highly probable that, as described in 2.9.1.1 (1), a stress and distortion concentration point had formed on the RGB helical input gearshaft at a subsurface location where an inclusion (0.03 inches long) was present, and this induced the generation of fatigue cracks that then grew helically from the inside toward the outside of the shaft along its contour under torsional stress caused by rotation of the shaft, which eventually resulted in fracture of the shaft.

It is also highly probable that, as described in 2.9.1.1 (2) and (4), the fatigue cracks had started from the impurity inclusion in the helical gear metal stock and subsequent application of repetitive cycles of stress brought about the fracture; the number of repeated stress cycles until the final fracture would be 182,000 as derived from the striations in the longest crack.

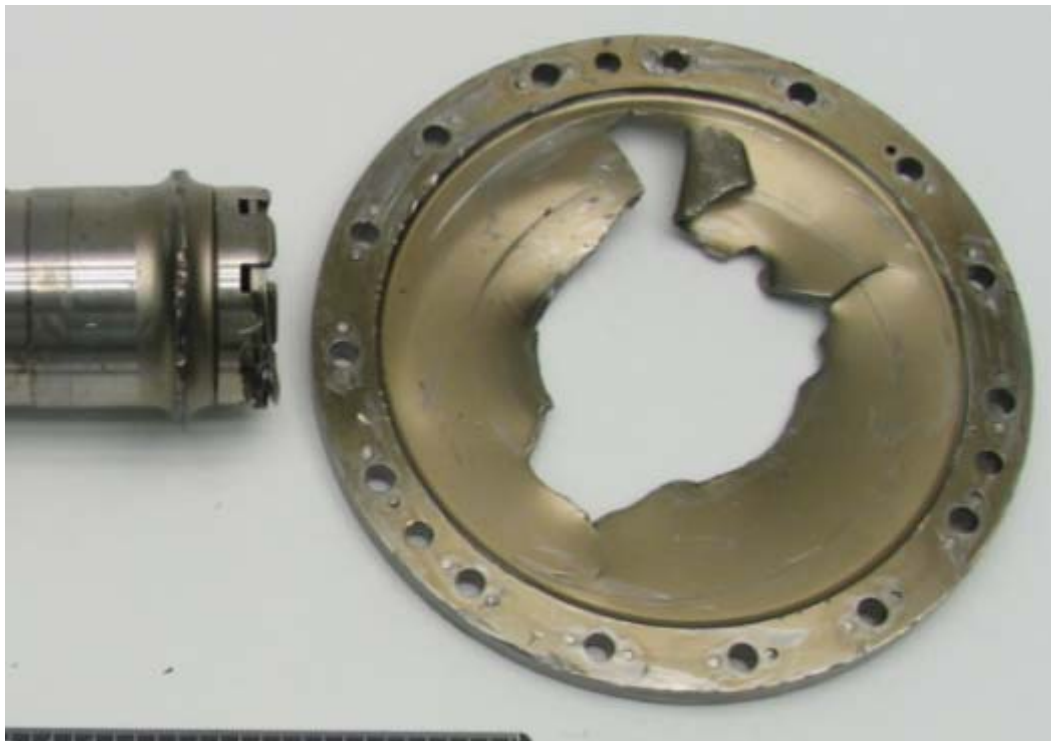
Photo 4 Fracture situation of RGB input shaft

- (1) The results of visual inspection revealed that the RGB input shaft was broken at the web of its flange.  
The front coupling shaft diaphragm was torn, which had been caused by an overload applied to the shaft.
- (2) The flanges at both ends of the RGB coupling shaft were torn and separated from the periphery of each end, showing signs of tearing due to the application of an overload. (See Photo 4 and Photo 5)

With regard to the fracture of the RGB input shaft and the RGB coupling shaft of the air inlet section, it is considered highly probable that, as described in 2.9.1.2, torsional overload was generated in the RGB helical input gearshaft due to the fatigue fracture of the RGB helical input gearshaft during its high-speed rotation, and as a result, the shaft flanges and the shaft diaphragm of the RGB input shaft and RGB coupling shaft were torn off and these shafts were eventually fractured.

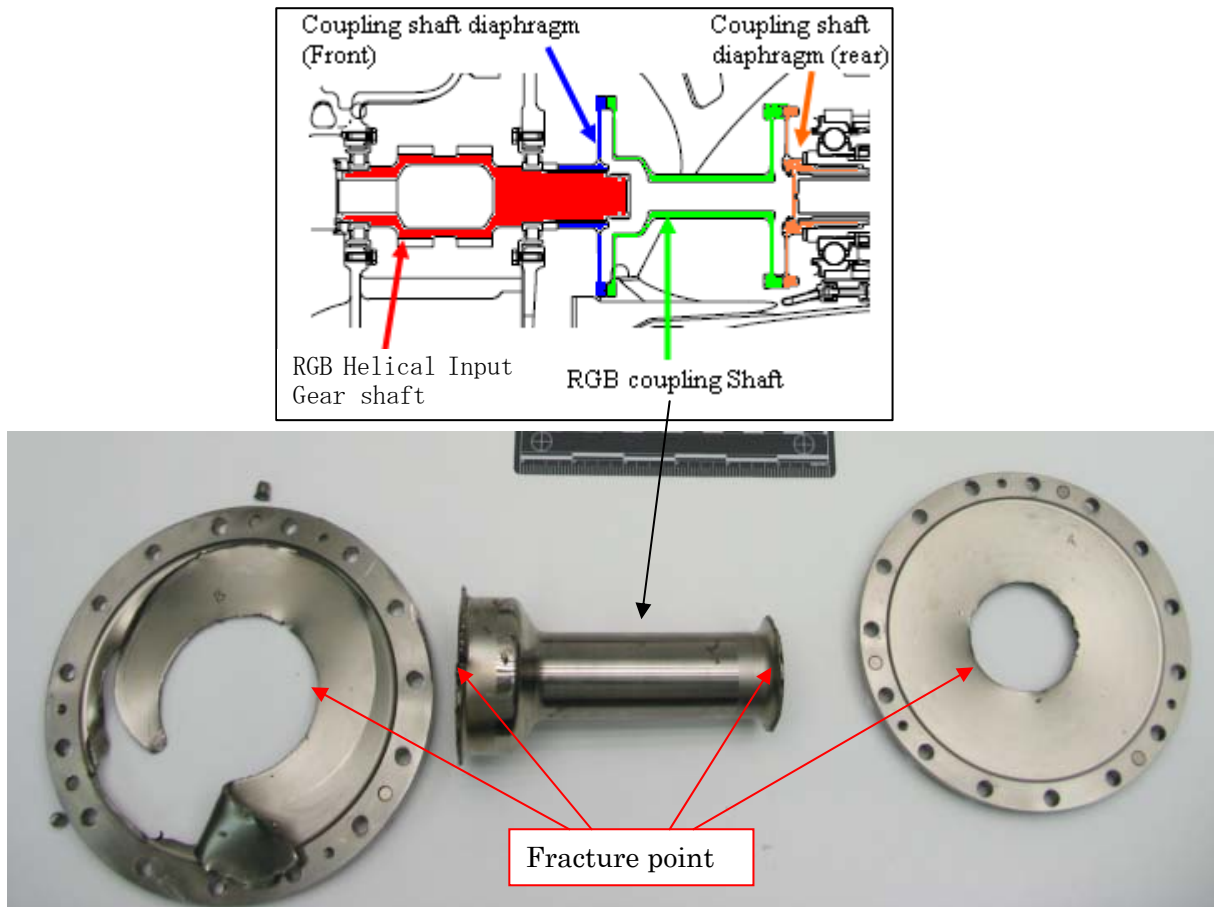
Photo 5 Fracture situation RGB coupling shaft

- (2) The diaphragm of the RGB input shaft in the air inlet section was torn off and separated from the shaft. The RGB coupling shaft was torn at the flanges on both ends and separated out of position.
- (3) All the blades of the high-pressure turbine (hereinafter referred to as “the HPT”) were fractured.

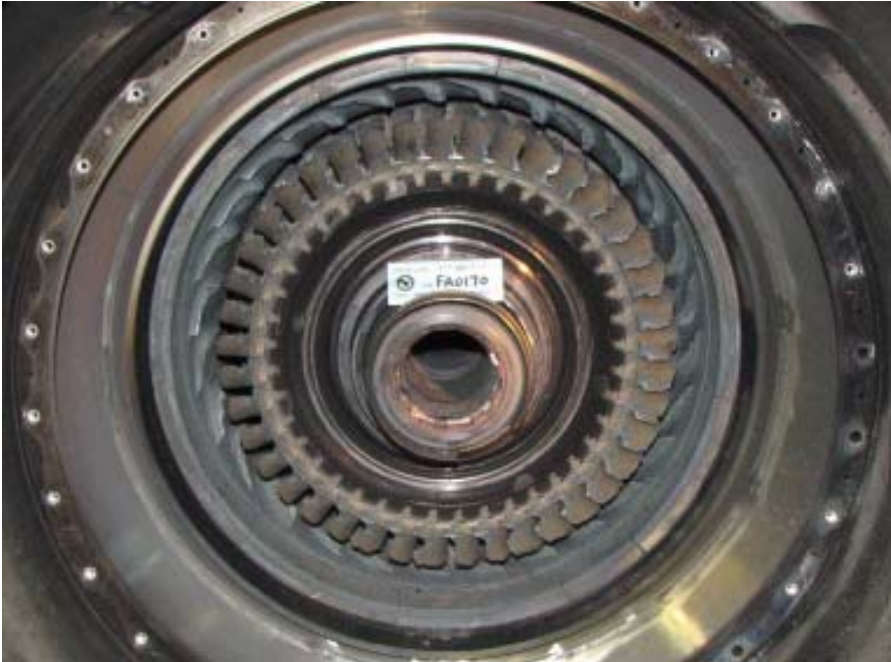
Photo 10 Fractured LPT blade

All the blades were fractured nearly at the midpoint along their length due to impact and overheat damage.

All the vanes were fractured into small fragments due to heat damage.

As described in 2.9.1.3 (1) to (3), it is considered highly probable that all of the HPT, LPT and PT turbine sections were fractured and damaged due to secondary breakage caused by overload on these components as a result of the RGB helical input gearshaft fatigue fracture.

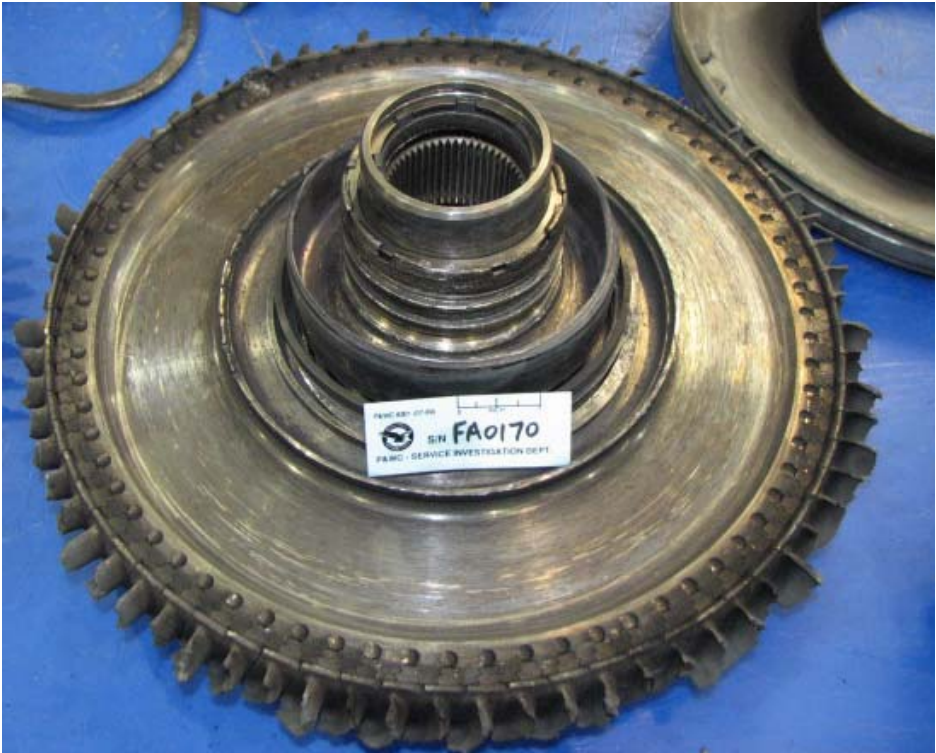
Photo 11 Fractured PT blade

The 1st stage blades were fractured at a point one-third along their length and the 2nd stage blades were fractured at their platform sections.

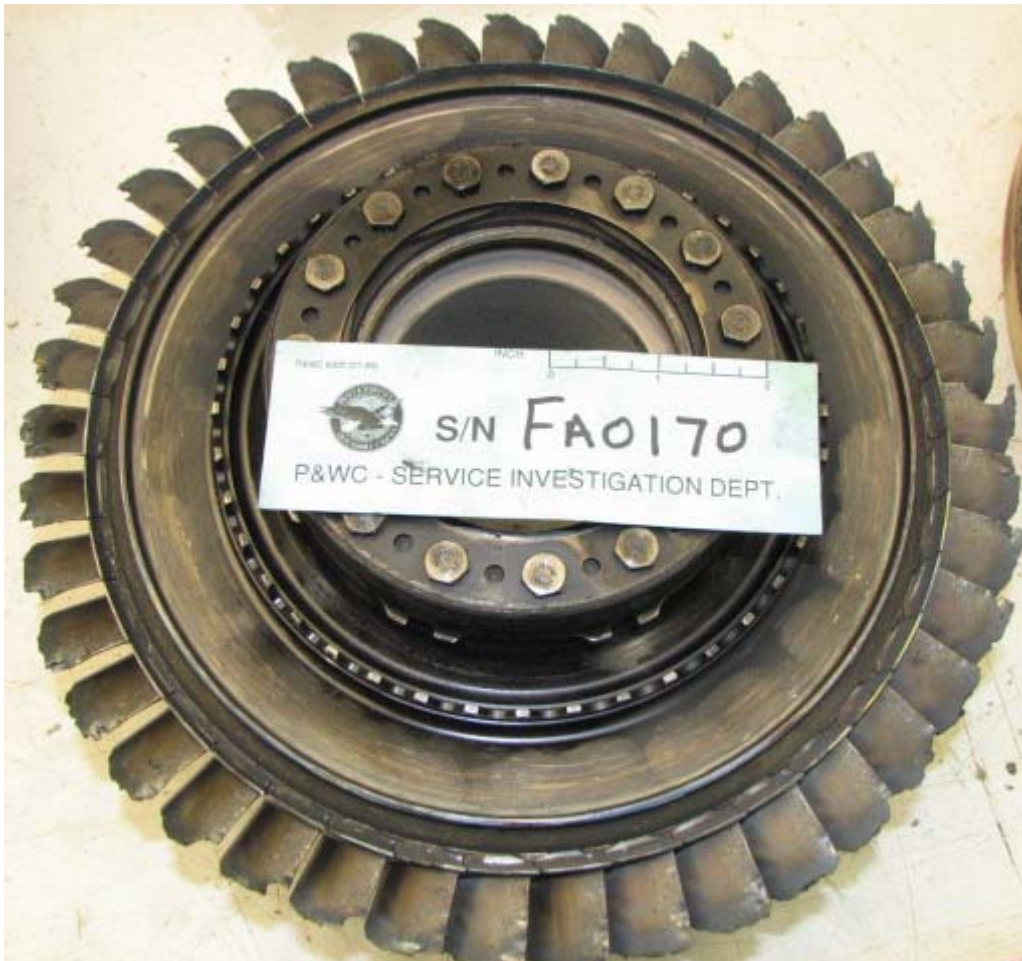
Photo 12 Damaged HPT blade

All the blades were fractured after having been damaged by impact and overheating. In addition, all shrouds\*<sup>8</sup> were damaged by impact and heat.

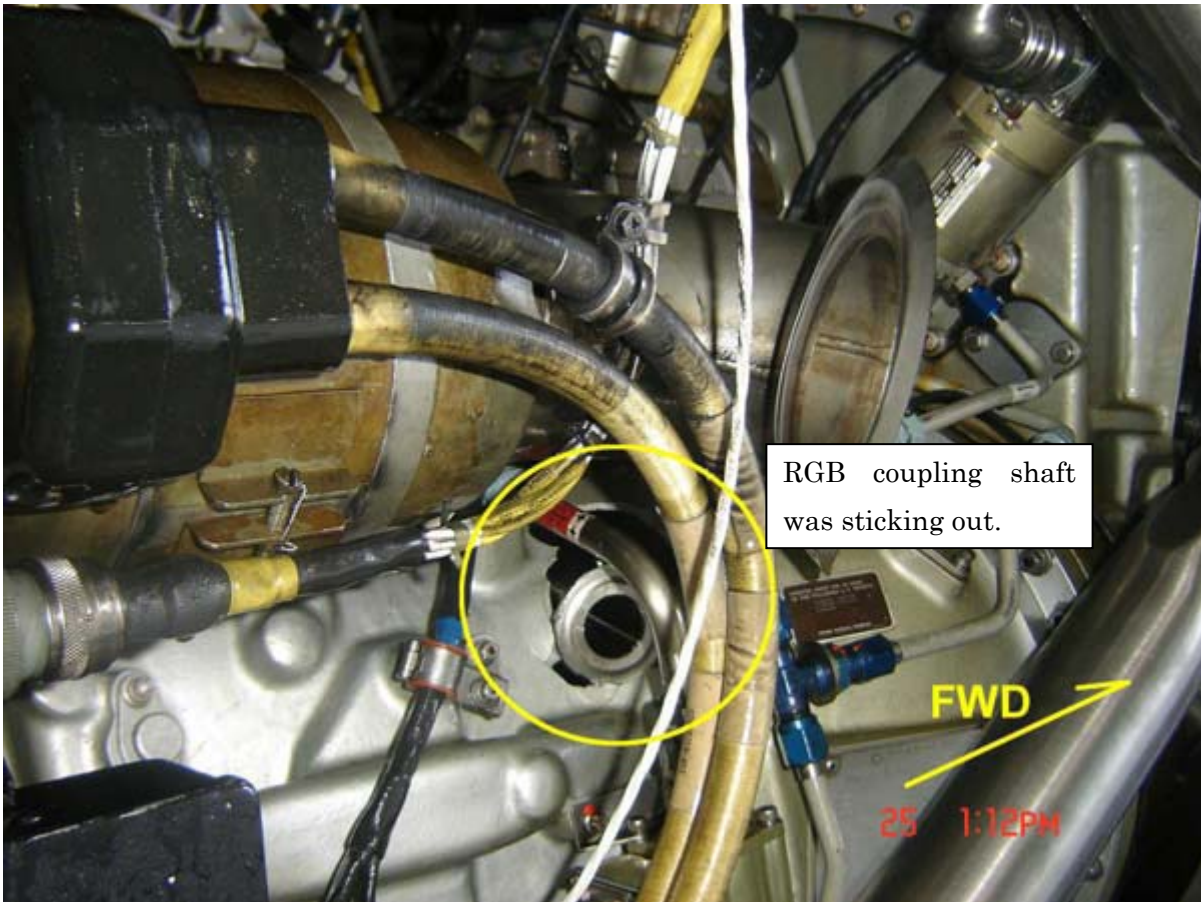
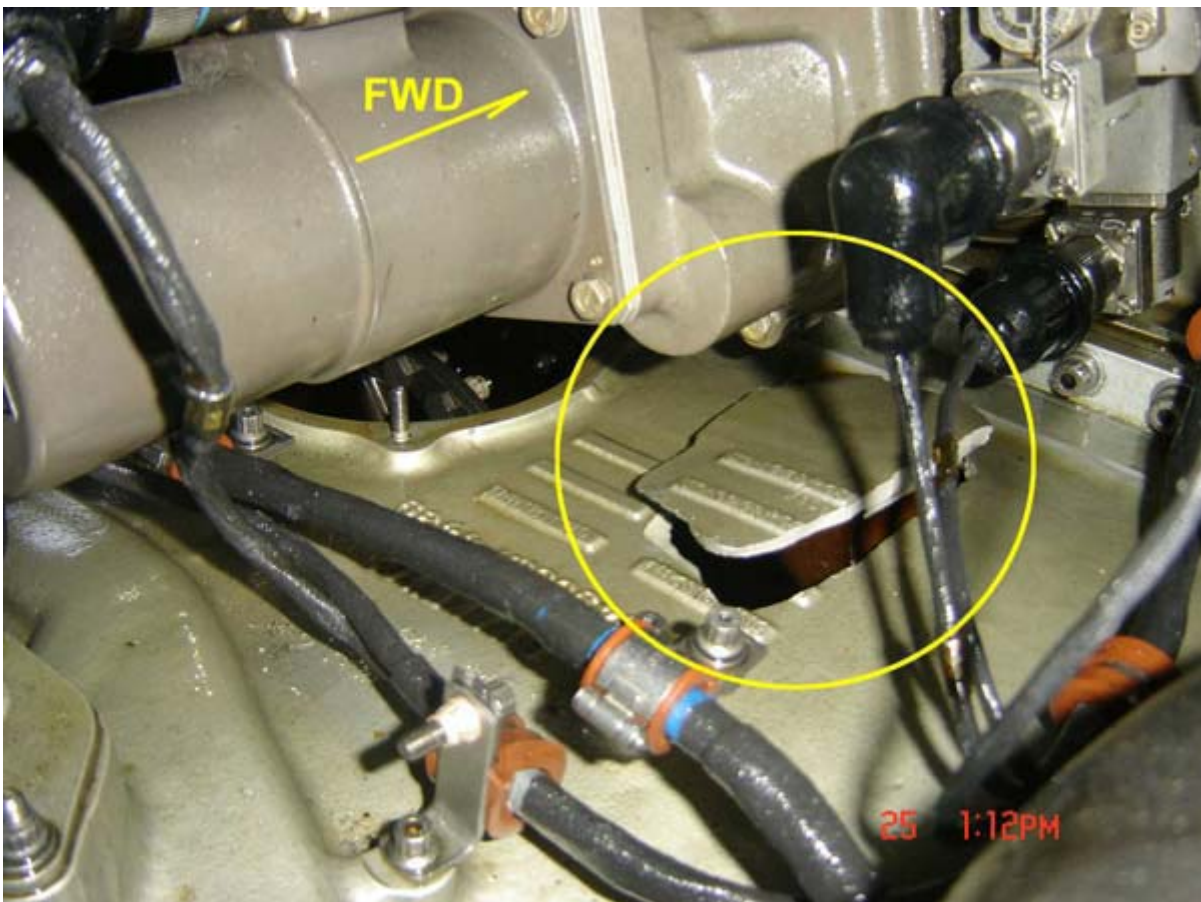
Photo 13 Damaged engine casing

- (4) One piece of the broken the RGB coupling shaft was found sticking out through a large opening on the engine case and another area on the case had another large opening caused by a broken piece of the coupling shaft striking against it.

It is highly probable that, after the fracture of the RGB coupling shaft, a broken piece of the coupling shaft was striking against the engine case, and therefore the broken piece stuck out through a large opening on the engine case and another area on the case had another large opening as described in 2.8.1 (4).

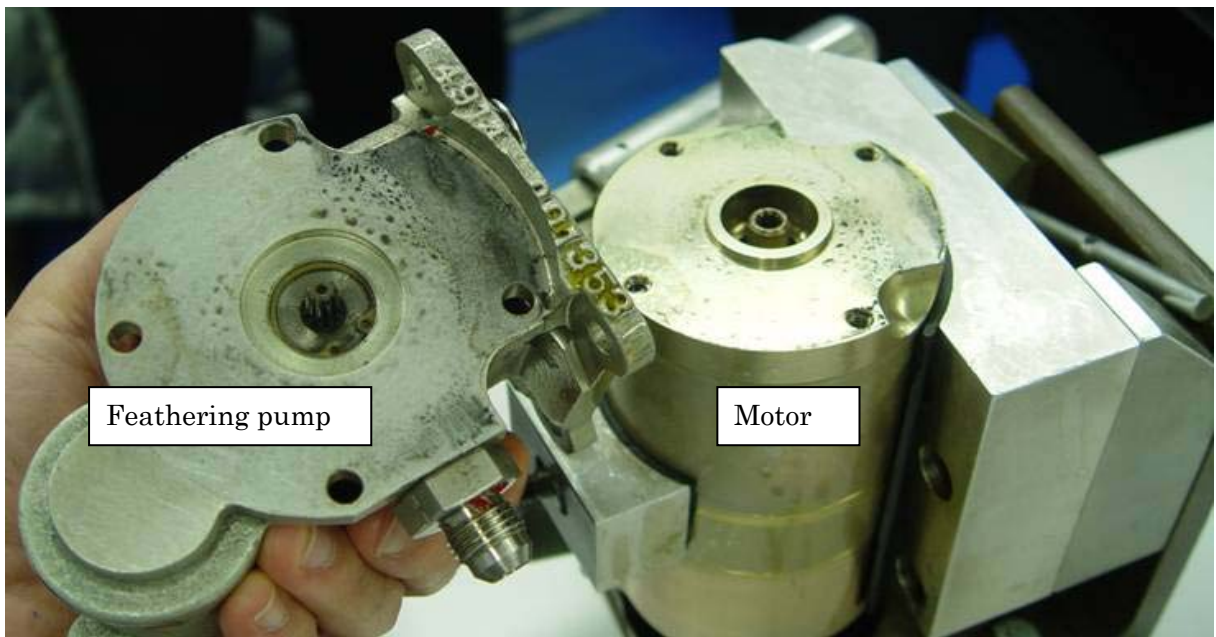
Photo 14 Motor of feathering pump

The feathering pump (pump for placing the propeller in feather mode) was operationally defective.

The motor was shorted to the ground and damaged.

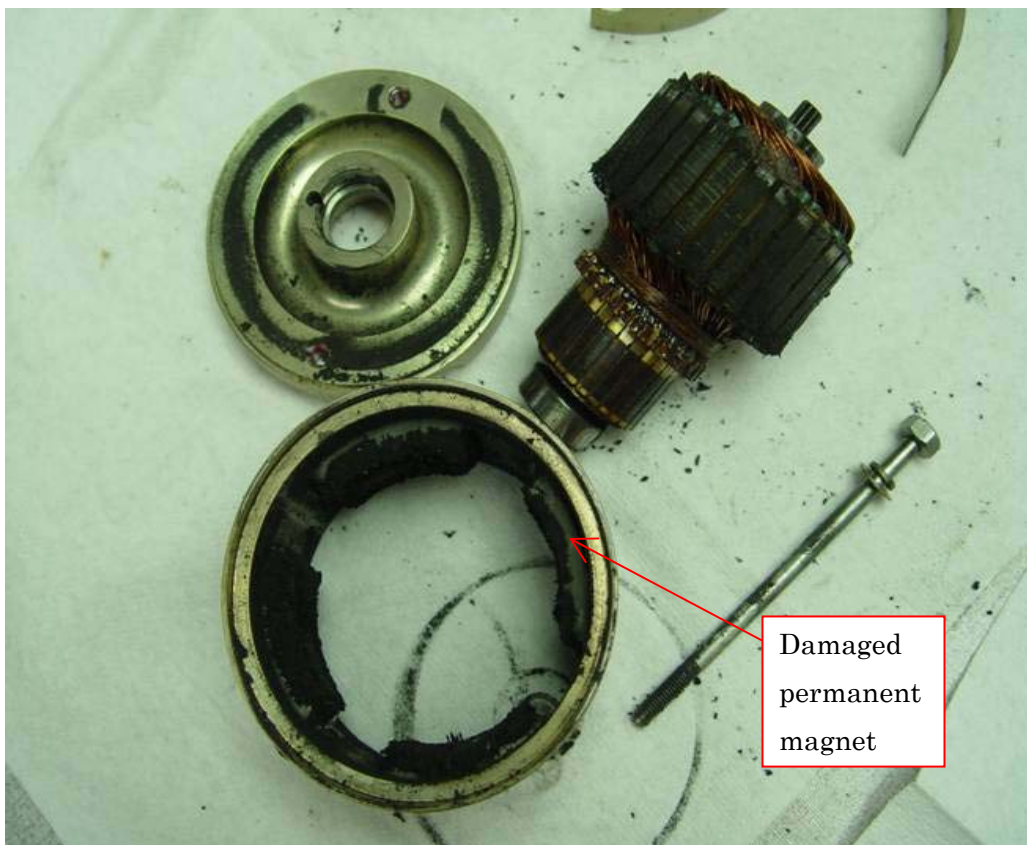
Photo 15 Damaged motor of feathering pump

powder dust. The permanent magnets were corroded.

- (2) The armature had cracks. The permanent magnets were found detached due to separation of the retaining adhesive from the inside of the case.
- (3) The armature had interfered with the permanent magnets, and both were damaged.

With regard to the motor failure, it is considered highly probable that the corroded permanent magnets having separated from the inside of the motor case interfered with the armature, causing
